Large-scale fire tests with textile membranes for building applications

SP Technical Research Institute of Sweden

**TEXTILE ARCHITECTURE –
TEXTILE STRUCTURES AND BUILDINGS OF
THE FUTURE**

SP Technical Note 2010:03

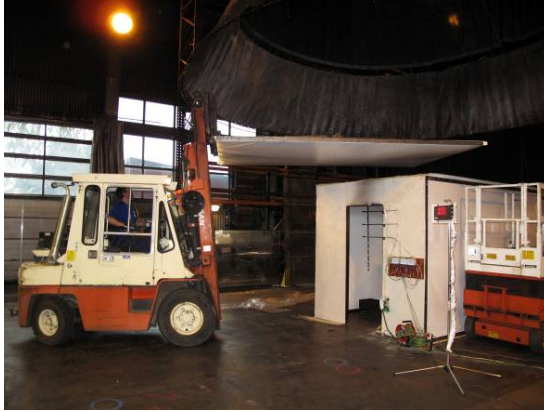
Figure 3 Mounting of roof membrane.

The tests were conducted with a room of size $3.60\text{ m} \times 2.40\text{ m} \times 2.40\text{ m}$ as specified in ISO 13784 and ISO 9705, with a door opening on one short side of $0.8\text{ m} \times 2\text{ m}$. The walls and the roof consisted of one layer of textile membrane. The wall on the short side with the door opening was, however, made of non-combustible mineral board (Promatect). A photo of the test building is given in Figure 1. The frame was constructed using 2 mm thick steel profiles $60\text{ mm} \times 60\text{ mm}$ with the exception of the vertical bars in the non-door corners which were constructed using 2 mm thick $40\text{ mm} \times 40\text{ mm}$ steel L-profiles. For clamping of the membranes, 60mm flat iron bars were used with a self-drilling screw every 300mm. Holes were predrilled in the frame and the flat bars, with slightly bigger holes in the flat bars. The membrane used for the walls was fastened at the top and bottom of the frame and on the door corners. One continuous length of membrane was used for all three walls. The membrane for the roof was mounted on a special frame for the roof. The roof frame was fastened to the walls using screws and the joint between the two frames was carefully calked using mineral wool. The mounting of the membrane is shown in Figure 2 and Figure 3.

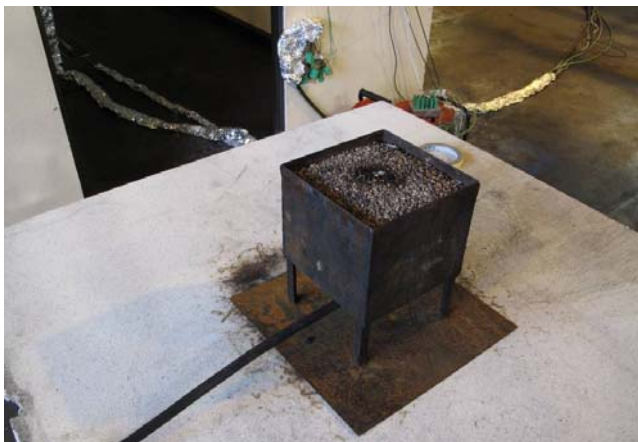
Figure 4 Burner for the reference scenario tests.

In the first series of tests, a 17 cm × 17 cm burner was placed in the left hand rear corner of the room with a heat release rate (HRR) from the burner of 100 kW for 10 minutes followed by 300 kW for 10 minutes, as in the ISO 9705 room corner test ². The burner is seen in Figure 4. The first series of tests were conducted in order to investigate a possible reference scenario for European reaction-to-fire classification tests.

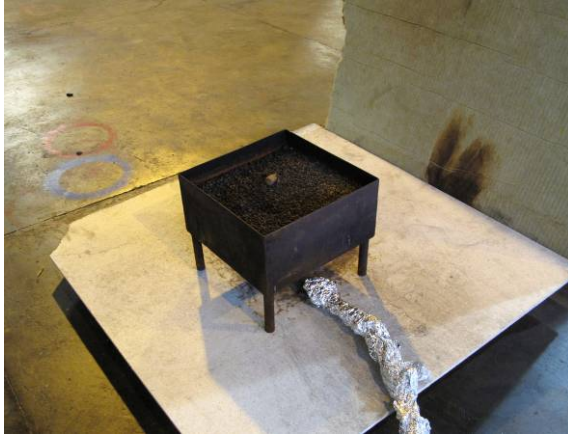
Figure 5 Burner for CFD-validation tests.

In the second series of test, a 30 cm × 30 cm burner was placed in the middle of the room. Two sets of tests with the burner located at different heights were made. In one set of test the burner was placed at a height of 45 cm with a HRR from the burner of 95 kW for 10 minutes, 140 kW for 10 minutes, followed by 300 kW for 5 minutes. In the other set of test the burner was placed at a height of 100 cm with a HRR from the burner of 95 kW for 5 minutes followed by 140 kW for 5 minutes. The burner is seen in Figure 5 and Figure 6. These test were conducted for validation of CFD modelling of hole opening in membranes during fire.

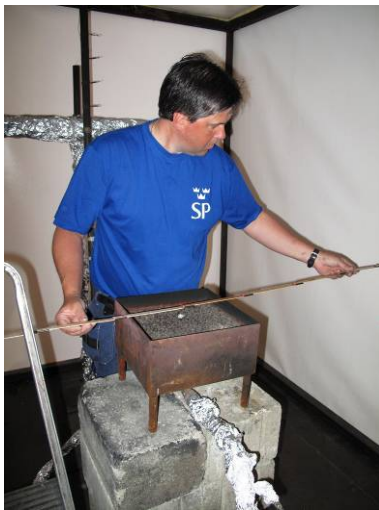
Figure 6 Placing the burner in the middle of the room in the CFD-validation tests.

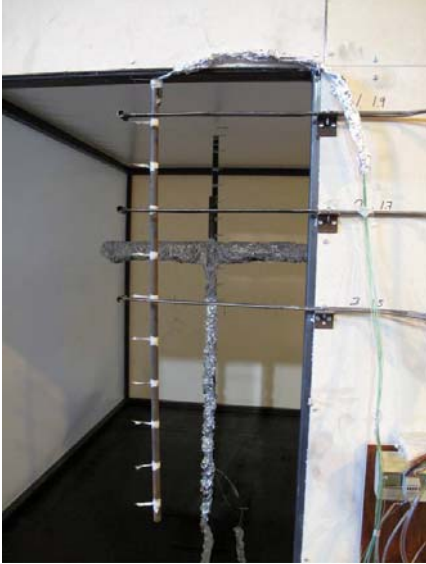
Figure 7 Velocity and temperature measurement in door opening. Smoke measurement and thermocouple tree in middle of room can also be seen.

In both series of tests, temperature and velocities in the door opening were measured. The temperature at 0, 10, 20, 30, 40, 50, 60, 70, 80, 90 and 100 cm below the soffit and velocities at 10, 30 and 50 cm below the soffit were recorded, as can be seen in Figure 7.

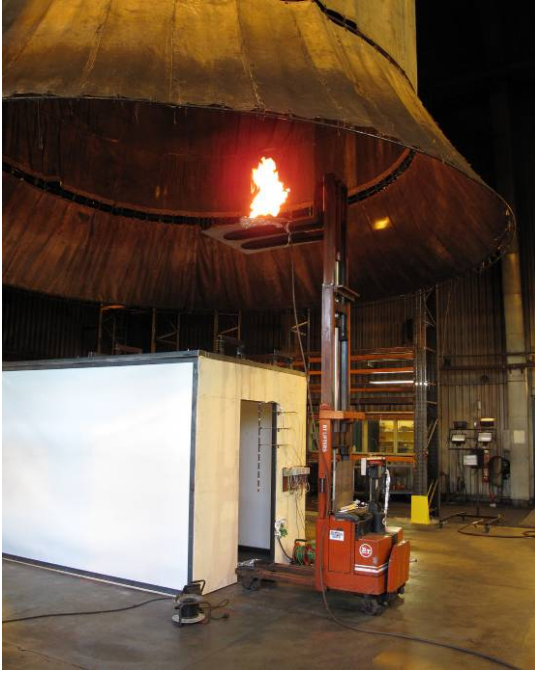
Figure 9 Calibration of HRR measurement with propane burner.

The test room was placed under a large calorimetric hood/duct system. Heat Release Rate (HRR) and smoke production were measured in the duct. Additionally, the velocities and temperature readings in the door opening were used to estimate the convective flow of heat out of the door opening. The HRR measurement in the duct was calibrated before each test with a propane burner as shown in Figure 9.

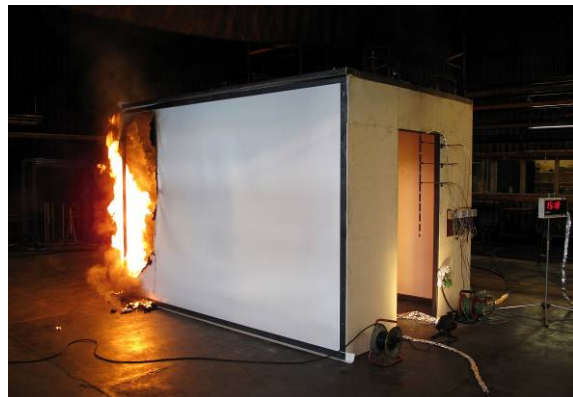
Figure 15 View from the outside at the highest burner output (Test 1, time 15:19).

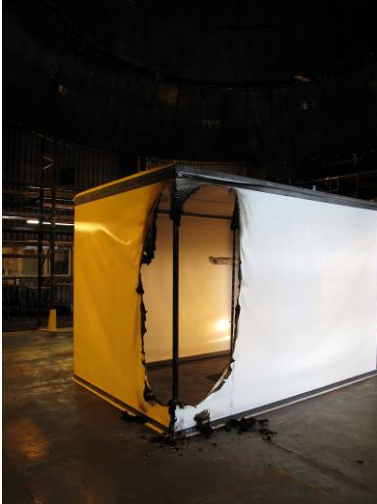
Figure 16 Damages in the corner of the room (Test 1, test completed).

Comment: The hole in the membrane after the fire was estimated from photos as 0.8 m × 2 m on both sides.

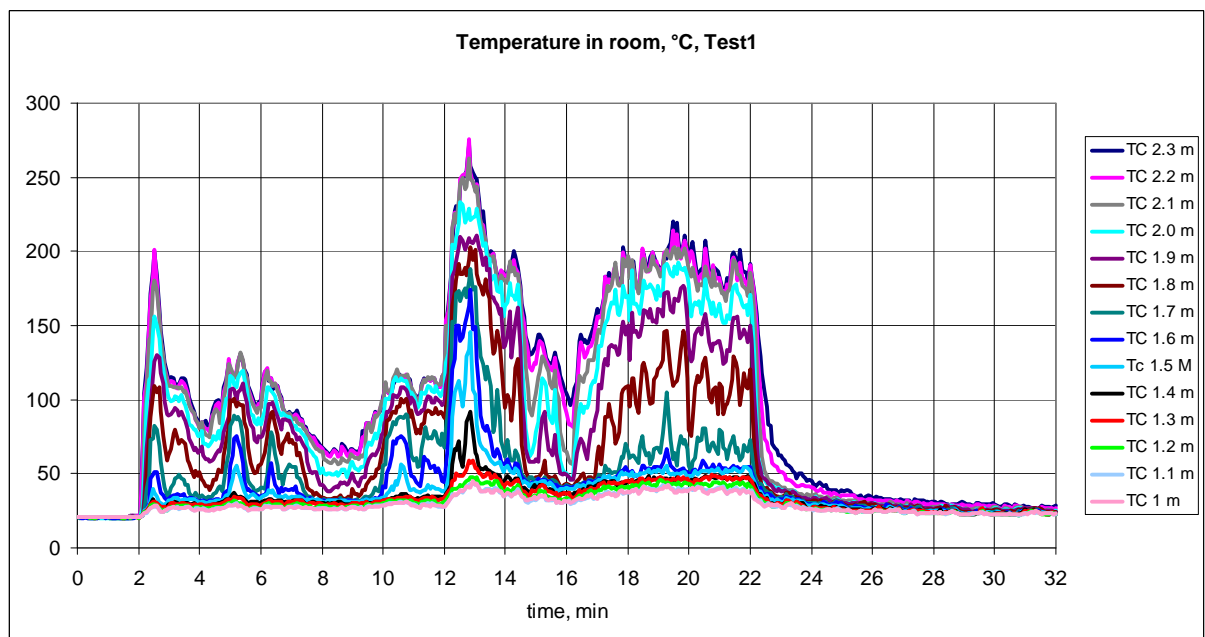
Figure 19 Temperature readings in middle of room test 1.

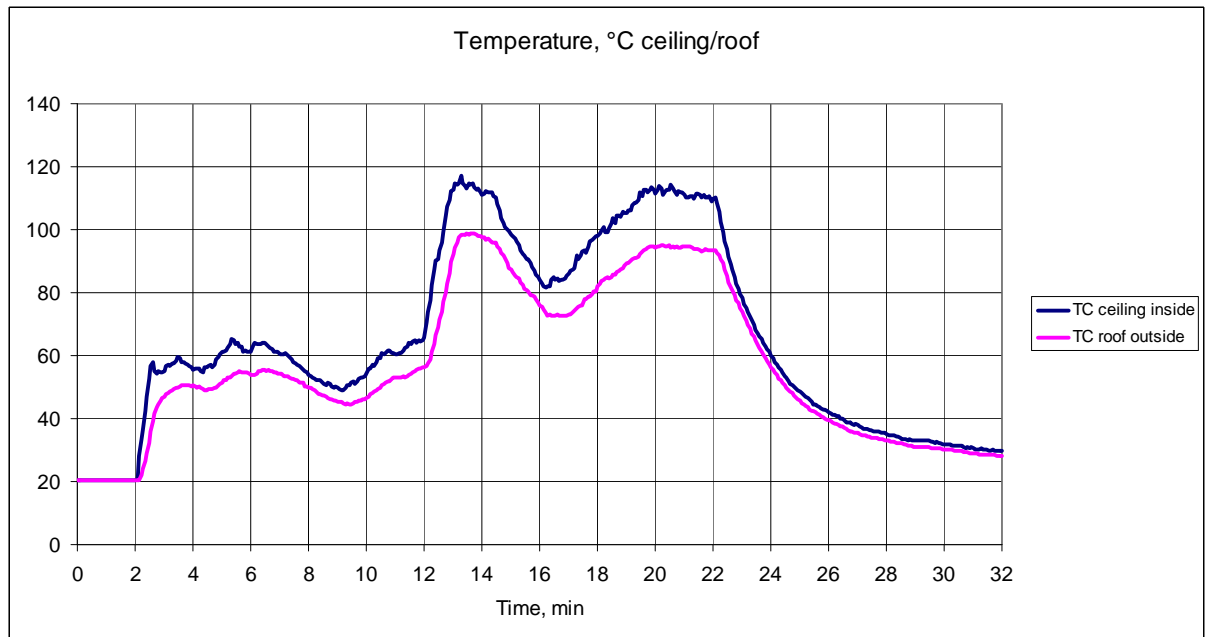
Figure 20 Temperature readings on membrane from test 1.

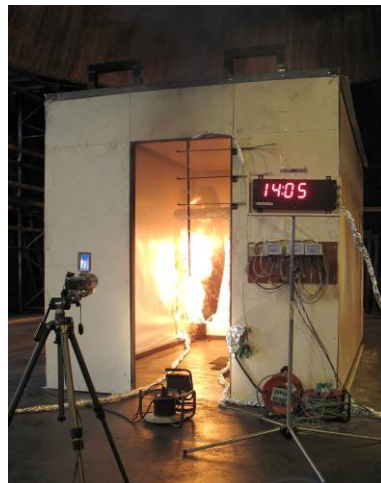
Figure 28 Illustrative photo of fire behaviour at the highest burner output (Test 2, time 14:05).

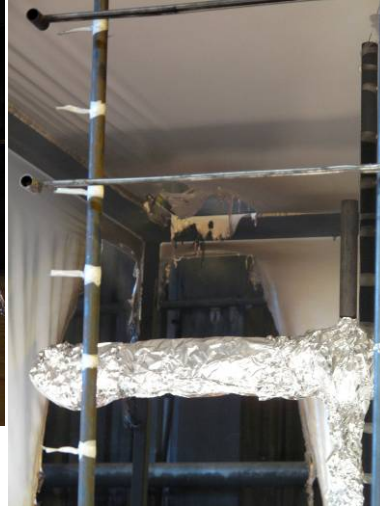
Figure 30 Close up of hole in the roof in the corner (Test 2, test completed).

Comment: At the end of the test the hole was 80 cm wide and 2 m high on the longer side and 60 cm wide and 2 m high on the short side. The hole in the ceiling was 40 cm × 25 cm.

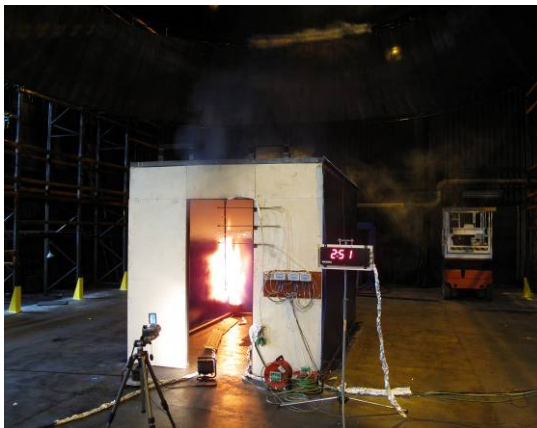
Figure 39 View of burner in corner of room shortly after ignition of burner (Test 3, time: 2:51).

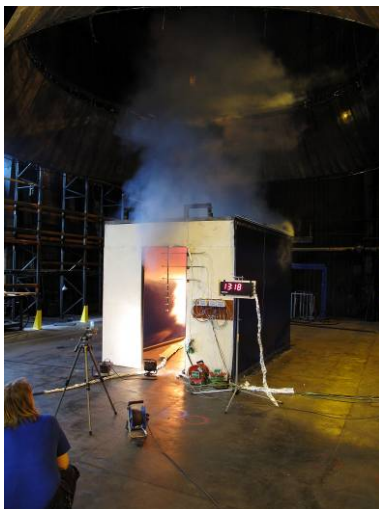
Figure 41 Illustrative photo of fire behaviour at highest burner output (Test 3, time: 13:18).

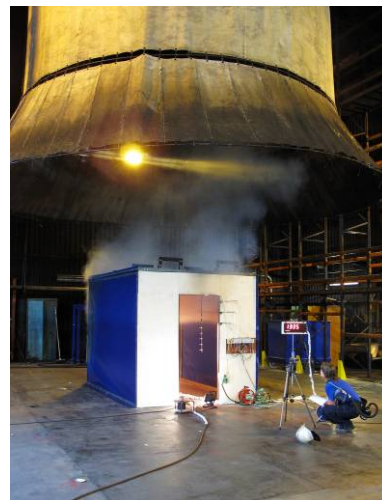
Figure 42 Smoke layer in room and decomposition/evaporation of coating material (Test 3, time: 13:18).

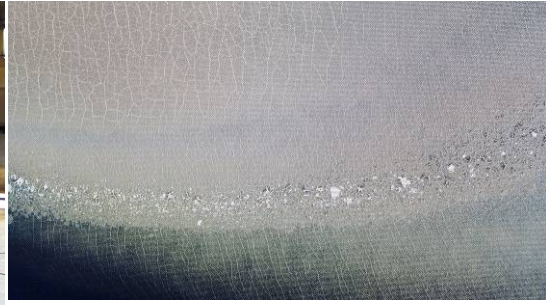
Figure 44 Close up on damages in corner (Test 3, test completed).

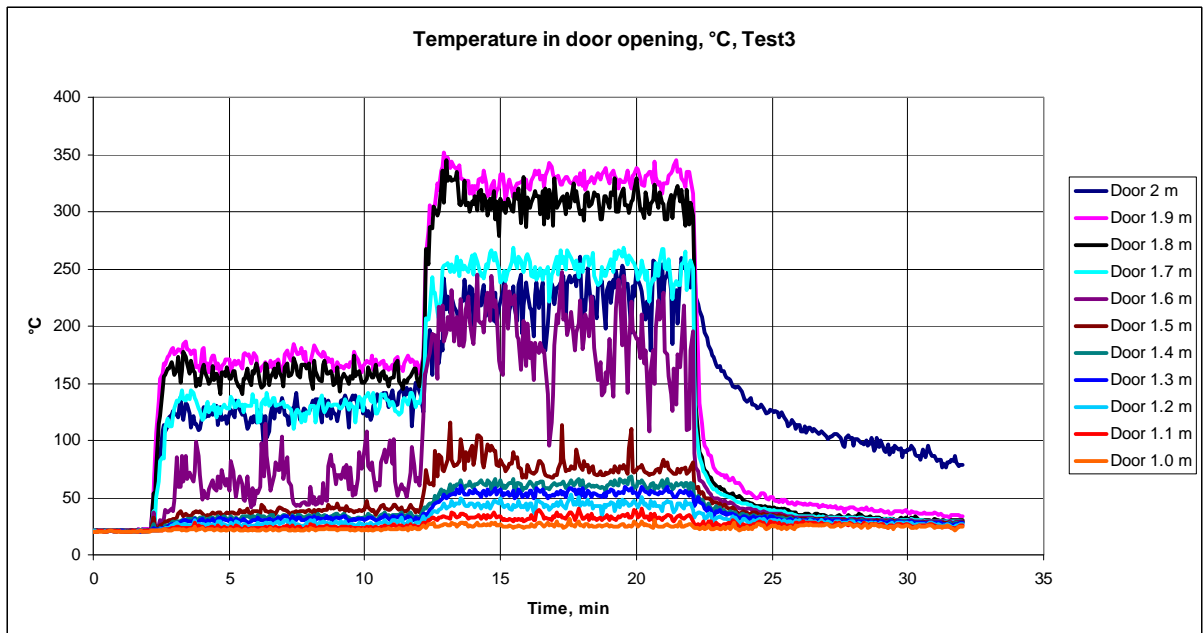
Figure 45 Temperature readings in door opening in Test 3.

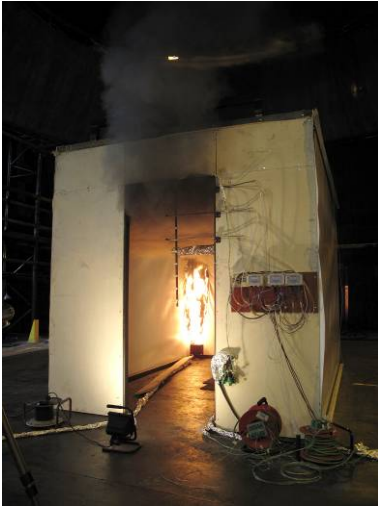
Figure 53 Black smoke out from the door opening, hole has opened in the corner (Test 4, time 2:52).

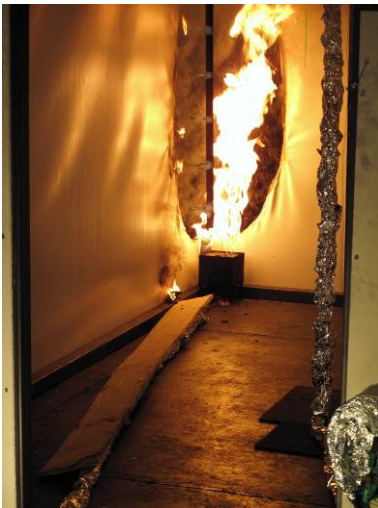
Figure 55 Close up of hole in corner at lowest burner output (Test 4, time 7:02).

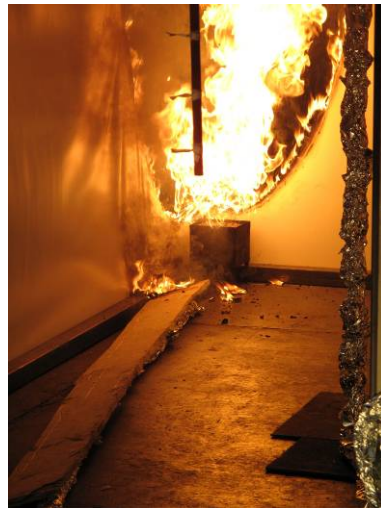
Figure 56 Close up of hole in corner at highest burner output (Test 4, time 13:33).

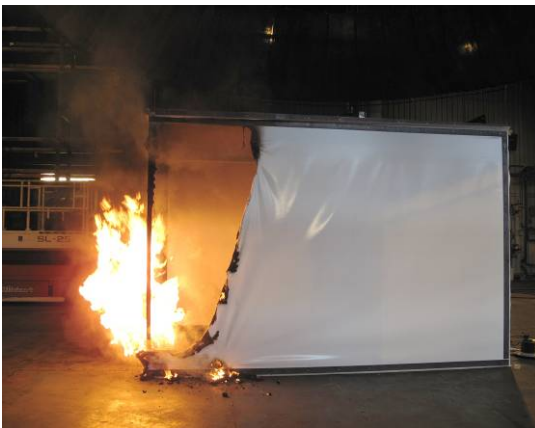
Figure 57 The corner with the burner in the end of the test (Test 4, time 15:19).

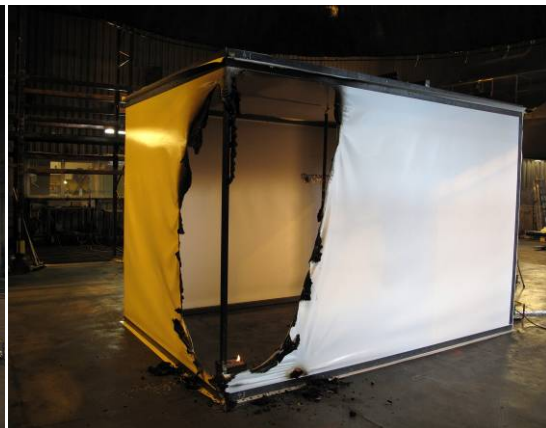
Figure 58 Damages in the corner of the room (Test 4, test completed).

Comment: The hole after the test measured $1\text{ m} \times 2.4\text{ m}$ and $0.75\text{ m} \times 2.2\text{ m}$ respectively.

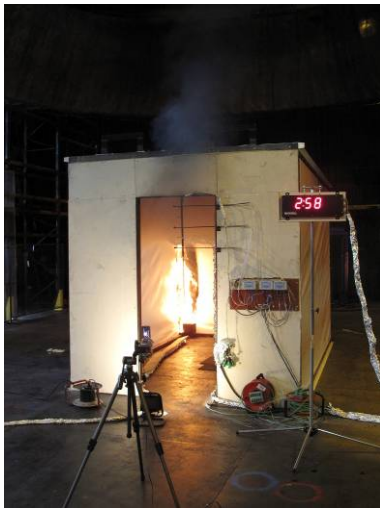
Figure 67 Hole has opened up in the corner (Test 5, time 2:58).

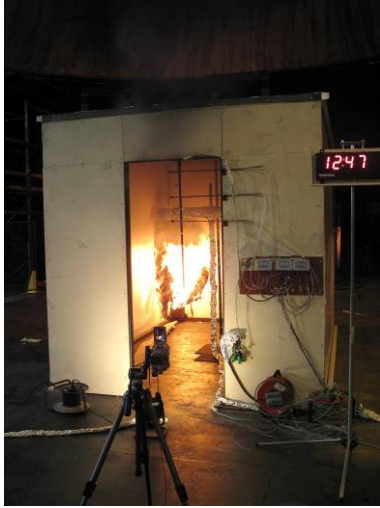
Figure 69 Hole in the corner after increasing to the highest burner output (Test 5, time 12:47).

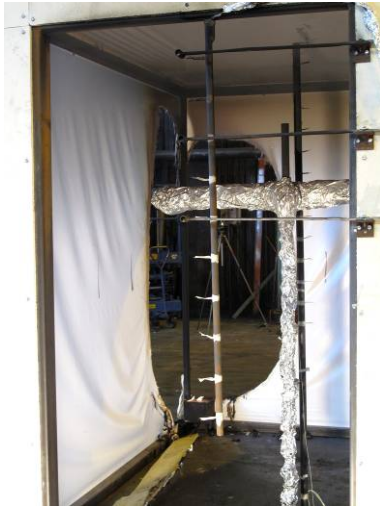
Figure 71 Damages in the corner of the room (Test 5, test completed).

Comment: The hole was measured as 0.7 m × 2.2 m on the long wall side, 0.8 m × 2 m on the short wall side and 15 cm × 2 cm ceiling.

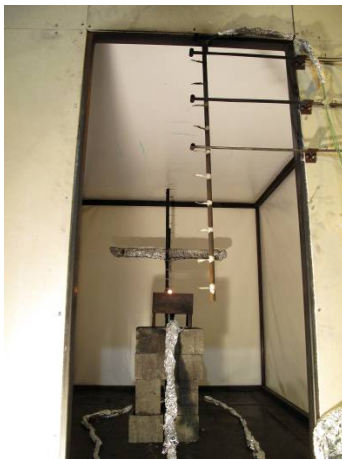
Figure 80 The textile room before the test (Test 7, prior to test).

The ceiling was not completely flat, but hung down approximately 6 cm in the centre of the room. The burner was placed in the middle of the room, 1 m above ground. Notes made during the test are presented in Table 9. Photos taken during the test are presented in Figure 80 - Figure 89 and measurements are presented in Figure 90 - Figure 97.

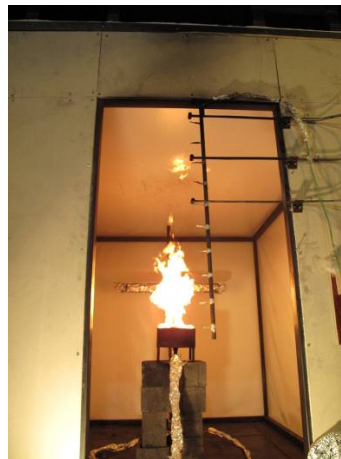
Figure 81 Early in the test with the burner at the lower heat output (Test 7, time 02:20).

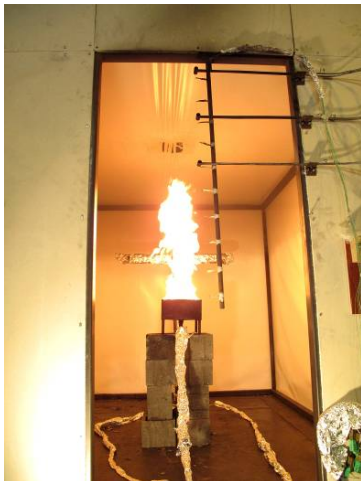
Figure 82 Hole is starting to open up (Test 7, time 02:59).

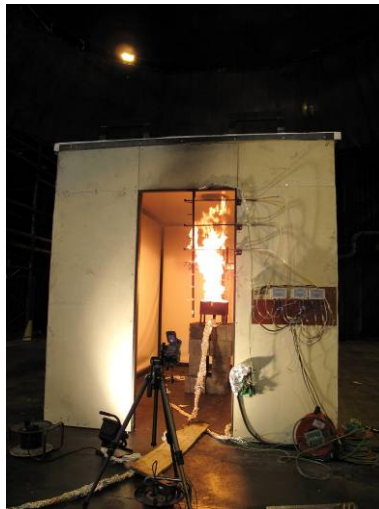
Figure 87 The burner at the higher heat output (Test 7, time 06:13).

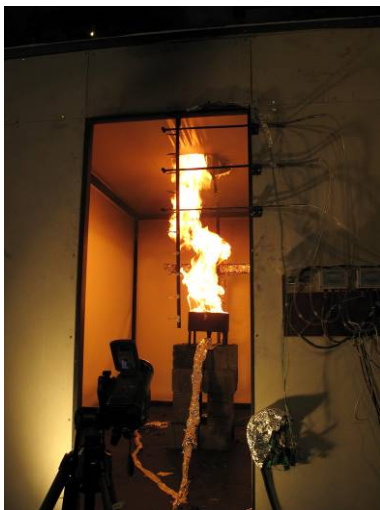
Figure 88 The hole in the ceiling at the higher heat output (Test 7, time 07:41).

Comment: The hole after the test was 0.65 m × 0.65m.

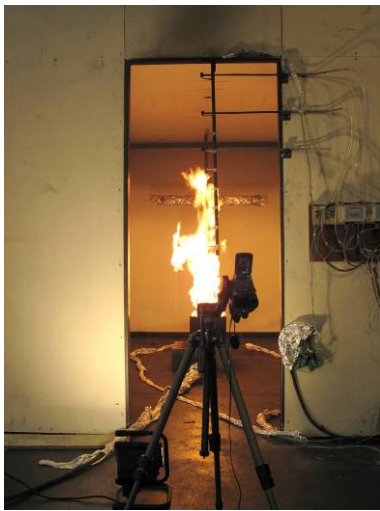
Figure 98 The burner at the lowest heat output (95 kW) before hole opening (Test 8, time 06:38).

The burner was placed in the middle of the room, 45 cm above ground. The burner start was delayed due to the fact that the main gas switch had been turned off. Notes made during the test are presented in Table 10. Photos taken during the tests are presented in Figure 98 - Figure 103 while measurement results are presented in Figure 104 - Figure 111.

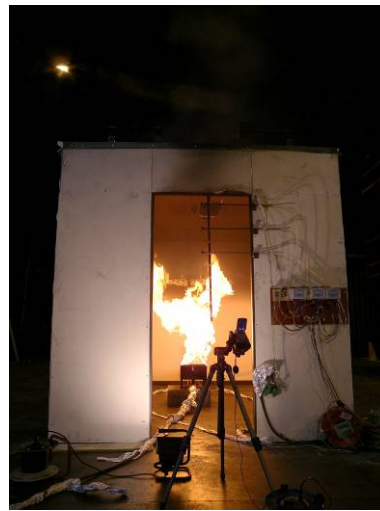
Figure 99 The burner at the highest heat output (300 kW) at the time of hole opening (Test 8, time 26:28).

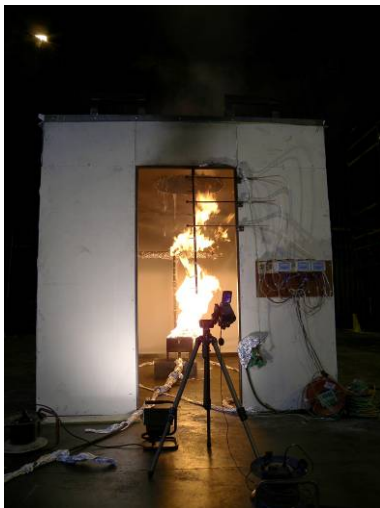
Figure 100 Hole has opened up more and dripping from rim of hole (Test 8, time 26:36).

Comment: The hole was measured to $0.95 \text{ cm} \times 1 \text{ m}$ afterward the test.

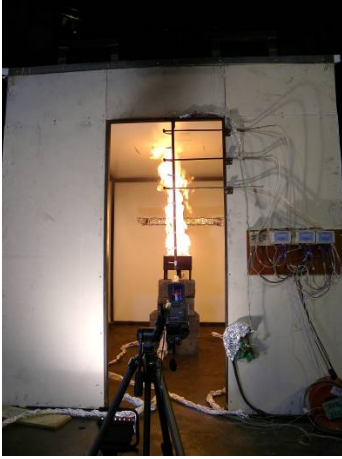
Figure 112 Burner ignited (Test 9, time 2:16).

The burner was placed in the middle of the room, 1 m above ground. Notes made during the test are presented in Table 11. Photos taken are presented in Figure 112 - Figure 117 and the measurement results are presented in Figure 118 - Figure 125.

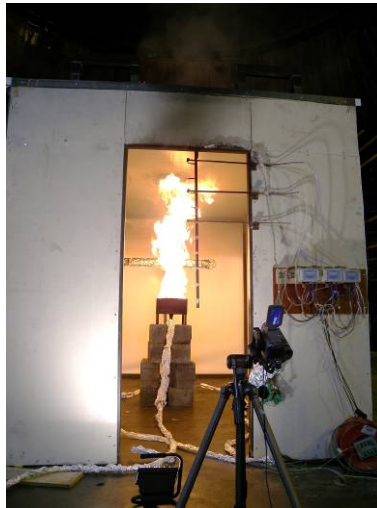
Figure 115 Burner increased to highest heat output (Test 9, time 7:22).

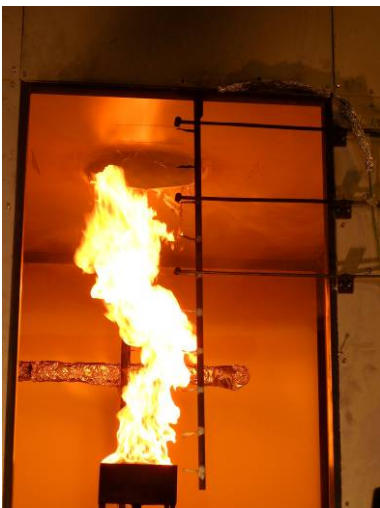
Figure 116 Close up of hole in ceiling (Test 9, time 7:50).

Comment: The hole was 63 cm × 62 cm.

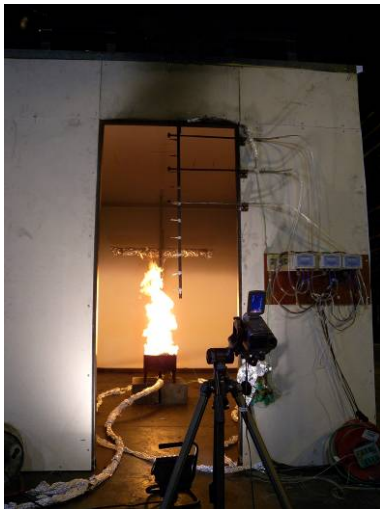
Figure 126 Burner at 140 kW heat output (Test 10, time 13:54).

The burner was placed in the middle of the room, 45cm above ground. Notes made during the test are presented in Table 12. Photos are presented in Figure 126 - Figure 131 and the measurement results in Figure 132 - Figure 139.

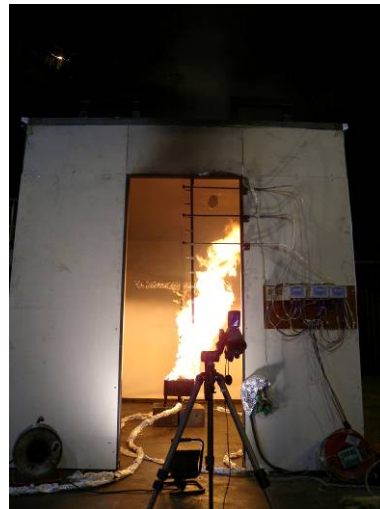
Figure 127 Burner at 300 kW. Flame leaning to the right and a small hole has opened in the ceiling (Test 10, time 22:32).

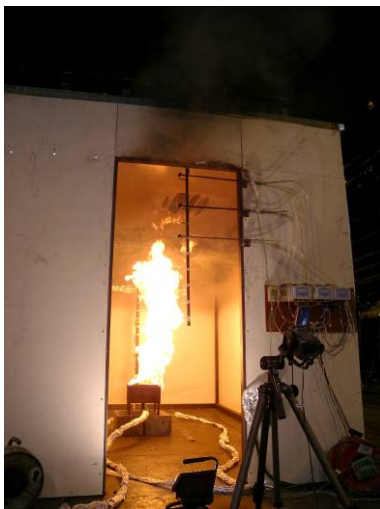
Figure 128 Larger hole is opening up in ceiling (Test 10, time 22:50).

Comment: The hole was 110 cm × 90 cm after the test.
