BRANDFORSK
2018:2:2

Mitigation of fire damages in multi-storey timber buildings – statistical analysis and guidelines for design

RISE Report 2018:43

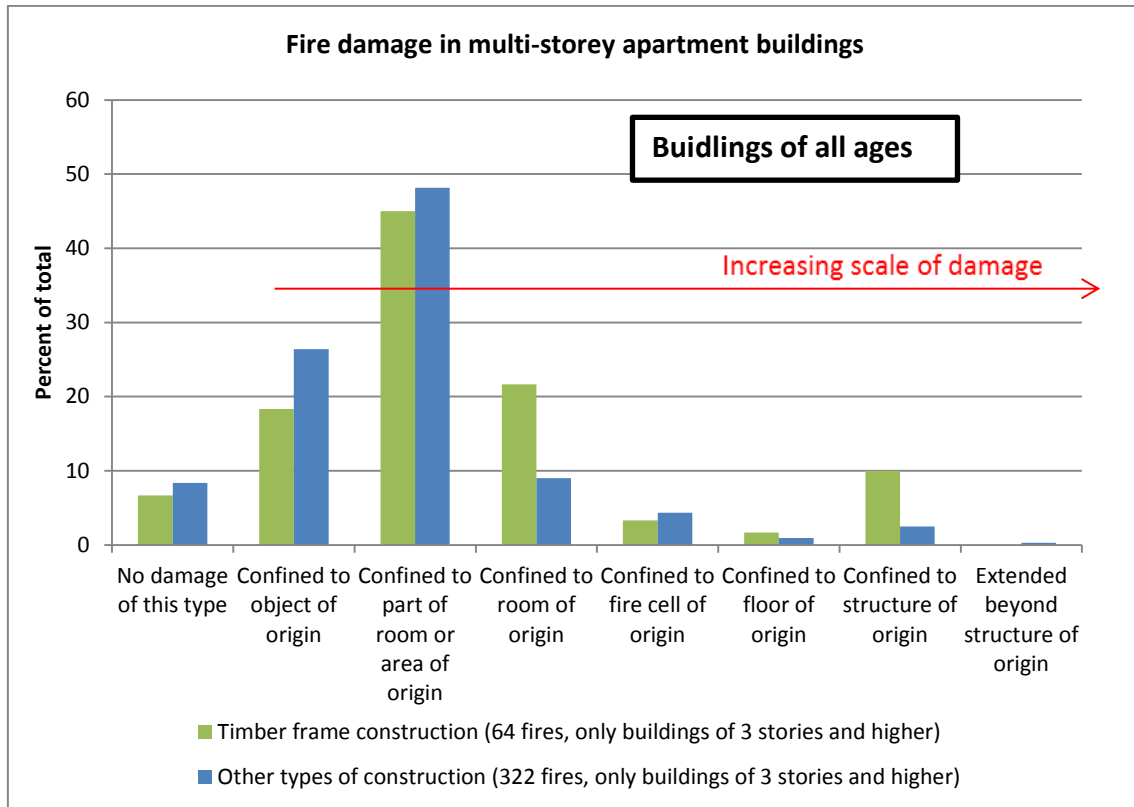
Figure 1: Fire damages after fires in New Zealand from 2000 to 2016, distributed in categories indicating the scale of the damage.

Figure 1 shows a distribution of direct flame damage (by flames and radiation). It should be noted that the data of this figure contains buildings of all ages. About half of the timber frame buildings were built before 1991 and about two-third of the other buildings were built before 1991. It can be seen that there is a higher frequency of large fire damages in buildings of timber frame construction than buildings of other types of construction. However, Figure 2, which includes only fire in modern buildings (constructed after 1991) shows that this difference of large fire damages does not exist for modern buildings. Of apartment buildings built after 1991, there was no fire that extended beyond the fire cell of origin, which indicates that the fire safety design objective was reached successfully for these buildings. The percentage of fires that spread beyond the fire cell of origin was lower for modern timber buildings than for other types of modern buildings. However, this difference is not statistically significant according to a 2-tailed two proportion test with a significance level of 0.05.

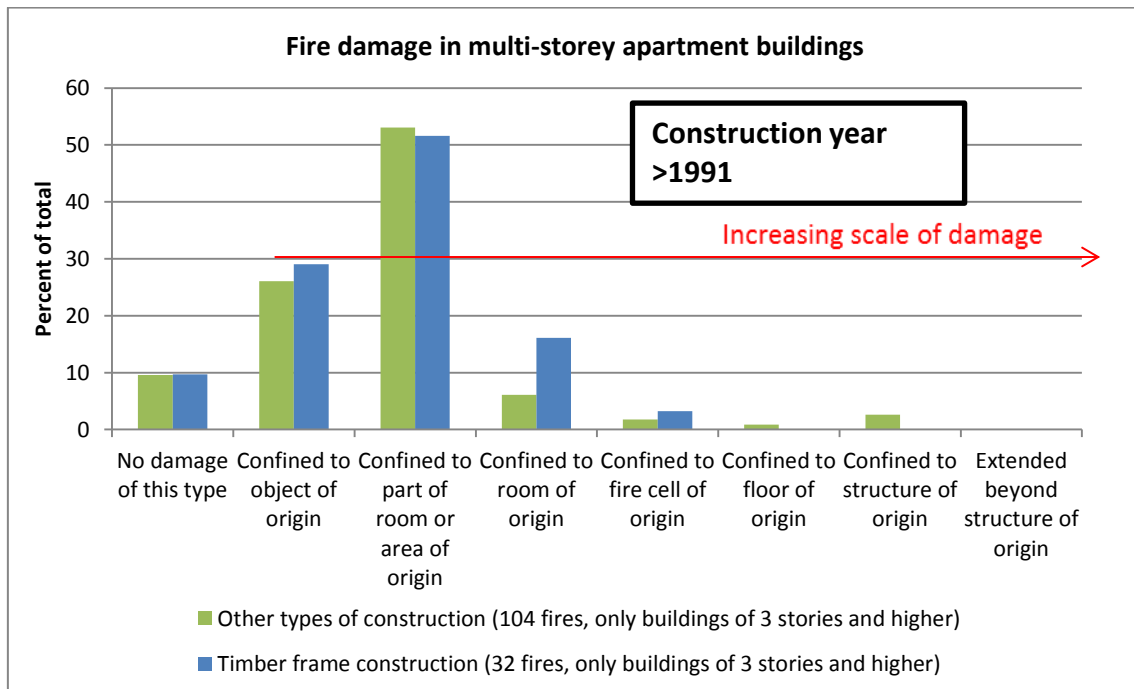
Figure 2: Fire damages after fires in modern buildings in New Zealand from 2000 to 2016, distributed in categories indicating the scale of the damage.

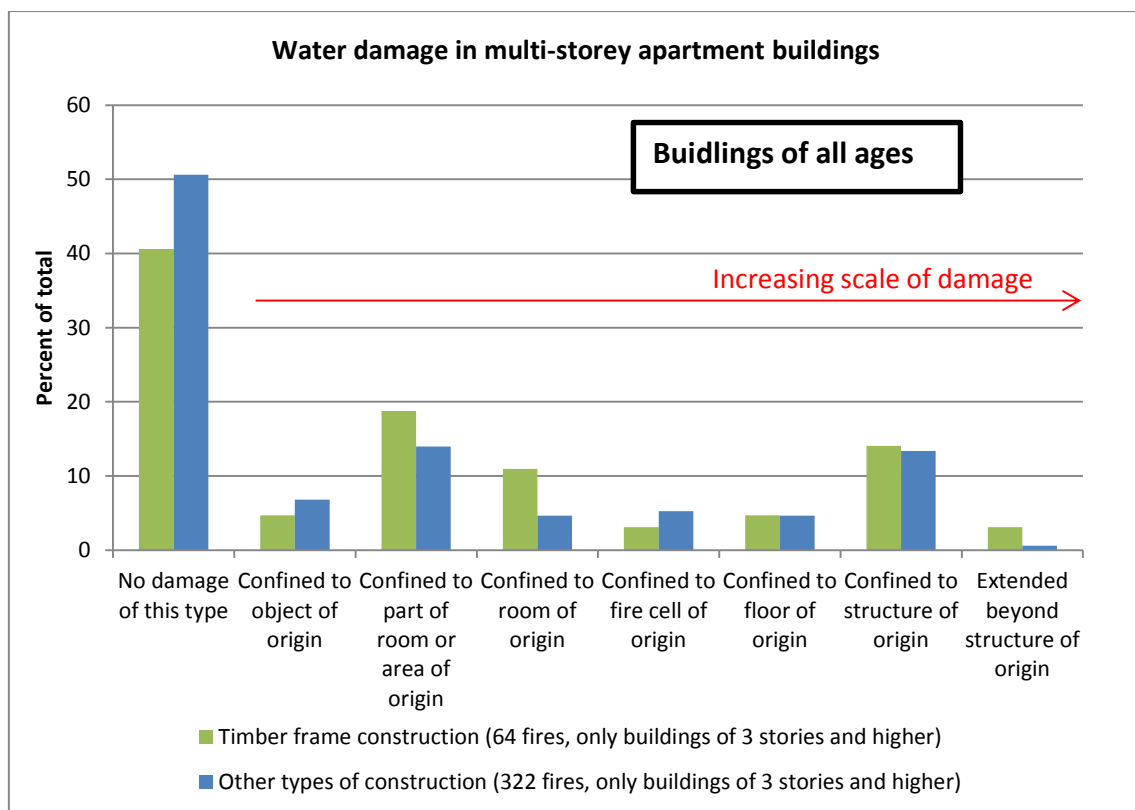
Figure 3: Water damages after fires in New Zealand from 2000 to 2016, distributed in categories indicating the scale of the damage.

Figure 3 shows the distribution of water damages based on the scale of damage. From the left to the right, the scale of the damage increases, from no water damage at all to damages extended beyond the building of origin. This data includes data of fires in old buildings as well as modern buildings. The distribution of water damages seems to be relatively equal in timber frame construction and other types of buildings.

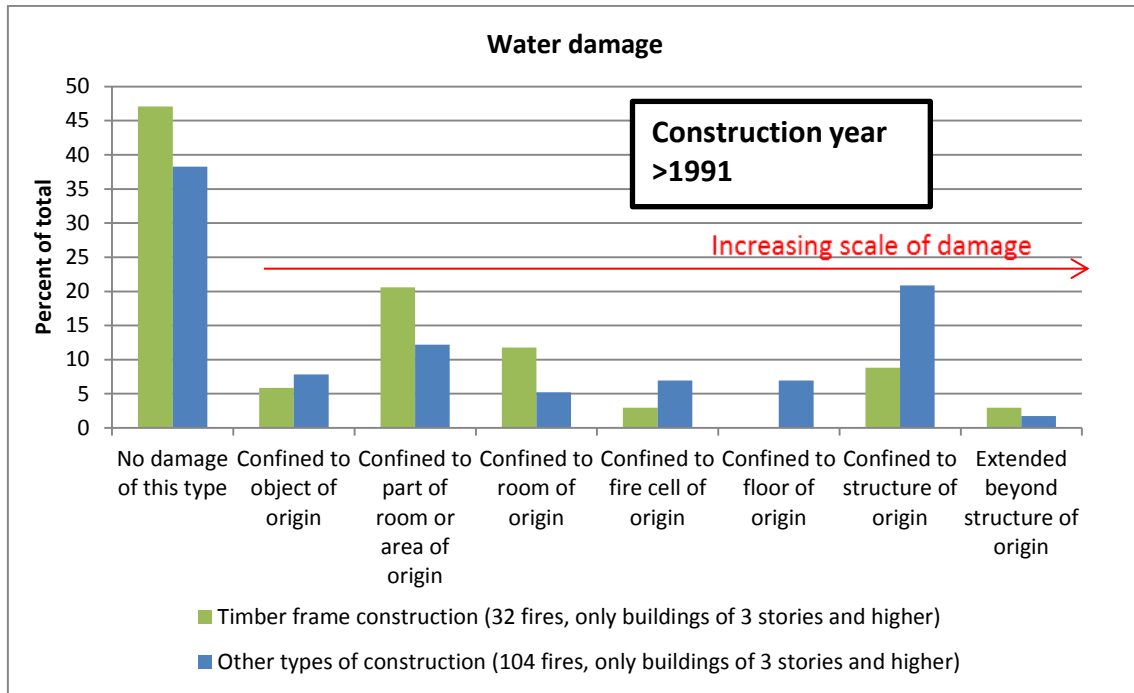
Figure 4: Water damages after fires in modern buildings in New Zealand from 2000 to 2016, distributed in categories indicating the scale of the damage.

Figure 4 shows a similar graph, for modern buildings only (built after 1991). It can be noted that the spread of water damage in New Zealand was smaller in modern timber frame buildings than in other modern types of buildings. The frequency of water damages that extended beyond the fire cell of origin is lower in modern timber buildings than in other types of buildings. In buildings of timber frame construction, approximately 12% of the water damages extended beyond the fire cell of origin, while in buildings of other types of construction, 30% of the water damages extended beyond the original fire cell. According to a 2-tailed two proportion test with a significance level of 0.05, this difference is statistically significant. It can also be stated that the frequency of high water damages was lower in modern buildings of timber construction than in traditional buildings of timber construction. These statistics are related to the area of the damage, but do not provide any information about the cost of the corresponding restoration. Unfortunately, reliable data needed to compare costs of restoration of water damages in buildings with different materials has not been found.

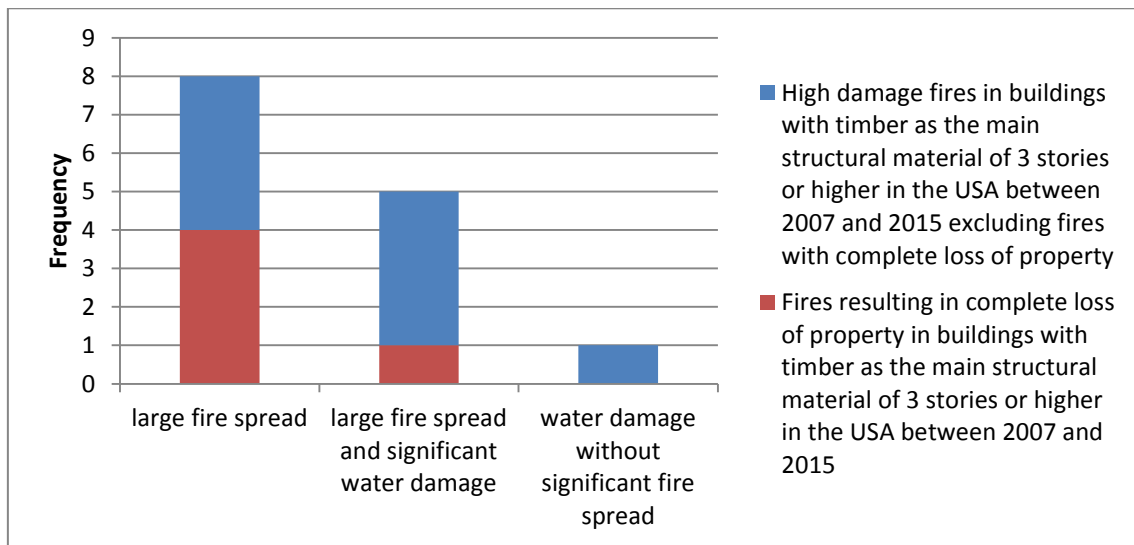
Figure 5: Main causes of high fire damages in the US and their corresponding frequency.

This selection of high damage fires includes 14 fires. Figure 5 indicates the main cause of financial losses according to the description of the fires. It should be noted that this data is dependent on the accuracy and completeness of the original reports owned by the NFPA and the interpretation of the researchers. One of the 14 high damage fires actually remained within one fire compartment. However, in that particular case, sprinkler activation led to extinguishment of the fire, but resulted in high water damages (38% property value loss). The fact that 13 out of the 14 identified high damage fires involve large fire spread, gives a strong indication that limiting the fire spread should be a main strategy to reduce property loss in fires. Of the 6 fires that led to high water damage, 1 was extinguished by sprinklers and 5 were extinguished by the fire brigade (Figure 6). 1 of these 5 fires led to complete loss of property value.

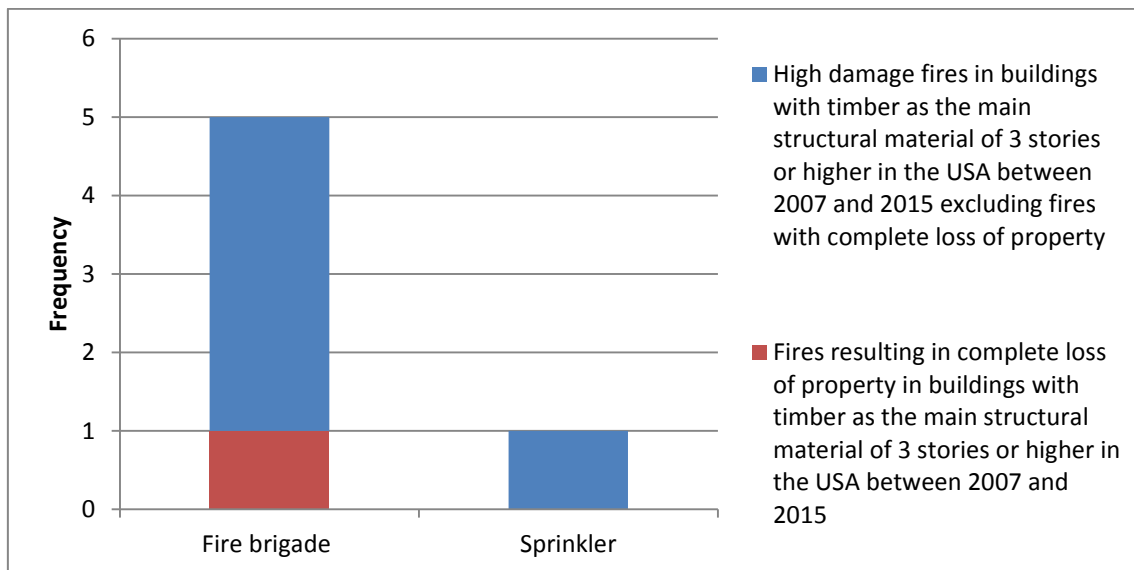
Figure 6: The method of extinguishment of fires that led to high water damages in the US

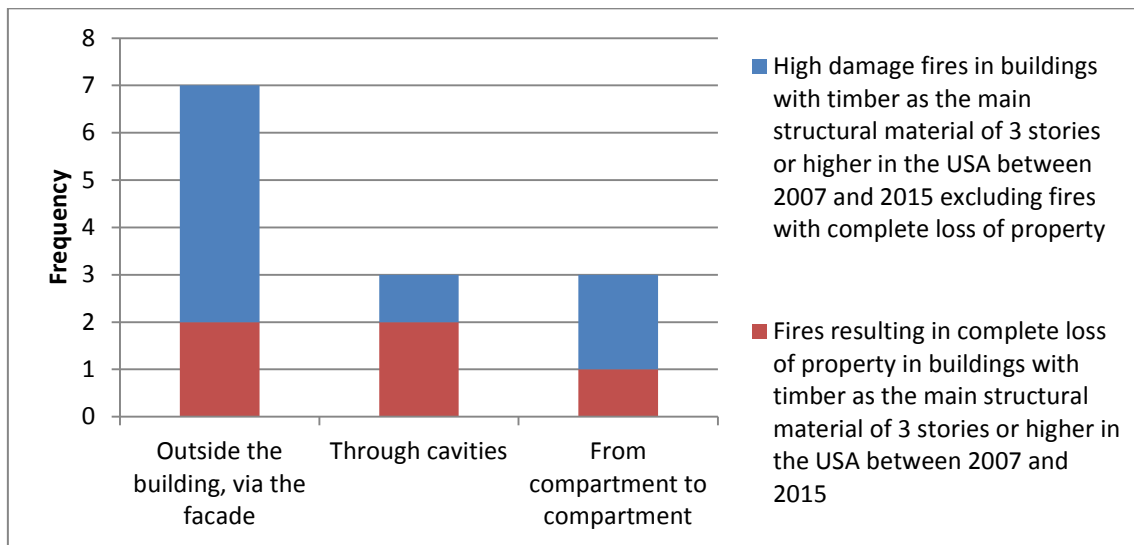
Figure 7: Main modes of fire spread and their corresponding frequency in large damage fires in the US.

Figure 7 shows that the most frequent mode of significant fire spread is via the façade. In three of eight cases, the fire entered into the attic according to the reports. Additionally, it can be seen that two of the three cavity fires of this high-damage selection led to complete loss of property.

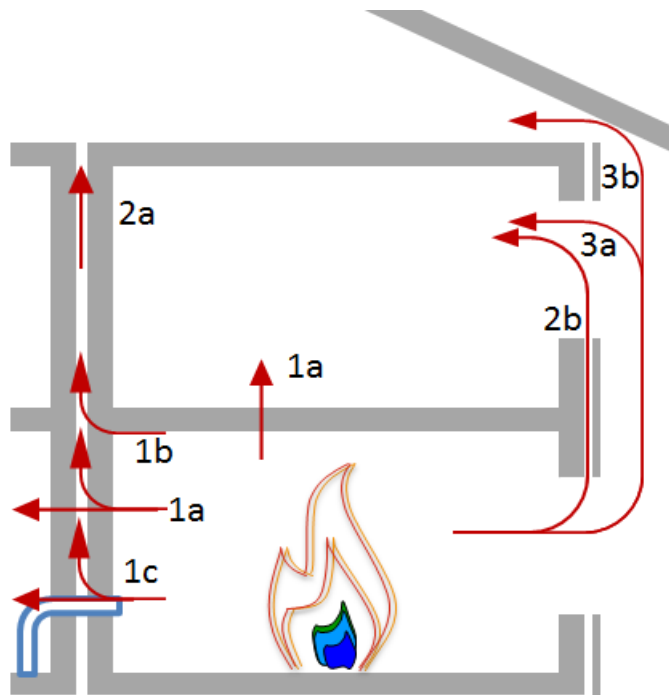
Figure 8: *Potential paths of fire and smoke spread out of the compartment considered for the building design*

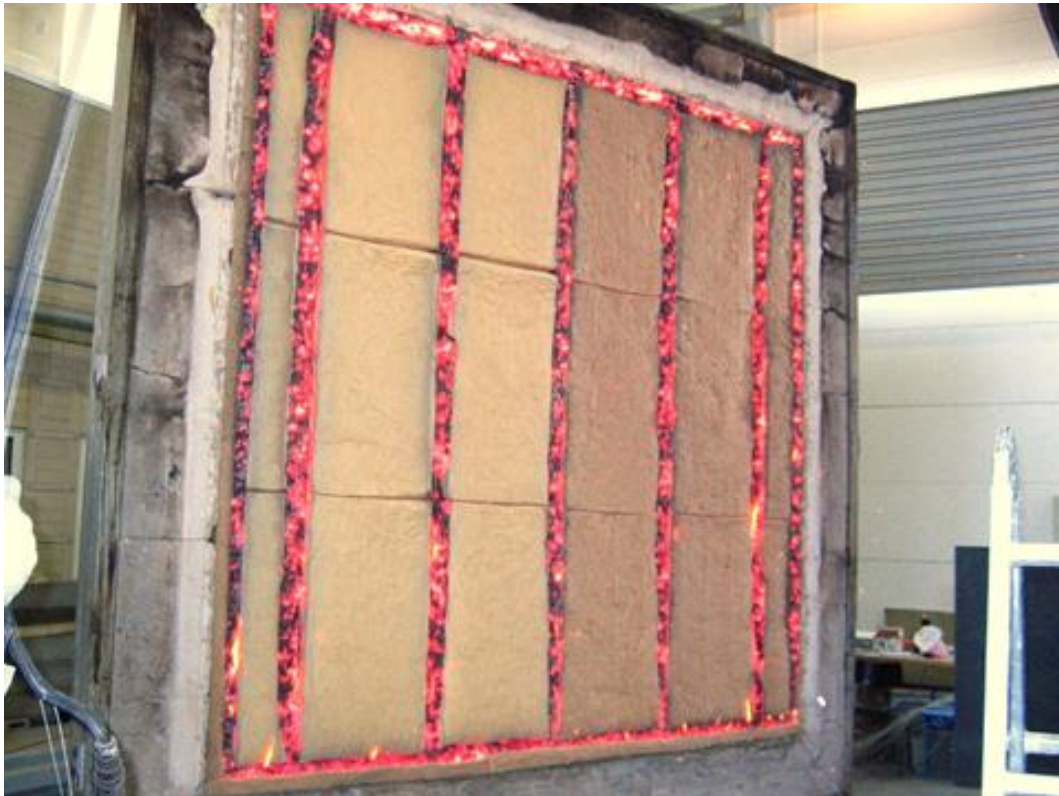
Figure 9: Stone wool fixed using over-dimensioning after 60 minutes fire test.

If the fire resistance is demonstrated with a fire resistance test, it is important that the exact same insulation material, product and fastening method are used in the designed building, as were implemented in the fire resistance test. This fastening method could involve fasteners, but also methods to clamp the insulation in place to preventing fall-off (Figure 9).

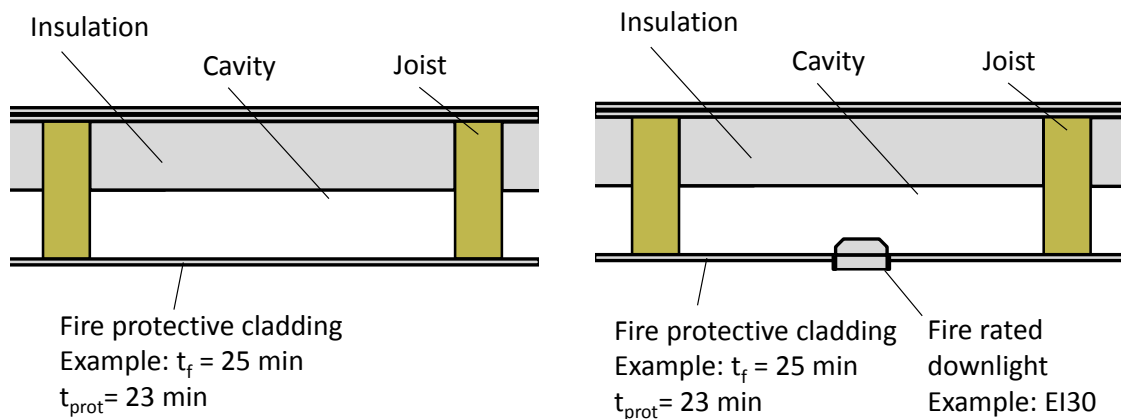
Figure 10: Example A - cross section of a 60minutes fire resistant ceiling (left) and a suitable application of a fire resistant lamp in this ceiling (right)

relevant) of the penetrated elements. Example A: A fire tested timber frame ceiling, with a fire resistance rating of REI60 (Figure 10, left) has one layer of fire protective cladding at the bottom (exposed) side. The ceiling is applied with fire rated and fire sealed downlights. The fall-off time and the protection time of the fire protective cladding are determined directly from tests in accordance with EN 1364 and are exceeded by the fire resistance rating of the downlights and sealant (see Figure 10, right). In this situation the fire resistance is not compromised with the implemented downlights. If the protection time and fall-off time of are not known, a fire resistance of the downlight that is equal to the required fire resistance of the whole assembly is a conservative solution (see Figure 11, Example B). Alternatively, a non-fire-rated downlight can be implemented if fire protective boards with at least the same fire resistive properties as the penetrated parts, protect the internal parts of the assembly. The integrity of the added protective boards should be warranted for at least the fall-off time of the boards, or, when this is unknown, for the duration of required fire resistance of the assembly (see Figure 12, Example C).

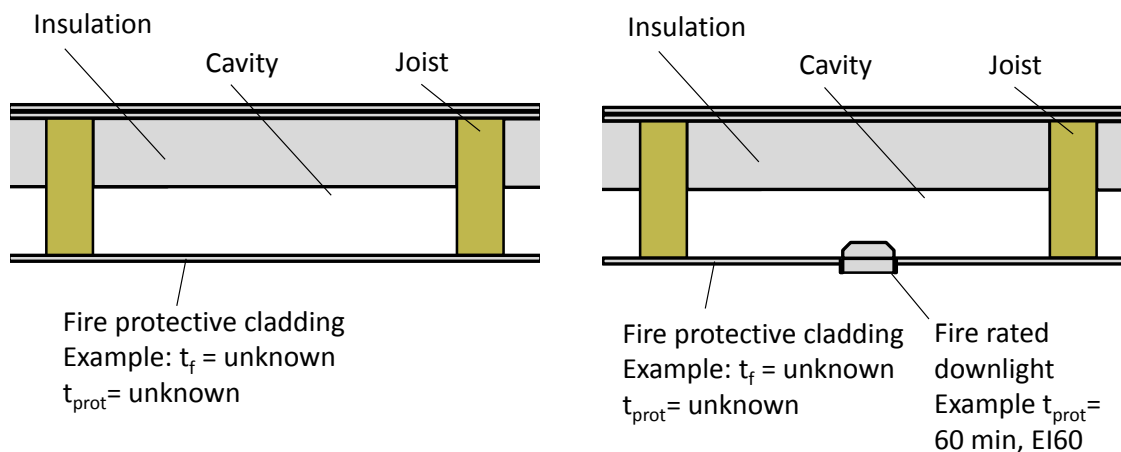
Figure 11: Example B - cross section of a 60minutes fire resistant ceiling (left) and a suitable application of a fire resistant lamp in this ceiling (right)

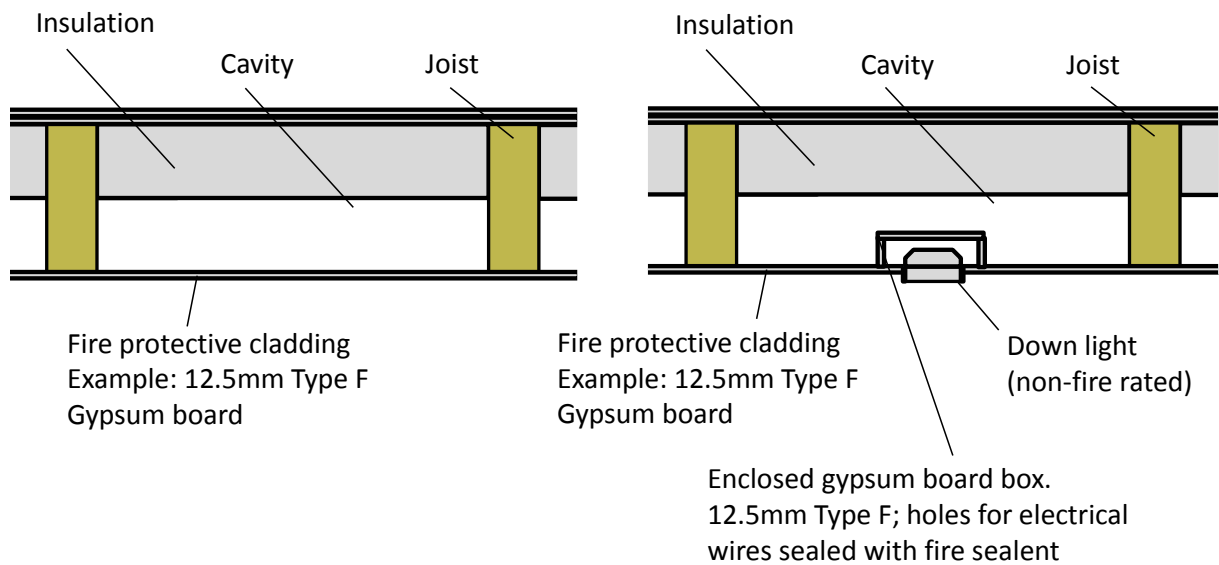
Figure 12: Example C - cross section of a 60minutes fire resistant ceiling (left) and a suitable application of a non-fire-resistant lamp in this ceiling (right)

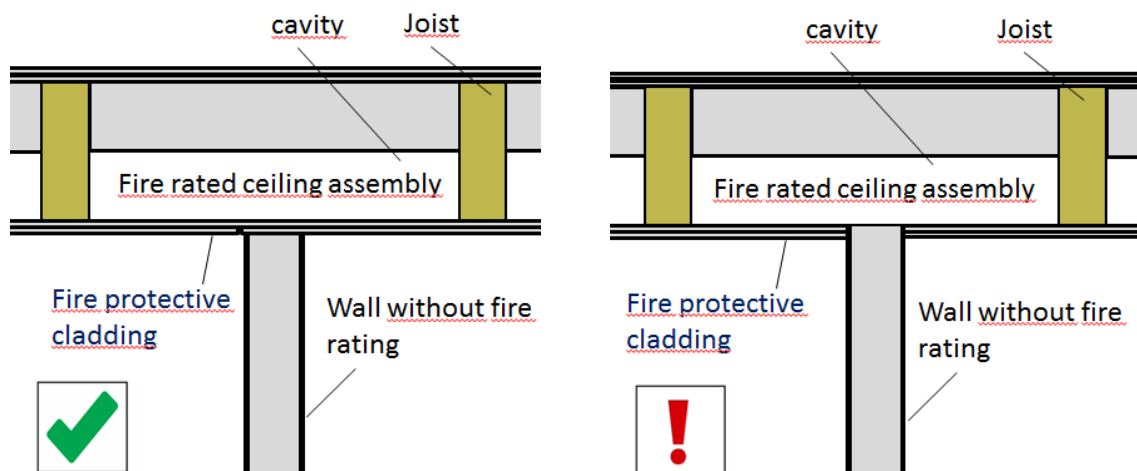
Figure 13: Example D - cross section of a 60minutes fire resistant ceiling (left) and a suitable application of a fire resistant lamp in this ceiling (right)

Within fire compartments there may be partitioning walls, which do not have fire resistance requirements. It is, however, important that the fire resistance of adjacent assemblies is not compromised by the failure of the non-fire-rated partitioning wall. Therefore, it is important that the fire protective cladding and insulation of fire resistive assemblies are not penetrated by non-fire rated partitioning walls, such as shown in Figure 13 and Figure 14. The assemblies on the left side of these figures are implemented correctly. The fire resistance of the assemblies on the right side is compromised if the wall fails earlier in a fire, than the base layer of fire protective board.

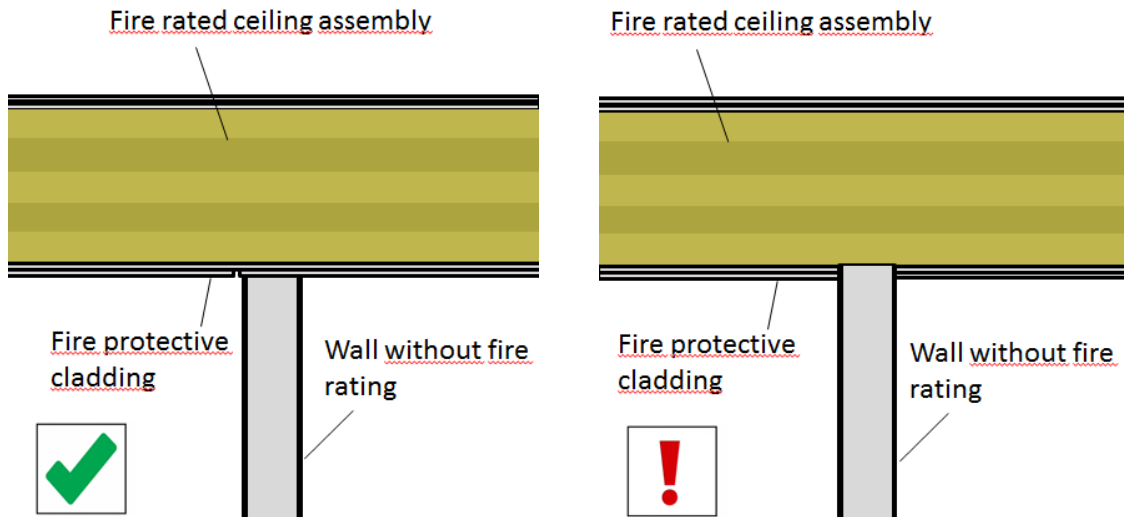
Figure 14: Example E - cross section of a 60minutes fire resistant ceiling (left) and a suitable application of a fire resistant lamp in this ceiling (right)

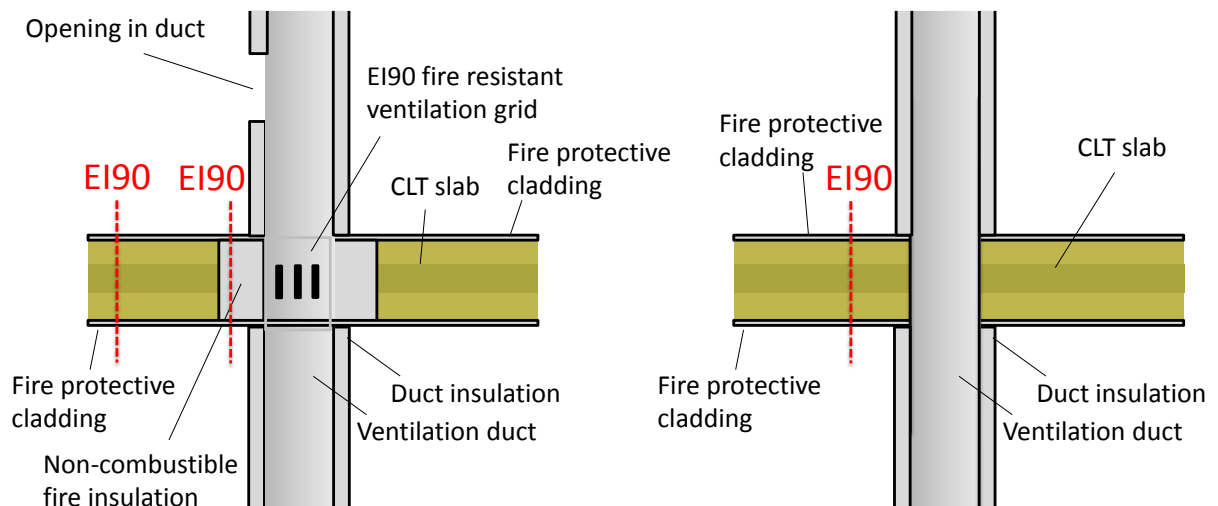
Figure 15: Example F - cross section of a 90minutes fire resistant wall with a ventilation duct with possibilities for flames to enter the duct (left) and without possibilities for flames to enter the ducts (right).

Ventilation ducts generally cross from fire compartment to fire compartment and have been the cause of fire spread out of the compartment in multiple building fires. If the fire can enter the ventilation duct, it is important to block the flames from spreading through the duct. This can be done directly at the ventilation openings, or at the compartment boundaries. Additionally, the duct should be insulated to prevent possible ignition of combustibles near the duct in a neighbouring compartment (Figure 15). A tight fit of the ventilation ducts into the wall opening is required.

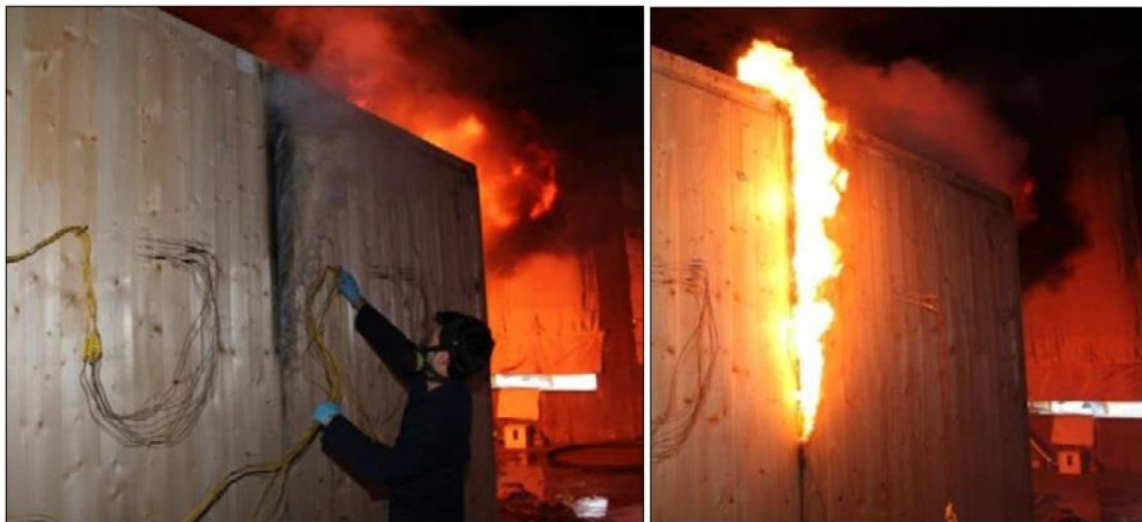
Figure 16: Fire spread through a CLT splice connection, taken from McGregor (2014).

Previous compartment fire tests (Medina Hevia, 2014; McGregor 2014; Kampmeier; 2009) have shown that connections between CLT slabs can be sensitive to fire and smoke spread, as can be seen in Figure 15. Connections are recommended to be sealed using methods, with for example intumescent strips or fire retardant sealant, that have been proven to be effective in fire resistance tests according to EN 1364. There are not enough fire resistance tests available to make conservative general guidelines regarding these connections at this stage.

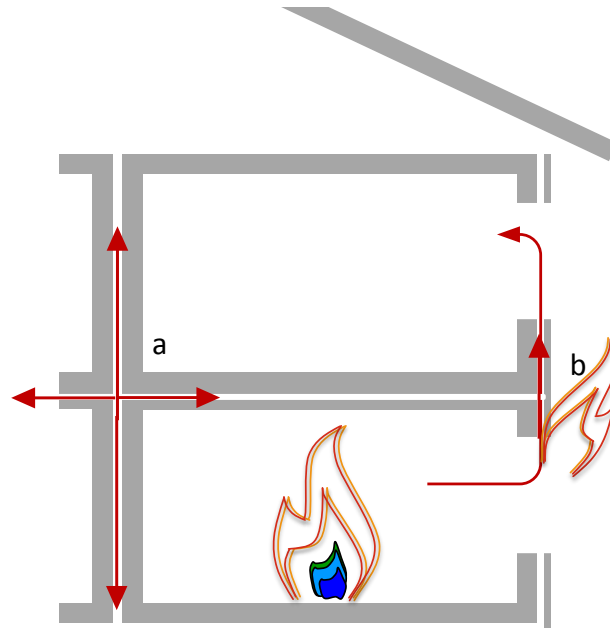
Figure 17: Potential paths of fire spread through cavities

- a) Fire stops in cavities with combustible materials between compartment and between buildings, aiming to stop slowly spreading and long lasting smouldering fires (see Figure 17, type a).
- b) Fire stops in cavities in the façade, aiming to stop fire plumes from traveling through the cavities (see Figure 17, type b).

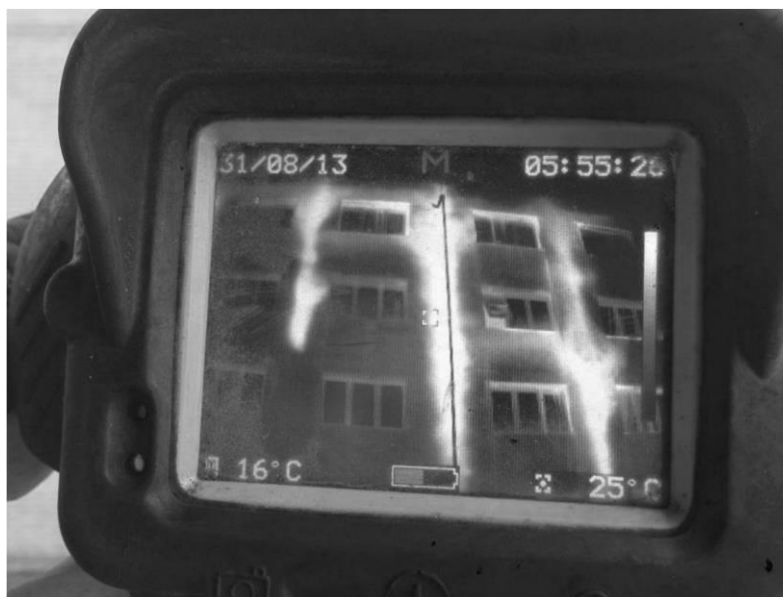
Figure 18: Infrared camera picture indicating a downwards fire spread through cavities²

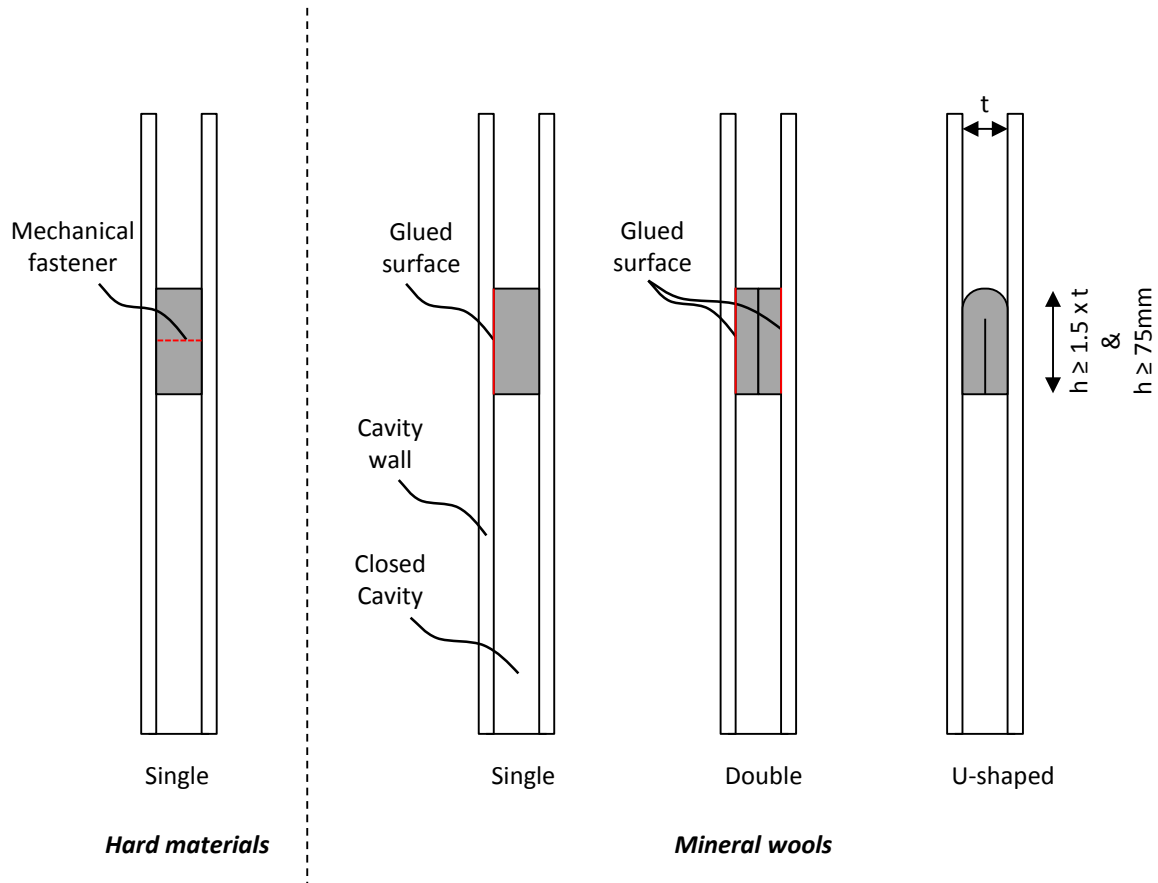
Figure 19: Cross-sections of single double and U-shaped fire stops

There are several installation methods recommended for fire stops. As shown in Figure 19, potential placement of the fire stops could be single, double, or U-shaped. In case mineral wools are used as fire stops, the minimum dimension is recommended to be chosen, so that its compressed density after installation is 50kg/m³ or higher. Additionally, its height after installation, h , should be at least equal or larger than the maximum of 75mm and $1.5t$, where t is the cavity width. For a U-shape placement of the fire stop, the cross-section should be at least $t \times 3t$. Additionally, the minimum density of the uncompressed material should be 25 kg/m³.

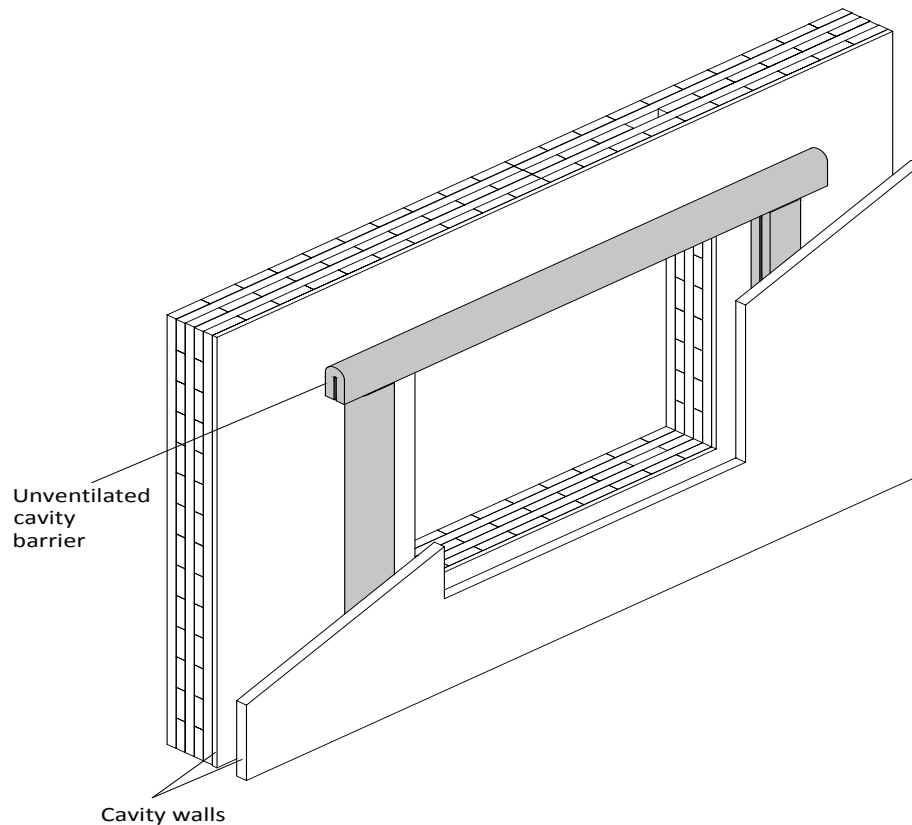
Figure 20: Prevention from falling of fire stop by robust design

The design of fire stops should aim to (1) avoid falling of the cavity and (2) avoid air channels across and along the fire stops. Falling of the specimens can be avoided by appropriate fixation methods and, if possible, by robust design. Using robust design, falling of the barrier can be avoided, even if the primary fixation method (using glue, fasteners or by clamping) fails. An example of a robust solution that prevents falling of highly exposed fire stops is shown in Figure 20.

A fire leaving a compartment through an opening will expose the upper side of the opening significantly more severely, than the lower side of the opening. Therefore, there is an increased risk that the fire stop above the opening falls, which would allow the fire to easily access the cavity. By letting highly exposed, horizontally positioned, fire stops within walls rest on the vertically positioned elements (Figure 20), the risk of falling becomes small.

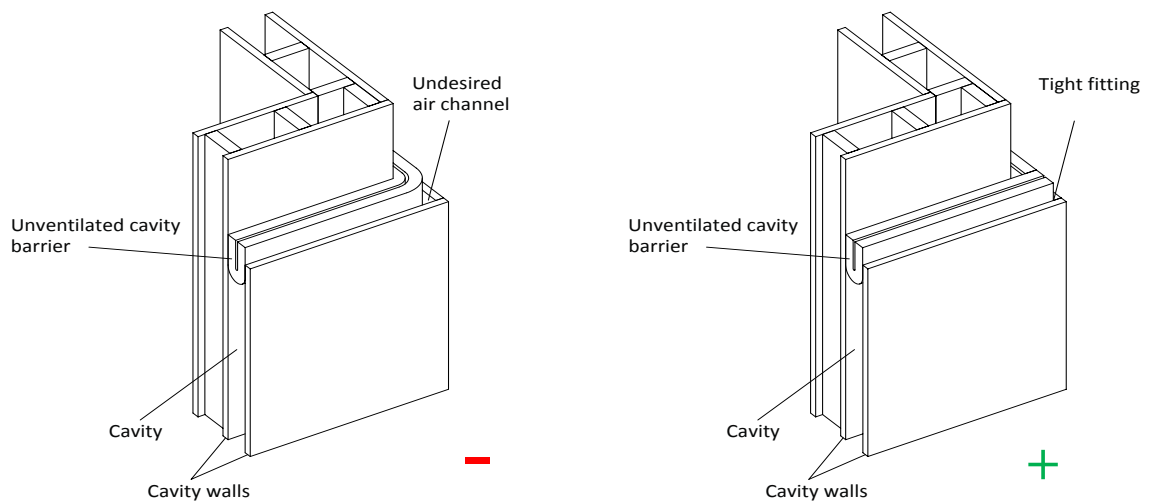
Figure 21: Possible risk for undesired air channel in the outer corner

Undesired air channels can be avoided by design. Such undesired air channels could occur in corners and bends of the fire stop material, as shown in Figure 21. Solutions can be obtained by designing separate fire stops which are connected, instead of using bended fire stop in corners.

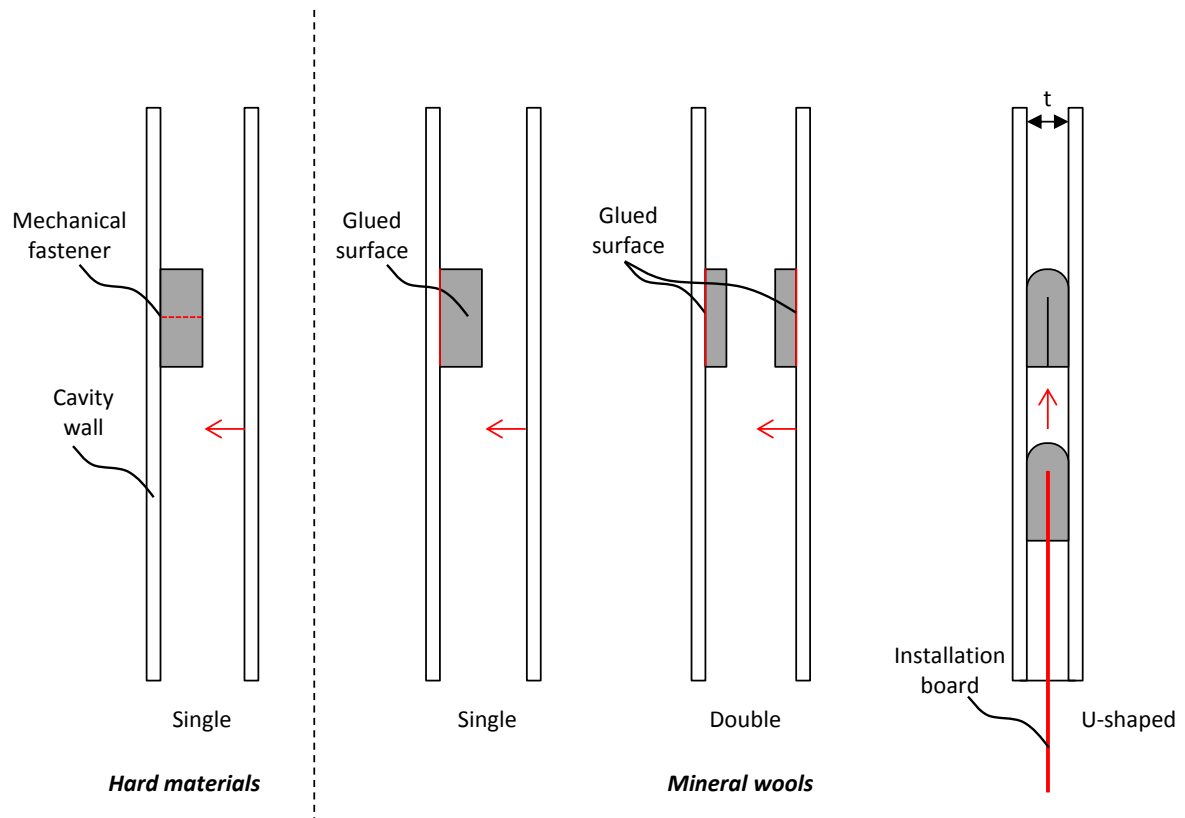
Figure 22: Schematic drawing of installation (red arrows indicate movement of assembly parts)

A schematic drawing concerning the installation of single, double or U-shaped placed fire stops is shown in Figure 22. The single and double placement of fire stops is especially applicable for cavities between modules of modular buildings. In this case the fire stops should be fixed to the cavity wall before the cavity is closed. Gluing of the cavity with high temperature resistant adhesives is recommended. For fire stops with a double placement, misalignment is allowed as long as the height of the contact area between the fire stops is equal or higher than the maximum of 75mm and $1.5 \times t$ (see Figure 23).

The U-shape placement should be done using an installation board, as shown in Figure 22 and Figure 24. The intended position should be ensured using this installation board, which is especially relevant at the locations of joints. The resistance of the board should be used to indicate whether the fire stop is installed firmly.

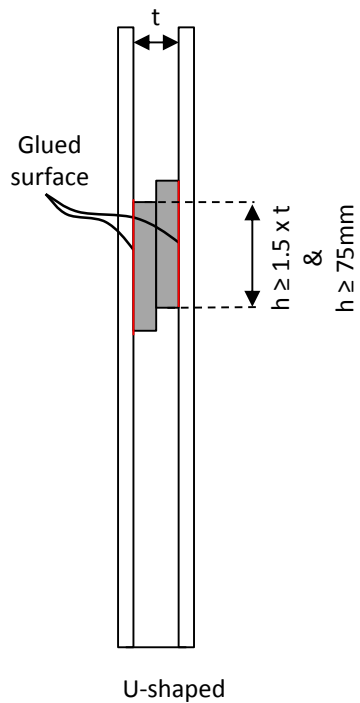
Figure 23: Allowable geometrical misalignment

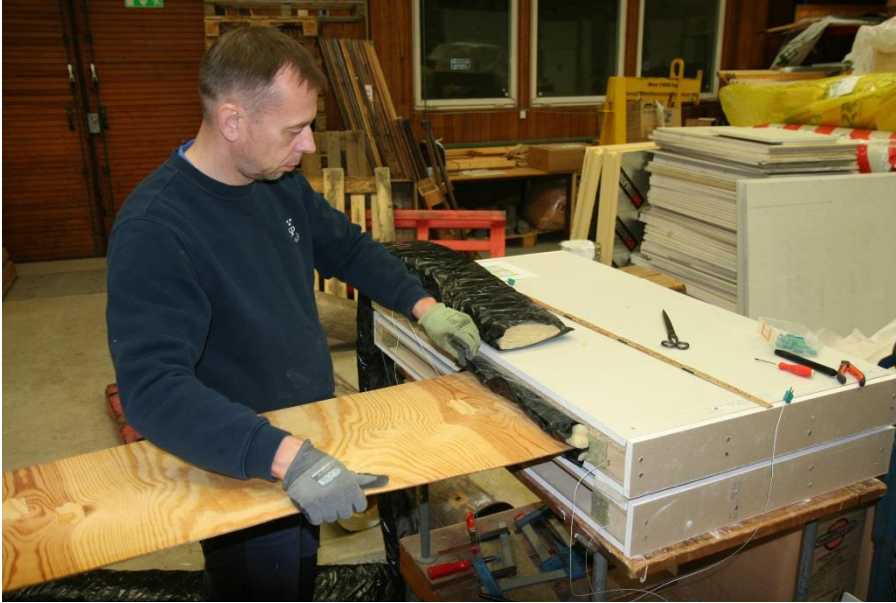
Figure 24: Sliding fire stop into the cavity for a U-shaped placement

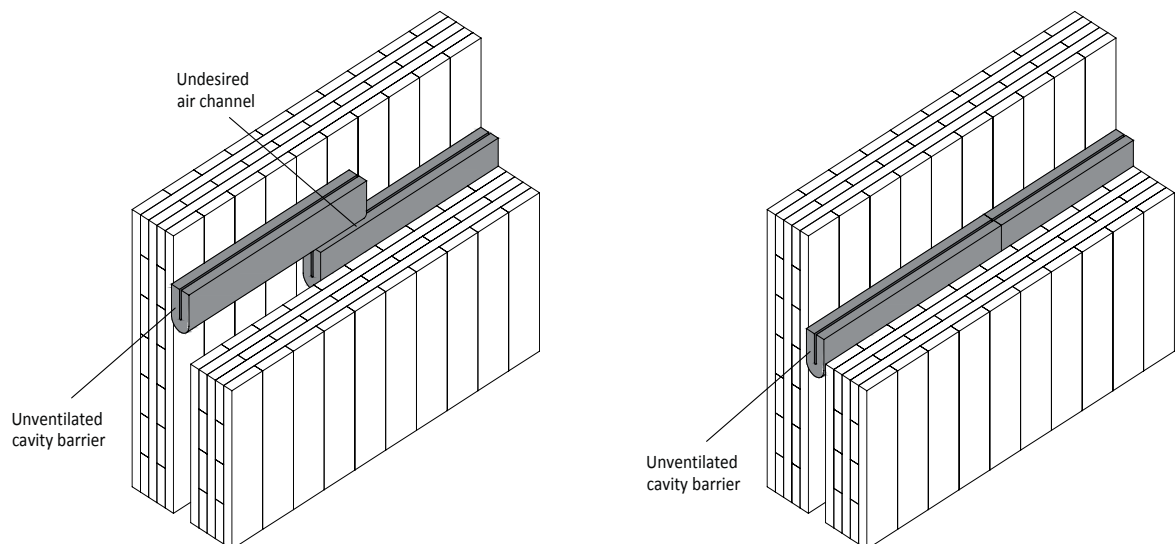
Figure 25: Possible risk for undesired air channel with overlapped joint

Joints between fire stops should be made, so that air channels in the joint are avoided. Using fire stops with a U-shaped placement could lead to undesired air channels in joints, as shown in Figure 25. Therefore, in-line and butt-joints are recommended for fire stops with a U-shaped placement. However, an overlapped joint, as shown on the left hand side of Figure 25, can be applied if (1) the length of the overlap is at least equal the height, h , of the fire stop and (2) the cavity is made of mineral wool without plastic covering. It must be ensured that both fire stops in one joint are placed tightly against each other.

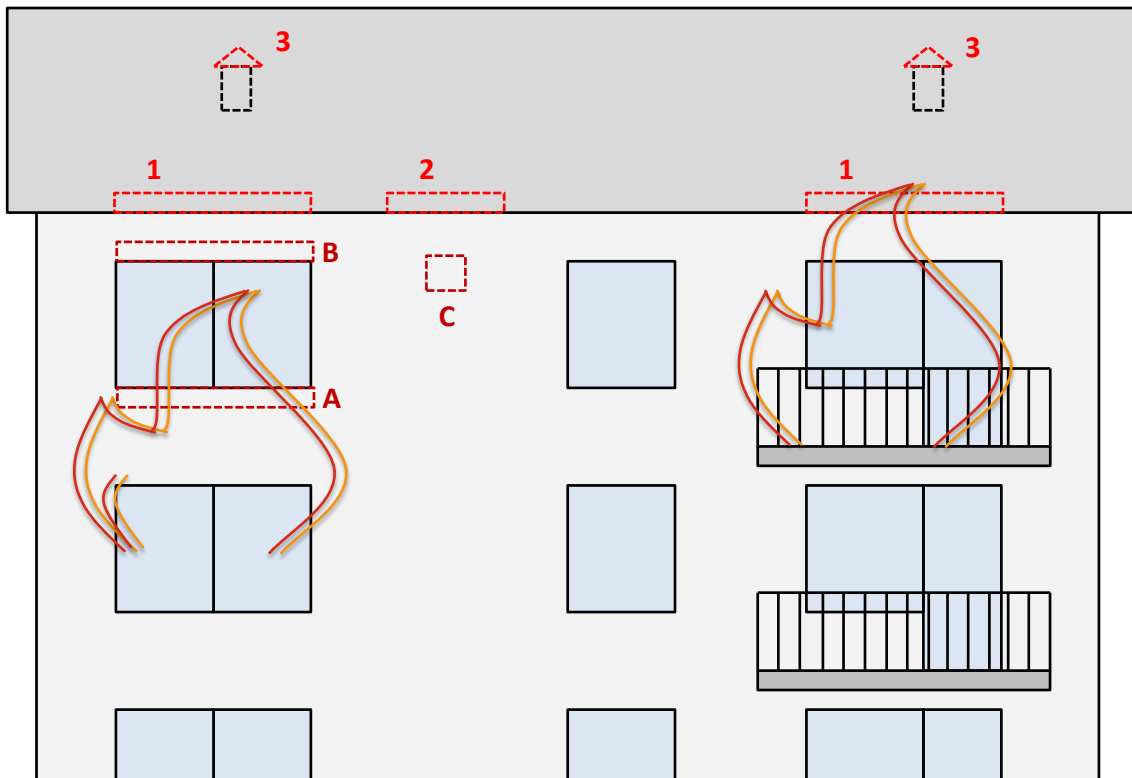
Figure 26: Common locations of ventilation openings for attics and other compartments

Ventilation openings for attics are commonly positioned at the façade at the eave (locations 1 and 2 in Figure 26). Ventilation openings placed above the window (location 1 in Figure 26) have been the access for fire spread to the attic in multiple building fires. A ventilation opening at location 2 instead of location 1 in Figure 26 reduces the risk of fire spread to the attic. However, dependent of the design of the roof, the fire plume may travel horizontally under the eave and potentially reach the ventilation opening at location 2. Therefore, it is recommended to apply fire stopping solutions in attic vents under the eave or to ventilate through other means such as mechanical ventilation using an air supply from other locations.

Ventilation openings for compartments are often positioned under windows (location A in Figure 26). However, in case of a flashover fire in the apartment below this ventilation opening, the fire plume may reach into this ventilation opening, increasing the risk of fire spread to multiple fire compartments. This risk is significantly smaller if the ventilation opening is above the window (location B in Figure 26). The risk is significantly more reduced if the ventilation openings are not positioned above windows or balconies or other potential sources of large fire plumes (location C in Figure 26).

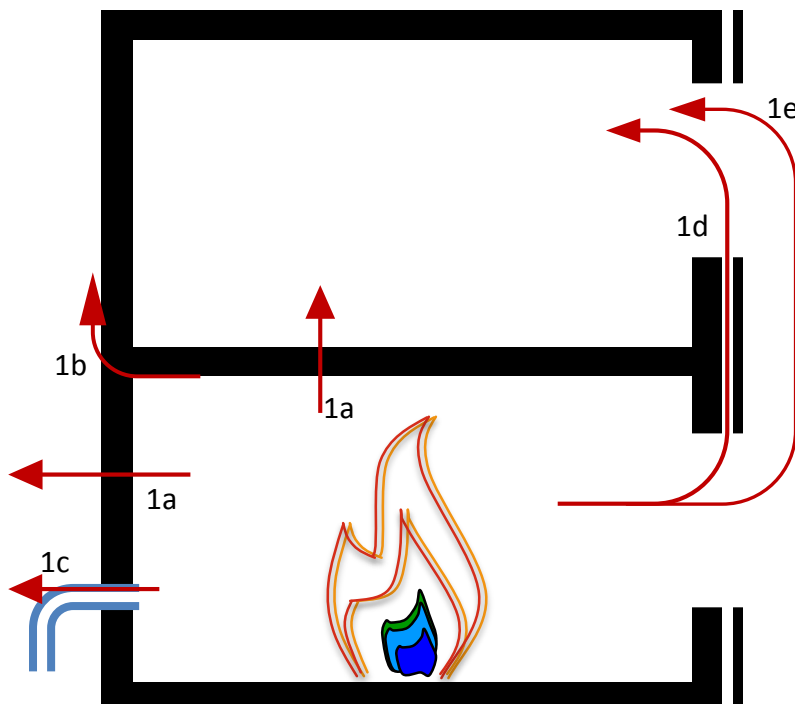
Figure 27: Potential paths of fire and smoke spread out of the compartment considered for the building design

- a. Limitation of spread through the wall or ceiling
- b. Limitation of fire and smoke spread through connections between CLT slabs
- c. Limitation of fire and smoke spread through wall and ceiling penetrations
- d. Limitation of fire spread via the cavity of the façade
- e. Limitation of fire spread via the façade surface.
