BRANDFORSK
2018:2:2

Mitigation of fire damages in multi-storey timber buildings – statistical analysis and guidelines for design

RISE Report 2018:43

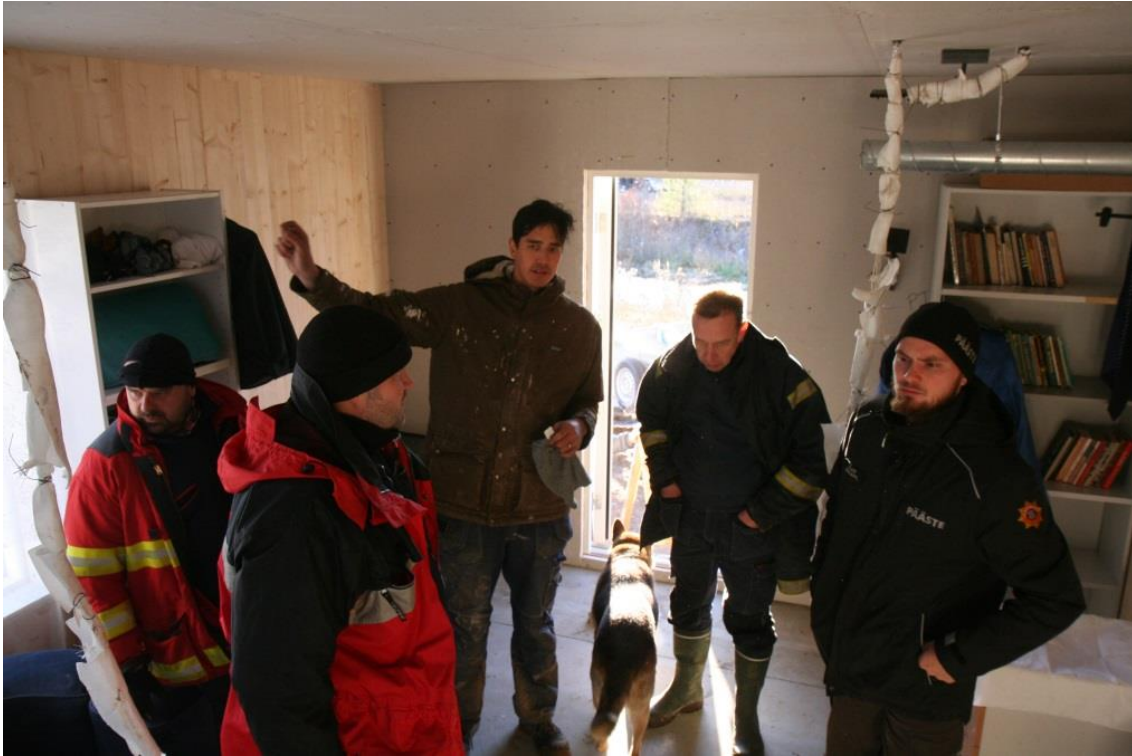
Figure 28: Interior of compartment before the fire test

The interior dimensions of the compartments on both floors were 4.5m x 3.5m x 2.5m (depth x width x height). Both compartments had two windows of 1.5 x 1.5m. The windows on the lower floor were intentionally broken 20 minutes after ignition, to allow flashover to occur.

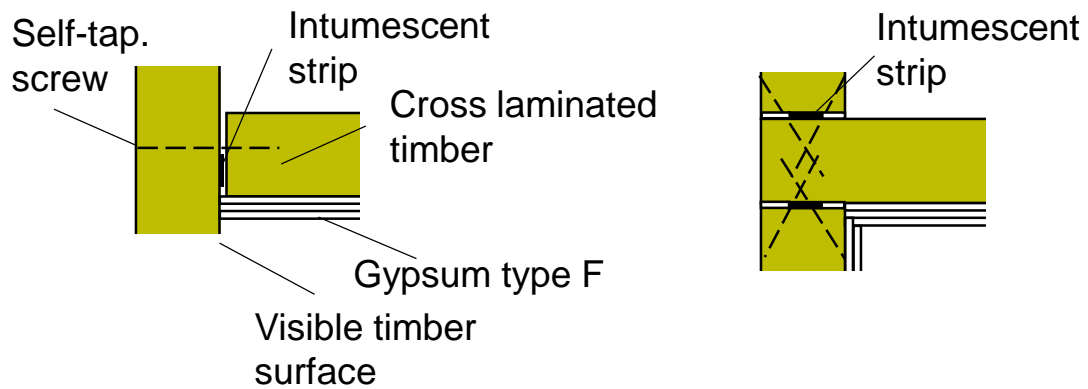
Figure 30: Implemented connections between floors and walls

Connection configurations in which the ceiling is positioned on top of a wall (see, Figure 30, left) and of connections in which the ceiling is hanging besides a continuous wall (see, Figure 30, right) were, both, tested. The largest gap measured between a CLT wall and the CLT ceiling panel was 14 mm (Figure 31).

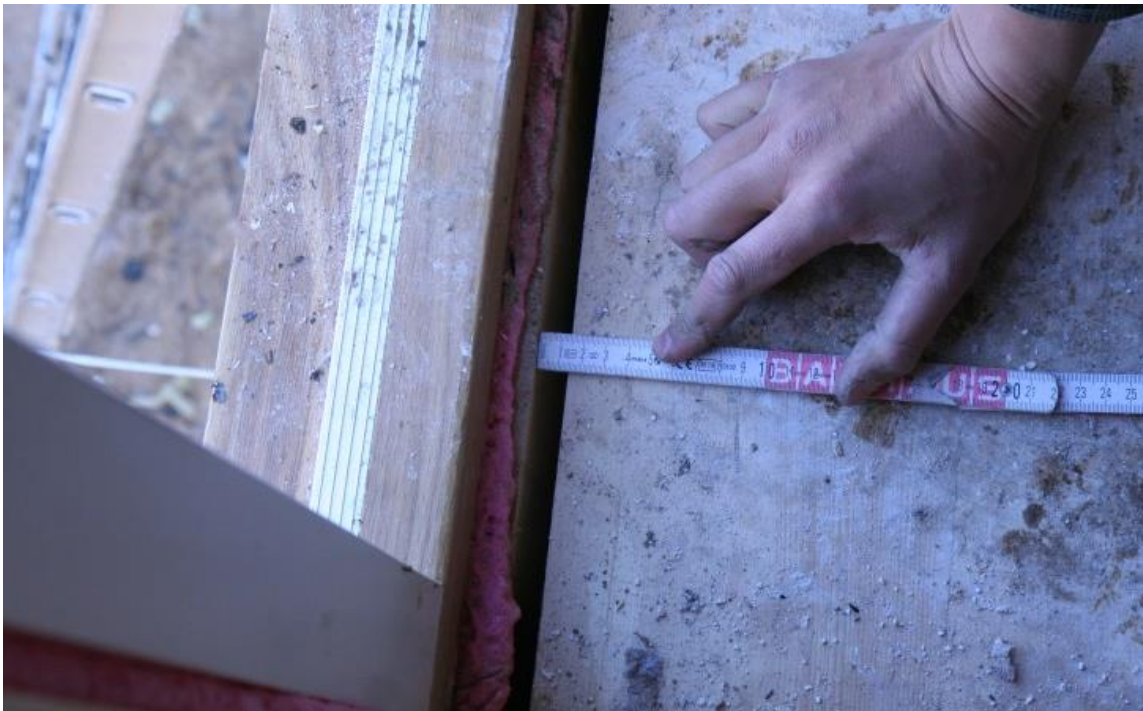
Figure 31: maximum gap measured (14mm) in between wall and floor slab

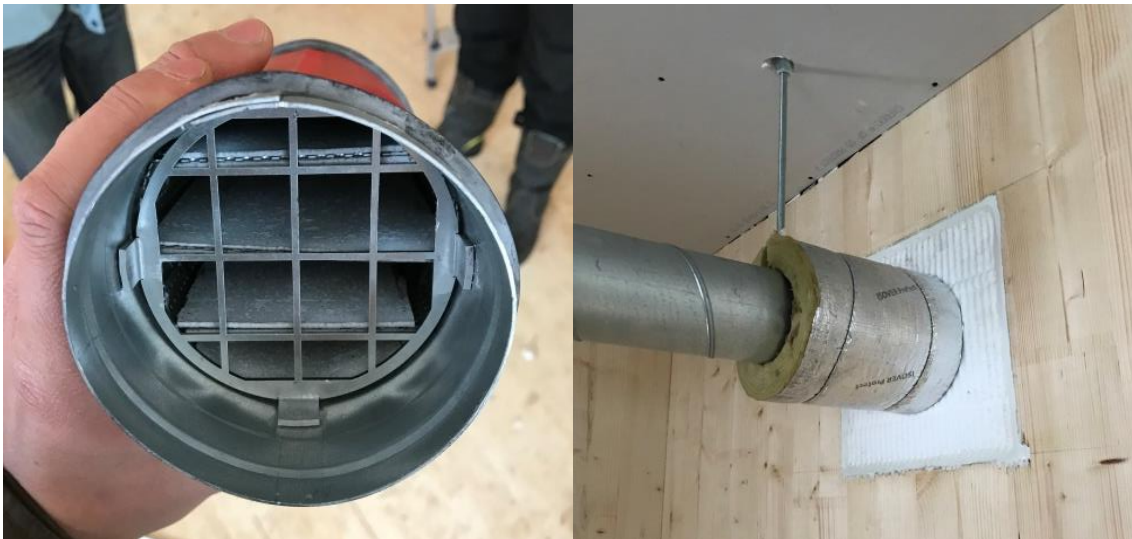
Figure 33: Fire resistive ventilation grid (left) installed in an exposed CLT wall (right).

Several small wall and ceiling penetrations and one larger penetration for a ventilation shaft were implemented. The ventilation shaft had a grid with intumescent strips that expand at elevated temperatures to stop the fire from spreading. The shaft was partially protected by stone wool insulation. The ventilation grid was positioned in a hole through stone wool insulation with the same thickness as the wall (see Figure 33). The other small penetrations were for cables and tubes. These were sealed using fire caulk, rated for 60 minutes fire resistance.

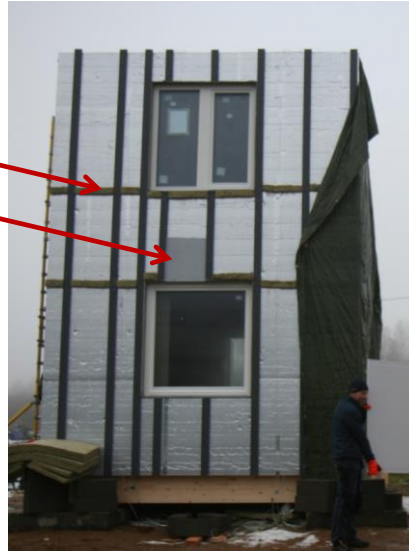
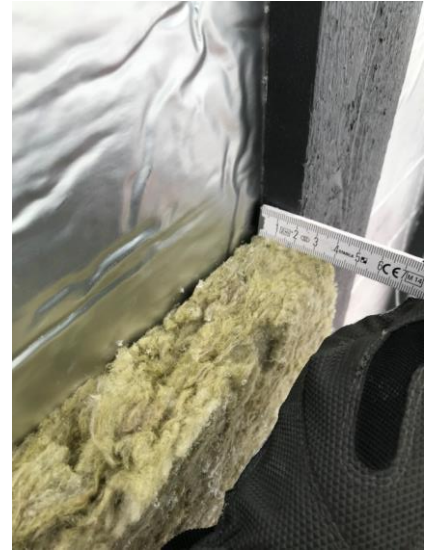
Stone wool fire stop
Intumescent paint for ventilated fire stop

Figure 34: Fire stops installed during the construction phase

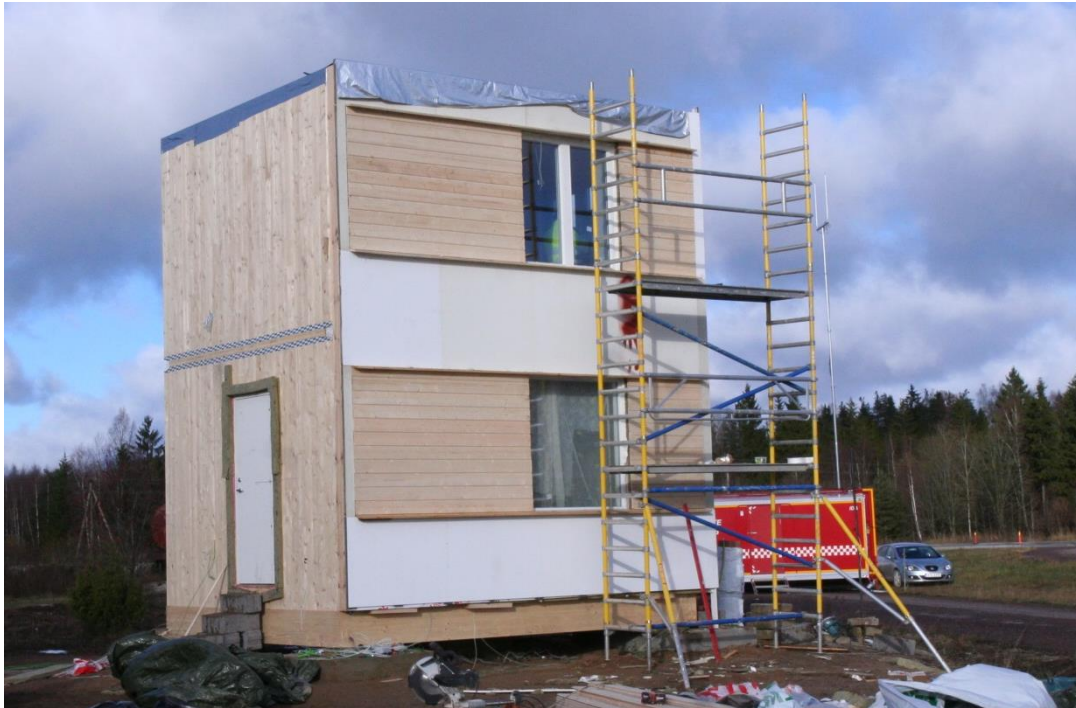
Figure 35: Façade of the building with timber panels and non-combustible cement board strips.

As timber is a combustible material, fire can generally spread on a façade with untreated timber. Treatment or impregnation of timber in a façade is, however, not recommended, as studied impregnations wear off within a few years. Therefore, this study seeks for a solution for implementing untreated timber in facades. Limiting the fire spread within the cavity is the first step of the strategy, as this can avoid heating the façade panels from two opposite sides. The fire spread on the façade is further limited by implementing a 1.2 meter strip of non-combustible cement board (see Figure 35). In order for the fire to spread from the first floor façade to the second floor façade, the fire needs jump over 1.2 meter of non-combustible material. 30 minutes fire resistant windows (EI30) were used in the second floor, in order to prevent fire spread to the upper floor.

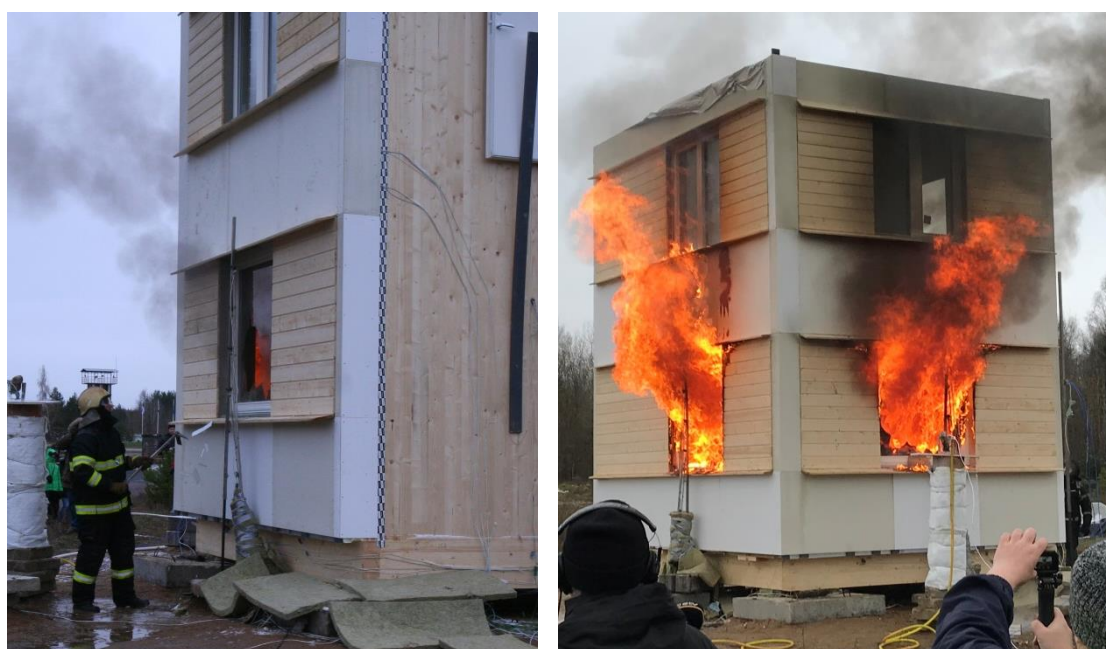
Figure 36: Breaking of the window at 0:20h (left) flashover at 0:47h (right)

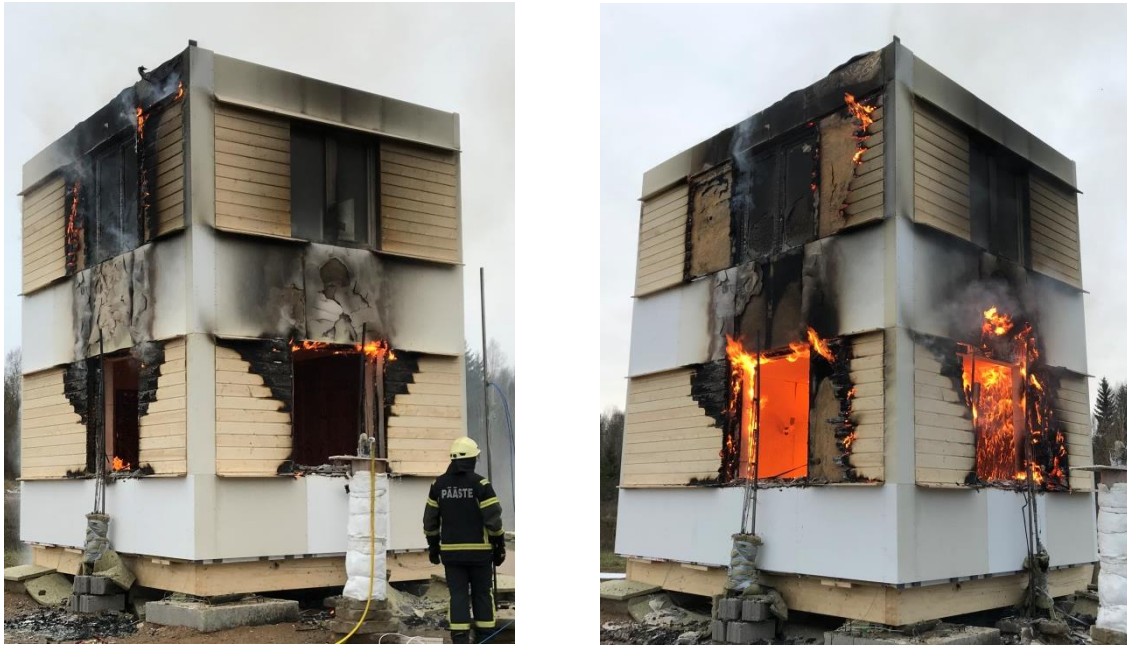
Figure 37: 35 minutes into the first decay phase at 1:17h (left) start of the second decay phase at 1:40h (right)

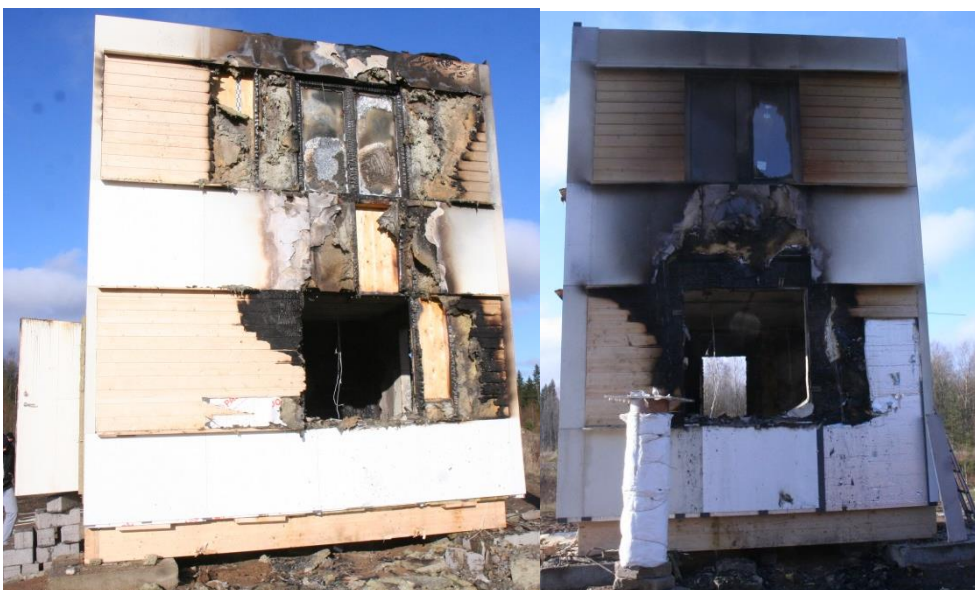
Figure 38: Façade with stone wool insulation (left) and PIR insulation (right, some panels removed)

Fire spread via the façade was larger for the façade with stone wool insulation than for the façade with combustible PIR insulation. In the PIR façade, the timber façade panels on the second floor did not ignite. The façade with stone wool insulation had fire spread to the timber panels on the second floor. Both facades had similar cavities and similar fire stops in these cavities. Both of the 30 minute fire resistant windows withstood the fire without failure of the inner glass. It should be stated that there are numerous PIR insulation materials. The performance of this PIR insulation does, therefore, not guarantee similar performance for other PIR insulation materials.

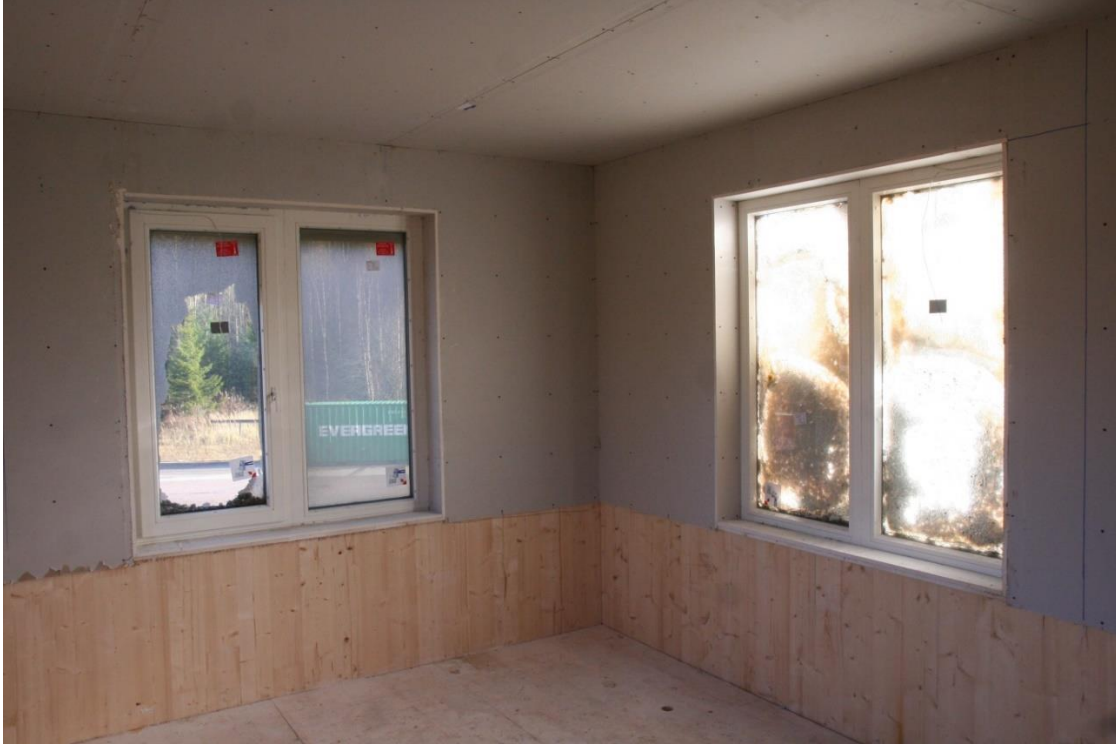
Figure 39: 2nd floor after the test

The interior of the upper floor was practically undamaged (Figure 39 and Figure 40). Besides some minor colouring of an area of approximately 30 cm², no fire damage could be seen. The intumescent strips in corner connections of the CLT elements expanded and the temperatures measured on the unexposed side did not indicate any fire spread.

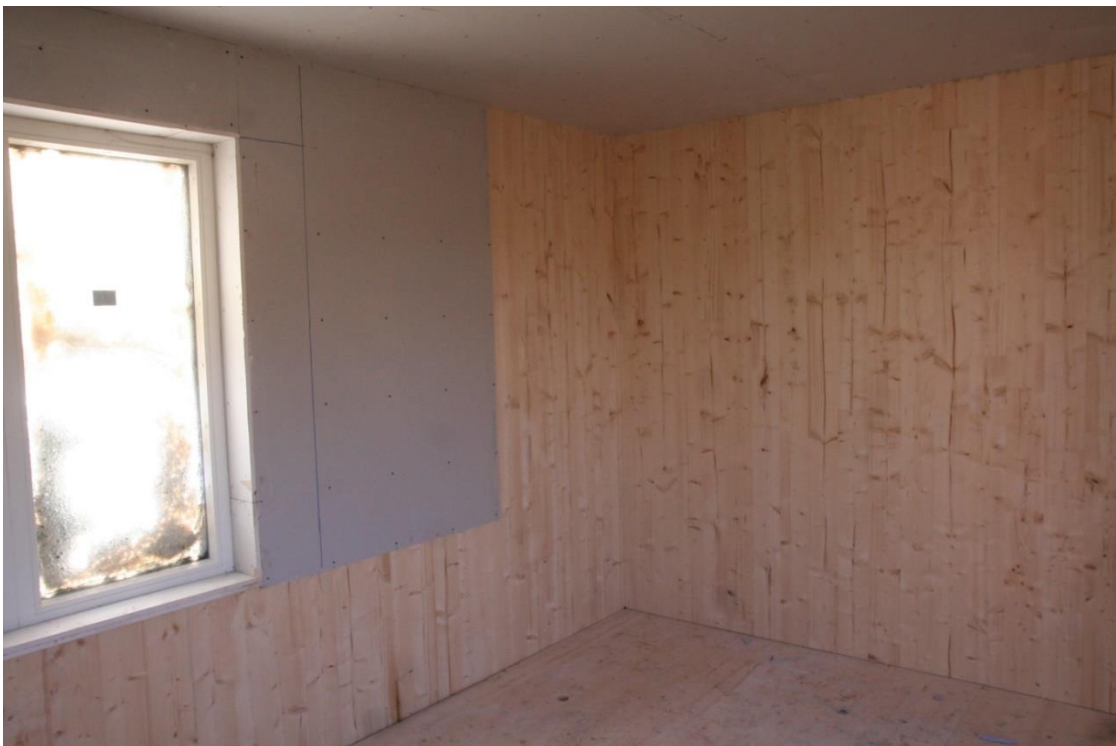
Figure 40: 2nd floor after the test (some minor colouring seen in the bottom of a wall)

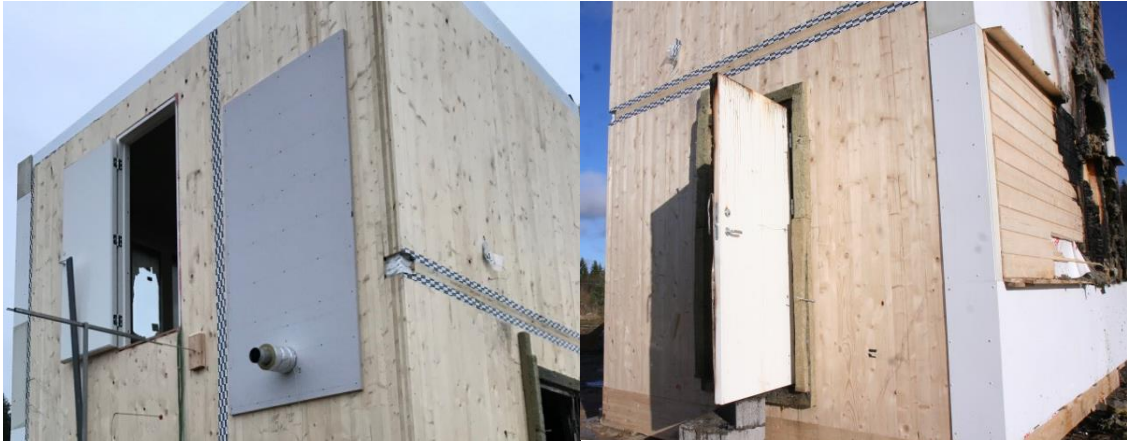
Figure 41: Unexposed side of the ventilation duct (left) and the 30 minutes fire resistant door (right).

Temperatures measured on the none-exposed sides of penetrations did not indicate fire spread and remained close to ambient temperature. Thermal cameras indicated that, the temperatures on the unexposed side of connections and penetrations did not increase significantly. Also visually, none of the penetrations showed any sign of fire spread (Figure 41). The 30 minutes fire resistant door withstood the fire without complete integrity failure. However, during the decay phase a significant amount of material fell from the door, which made a loud noise and was observed visually through the window.
