BRANDFORSK  
2017:I

## Fire Stops in Buildings

Alar Just och Daniel Brandon

Fire stops, cavity barriers, model scale fire tests

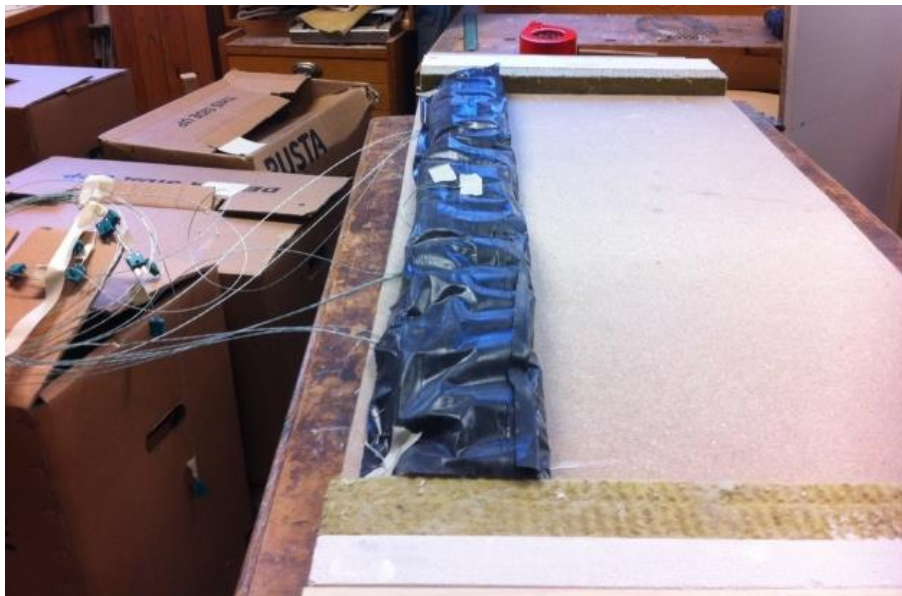
*Figure 1 - Single-barrier specimen of test series 1*

A first test series was performed in order to make a first assessment of a method that includes combustible materials in the cavity. In the test series called test series 1, cavity barriers were placed between two particle boards. The cavity barriers were glued on one of the cavity walls before the second cavity walls were placed (see Figure 1). Specimens were placed on top of a furnace (Figure 2) and then they were exposed to a standard fire in accordance with EN1363 for one hour.

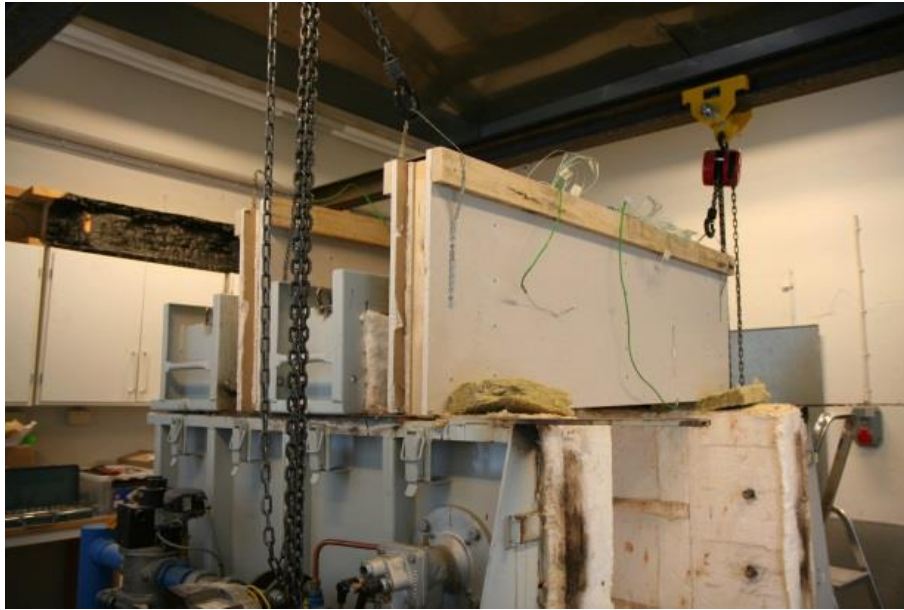
*Figure 2 - Positioning of 2 specimens on top of a furnace.*

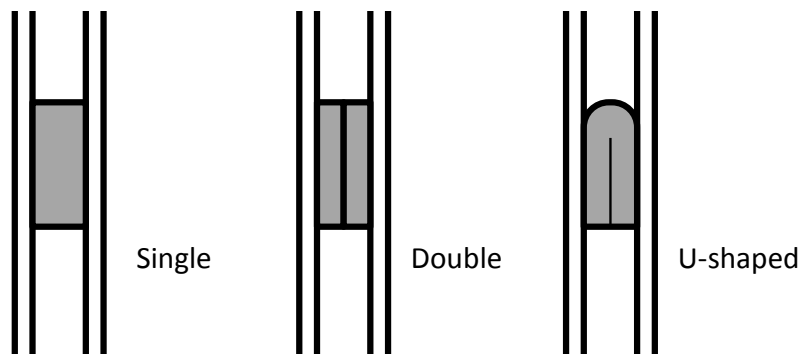
*Figure 3 - Single, Double and U-shaped positioning between two cavity walls*

Test series 1 included four different cavity barriers, of which an overview is given in Table 1. The brands of the cavity barriers are kept anonymous as this is an ad hoc procedure, but a description of the different barriers is given in Table 1 and Table 2. Common methods to install cavity barriers are illustrated in Figure 3. The aim of this first test series was to identify weaknesses of an initial test method. Therefore, it was chosen to install the cavity barriers differently, using the most practical way considering the dimensions and compressibility.

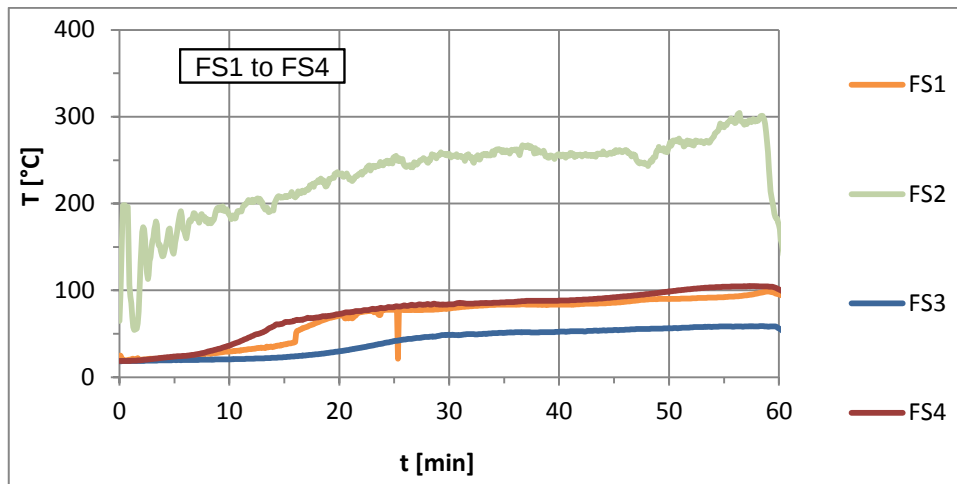
Figure 4: temperatures on the unexposed side of the cavity barriers

Figure 4 shows temperatures measured on the unexposed side of cavity barriers. It can be seen that the best performance was achieved with plastic covered glass wool of 50 x 160mm, which also had the largest volume. The stone wool did reach the failure criterion as the temperatures on the unexposed side were over 300°C. The method seems to be able to differentiate between performances of different materials. However, it can be questioned whether the specimens are exposed to conditions that are severe enough, so that the fire stops can be used to avoid high damage cavity fires. For an assessment of weaknesses of the preliminary test method a review of real cavity fires is performed. This is discussed in the next chapter.

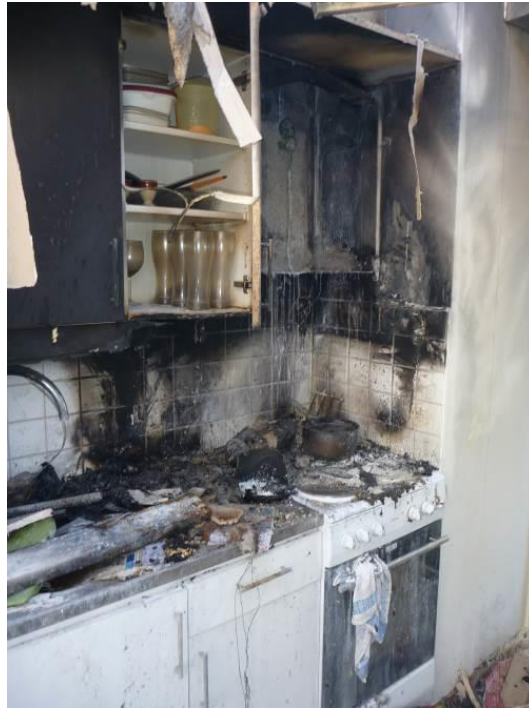
*Figure 4 - Fire damage after extinguishment of the fire in the ignited compartment<sup>2</sup>*

The fire originated in a kitchen due to ignited oil in a saucepan. The fire brigade arrived quickly at the fire and managed to extinguish the fire in the original compartment (see Figure 5). However, the fire spread through the ventilation shaft and ignited combustible material in the attic. The attic burned out after approximately 1.5 hours, at which the visible fire stopped. However, within the cavities the fire spread downward (see Figure 6) and caused re-ignition of the fire in lower floors. The fire brigade struggled to extinguish the fire and had to demolish building elements in order to find and reach the fire. After the fire, the building had to be demolished as the fire damage was too severe for recovery.

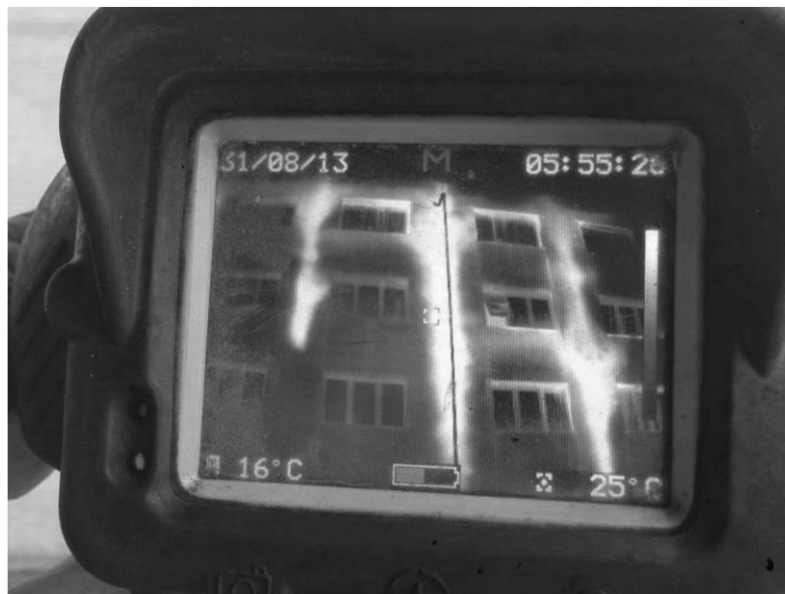
*Figure 5 -Infrared camera picture indicating a downwards fire spread through cavities<sup>2</sup>*

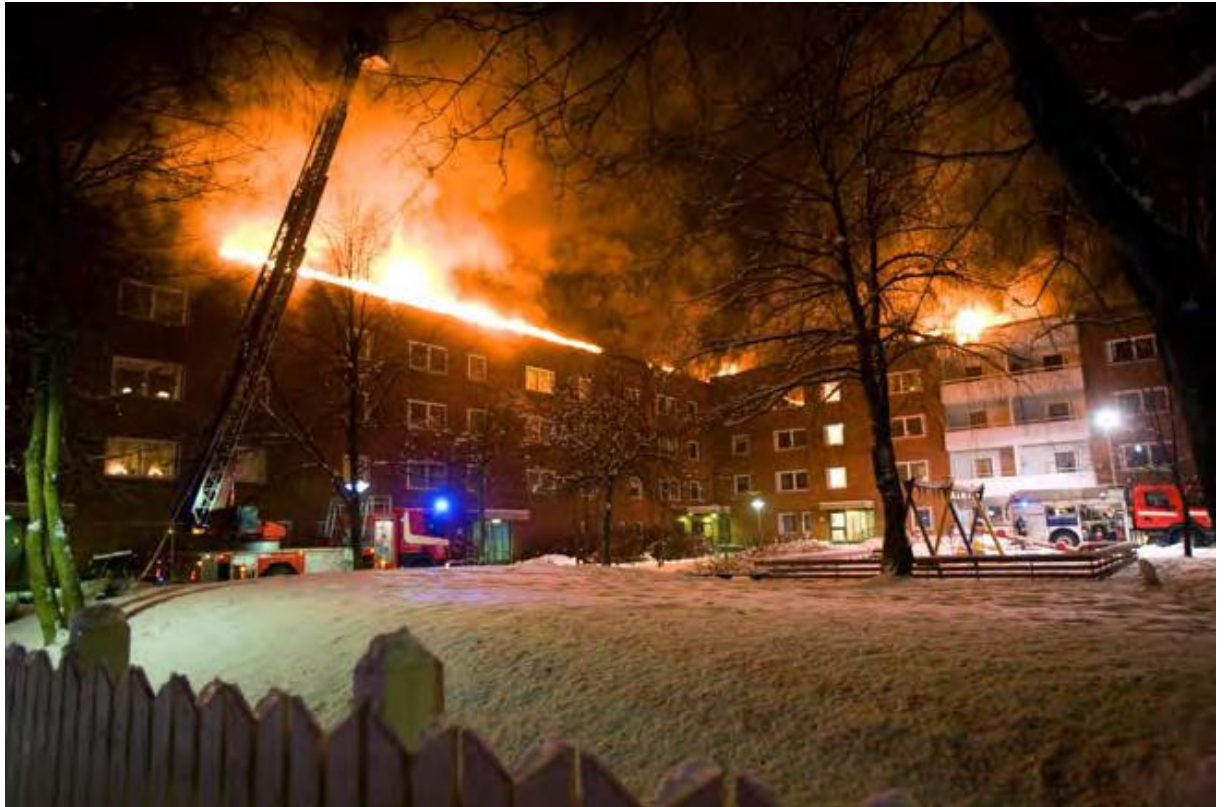
Figure 6 - Building fire in Umeå, Ålidhem (Umeå Kommun Brandförsvar och Säkerhet, 2009).

The building consisted of three buildings parts adjacent to each other (see Figure 6), each part consisted of four floors and an attic. The building had a concrete structure and a masonry façade. The attic ranged over the whole building without fire walls (Umeå Kommun Brandförsvär och Säkerhet, 2009). The building in Umeå had a non-combustible structure, but had combustible material in the cavities.

The fire ignited in a pan with oil in the kitchen and spread to the cupboard above the kitchen range. The fire was extinguished quickly by the fire brigade, after which the situation was assessed to be safe. However, after a few hours the fire re-ignited in the attic and the fire spread down to several apartments. Investigation of the fire showed that the fire spread through the cavity in the external wall, where any cavity barrier was absent.

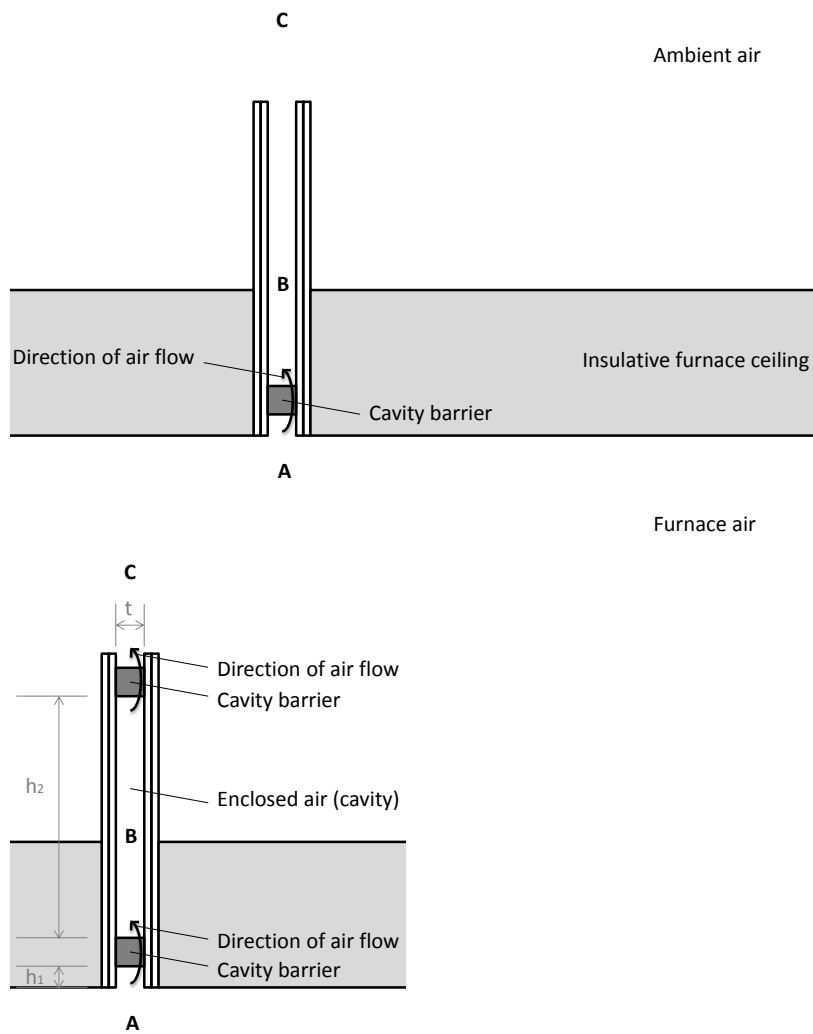
Figure 7 - Single-barrier (left) and double-barrier specimens (right), schematic

In test series 2, an enclosed cavity is tested by using two fire barriers in a single specimen (Figure 7, right). These specimens are here simply referred to as double-barrier specimens. In contrast with the single-barrier specimen (Figure 7, left), which is in accordance with the draft of EN 1364-6 (2016), the double-barrier specimen contains an enclosed cavity. Both specimens contain a fire barrier between the cavity (B) and the furnace (A, Figure 7), which limits the temperature rise and air flow in the cavity during the heating phase of a fire. However, the temperatures in the cavity of the double-barrier (B, Figure 7) specimen can be significantly higher than those in the single-barrier specimen, as there is a barrier between the cavity and the ambient air (C, Figure 7, right). As buildings generally have multiple fire barriers and enclosed cavities, it is, as a worst case scenario, important to consider double-barrier specimens instead of single-barrier specimens.

where  $t$  is the cavity width as denoted in Figure 7

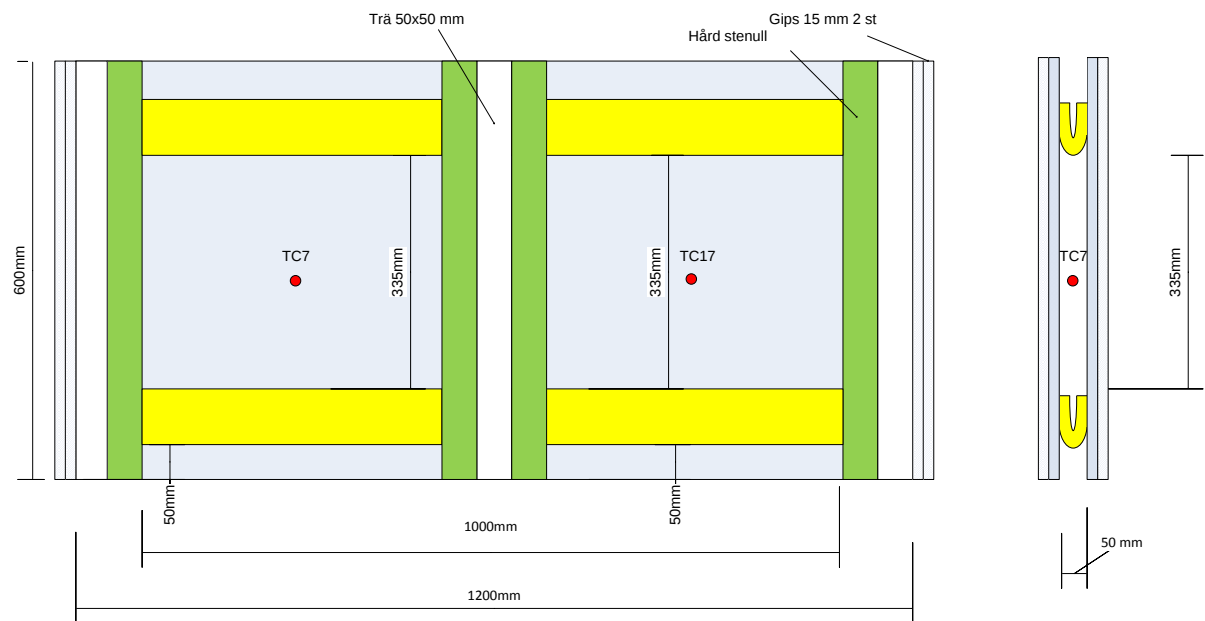
Figure 8 - Cross-sections of specimens of test series 2, exposed from the bottom

The cavity walls comprised of 10mm thick particle board with 15mm gypsum board screwed on the unexposed sides. The density of the particle board was 812 kg/m<sup>3</sup>. The cross-section of the specimens is shown in Figure 8. Seven different cavity barriers were tested, in order to evaluate the testing method. An overview of these cavity barriers is given in Table 2 and Table 3.

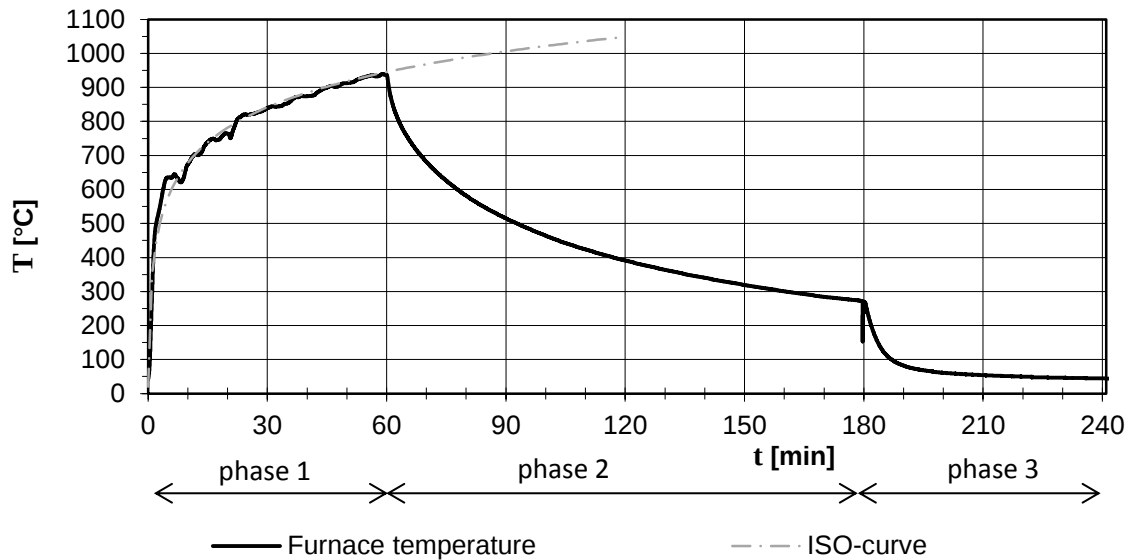
Figure 9 - Average heat exposure measured using two plate thermometers (test 1)

For this study, the heating phase (Phase 1) was performed in accordance with the standard fire curve defined in EN 1363-1 (see Figure 9). The pressure in the furnace was controlled and was 19 Pa +/- 4 Pa, 100 mm from the top of the furnace. Phase 1 was maintained for 1 hour. Subsequently, Phase 2 considered the cooling phase as shown in Figure 10, while the furnace remained closed. A cause of re-ignition was stimulated

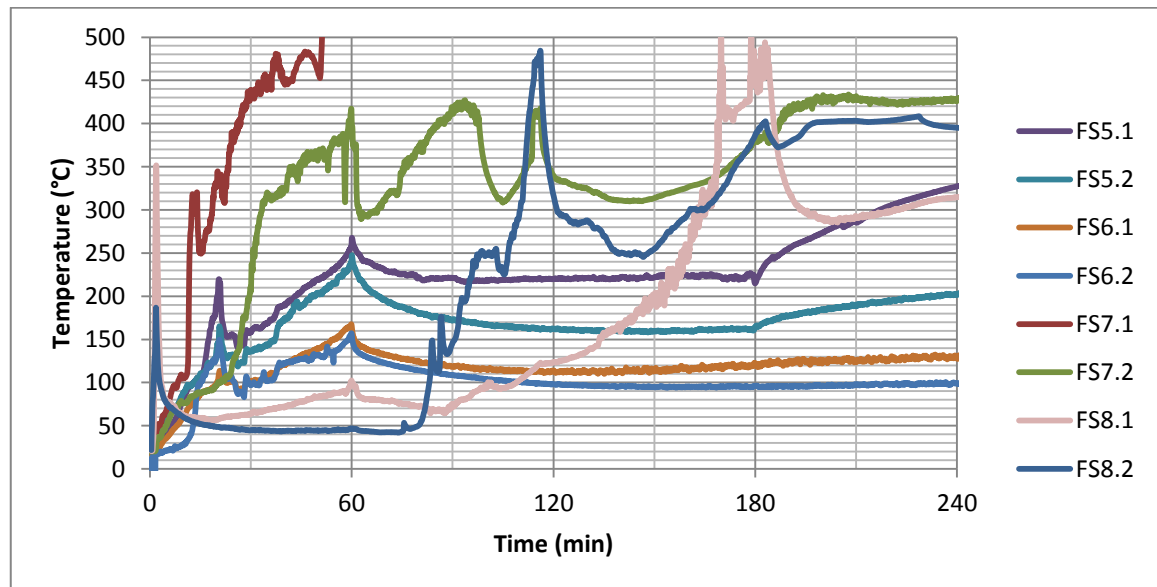
Figure 10 - Temperatures measured in the centre of the cavities

The temperatures measured in the centre of the enclosed cavities are shown in Figure 10. The curves corresponding to, at room temperature closed cavities, (all curves except for FS8.1 & FS8.2) showed a large variation. The temperature in specimen FS7.1 increased rapidly during the heating phase. After approximately 80 minutes visible flames started leaving the top of specimen FS7.1, after which the cavity was filled with stone wool to stop the fire. According to the two failure criteria mentioned before, the cavity barriers corresponding to specimens FS5.1, FS7.1, FS7.2, FS8.1 and FS8.2 fail the test, as the temperatures remained higher than 300°C. The barriers of specimen FS5.2 and FS6.1 fail the test as well, because they show a significant temperature increase during Phase 3. It should be noted that the specimens FS5.1 and FS6.1 are identical, but show significantly different temperatures. Whether this is caused by, (i) variations in the product, (ii) variation in the mounting or (iii) something related to the chosen test method we do not know, further investigations will show that. This indicates that more than one model scale

The two curves in Figure 10 that correspond to ventilated cavities (FS8.1 and FS8.2) show a peak at the very beginning of the test which is logical as this is cavity barriers that are open at room temperature. However, the temperature decreased rapidly afterwards, which indicates that the lower intumescent cavity barrier expanded. The temperature in the center of the cavity did not significantly increase for the first 80 minutes, indicating that the upper barrier was not fully activated during this period. During this period the test could, thus, be considered as a single-barrier test (see Figure 7A). Therefore, the applied method should be questioned for ventilated cavities. The increase of the temperature observed after 80 minutes could be caused by potential expansion of the upper barrier or possible degrading of the lower barrier.

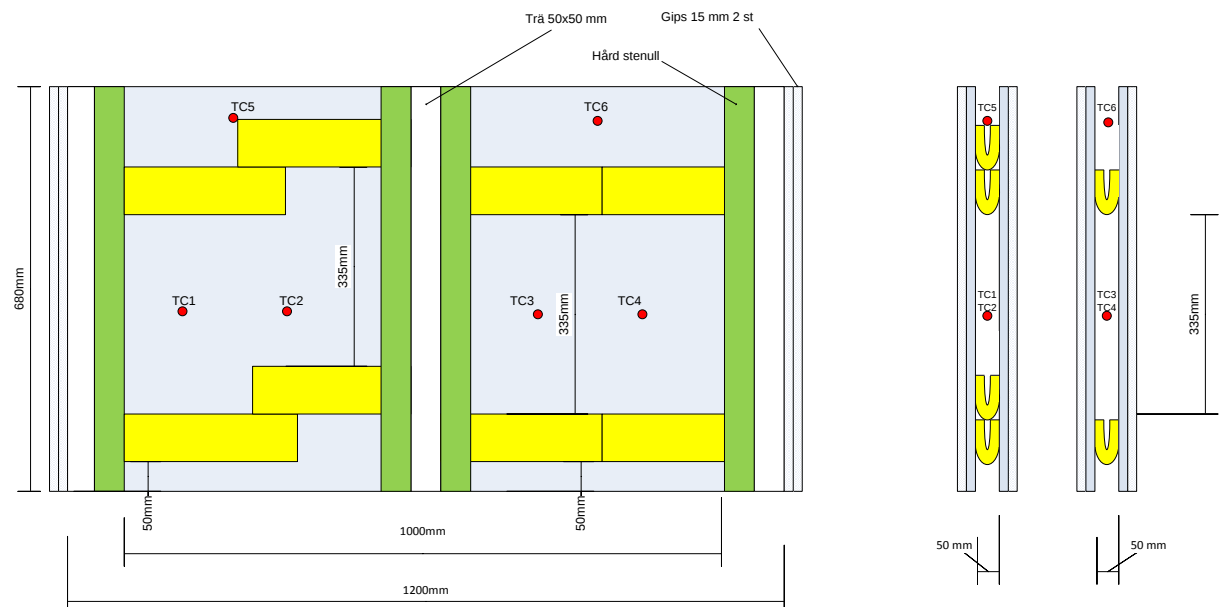
Figure 11 - Cross-sections of specimens with overlapping joints (left) and butt joints (right), exposed from the bottom

Table 5 gives an overview of the performed tests of test series 3. The performance of overlapping joints and butt joints between cavity barriers, as shown in Figure 11 was studied. Test FSJ1.1 and FSJ1.2 comprised of plastic covered cavity barriers which were positioned in a cavity with walls made of particle board. The unexposed sides of the particle board were covered by gypsum plaster boards similar to the specimens of the previous test series. Tests FSJ1.1 and FSJ1.2 functioned as reference tests for the other tests. Tests FSJ2.1 and FSJ2.2 were similar tests, without plastic covering of the cavity barriers. The difference between FSJ3.1 and FSJ3.2 compared with FSJ 1.1 and FSJ 1.2 was the combustible wall material of the cavity, as FSJ3.1 and FSJ3.2 were made using plywood with a density of 680kg/m<sup>3</sup> instead of particle board.

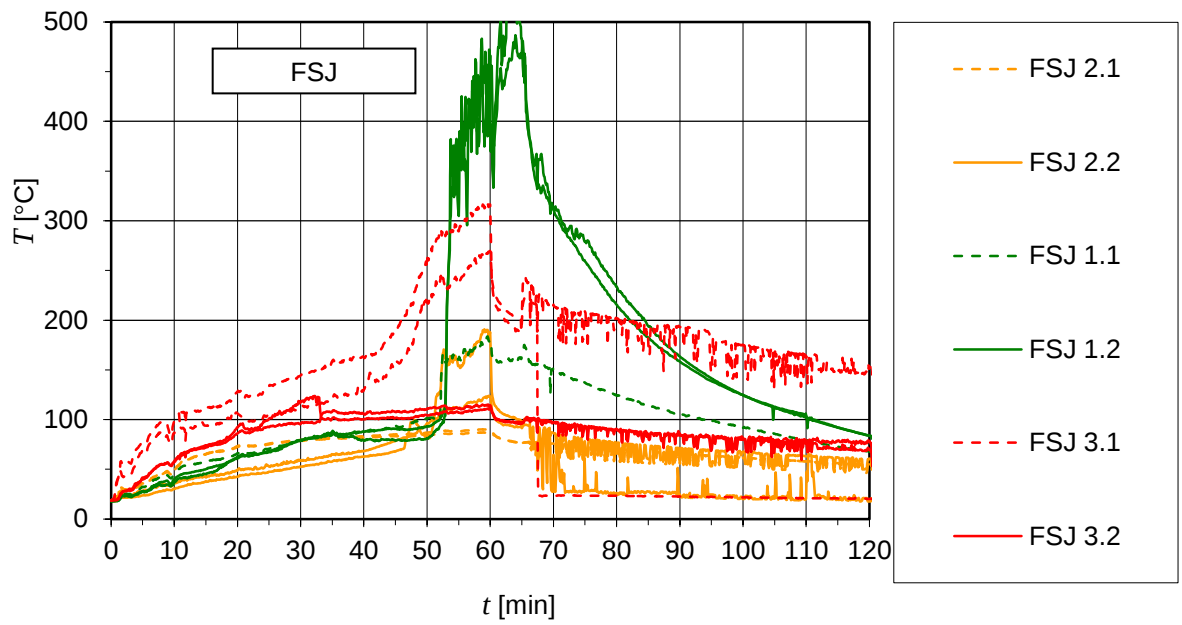
Figure 12 - Temperature measured in the center of the cavities

Temperatures measured in the centre of the cavities are shown in Figure 12. Test FSJ 1.2 showed the highest temperatures in the cavity after one of the cavity barriers fell into the furnace. It can be seen that FSJ2.1 and FSJ2.2 showed the best performance. These correspond to tests of cavity barriers without plastic. Observations of the test specimens after the tests, indicated that there was a significant air flow across the cavity barriers (Figure 13). Air channels are indicated by dark lines in the wooden surface at the position of the barriers. In contrast, the specimens of FSJ 2.1 and FSJ 2.2 (Figure 14), which correspond to cavity barriers without plastic, did not show these lines. The temperatures measured in the cavity were also significantly lower during the test. This indicates that cavity barriers without plastic covering are more suitable to limit the air flow into the cavity.

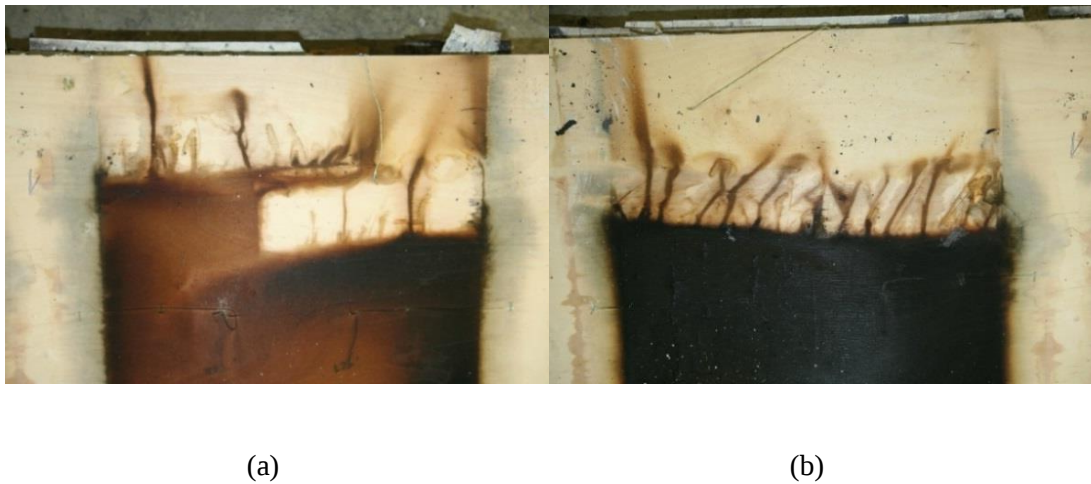
Figure 13 - Cavity walls of FSJ1.1 (a) and FSJ1.2 (b) after the test

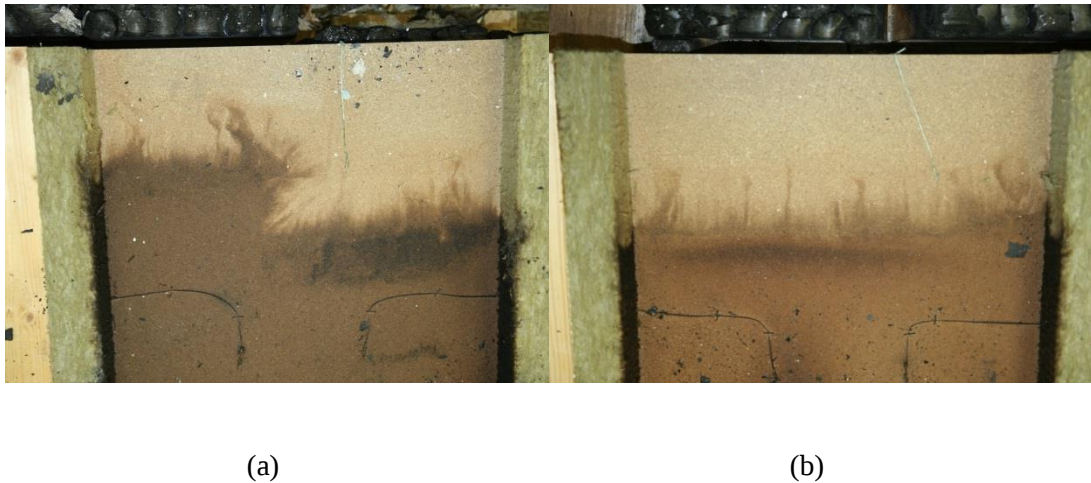
Figure 14 - Cavity walls of FSJ2.1 (a) and FSJ2.2 (b) after the test

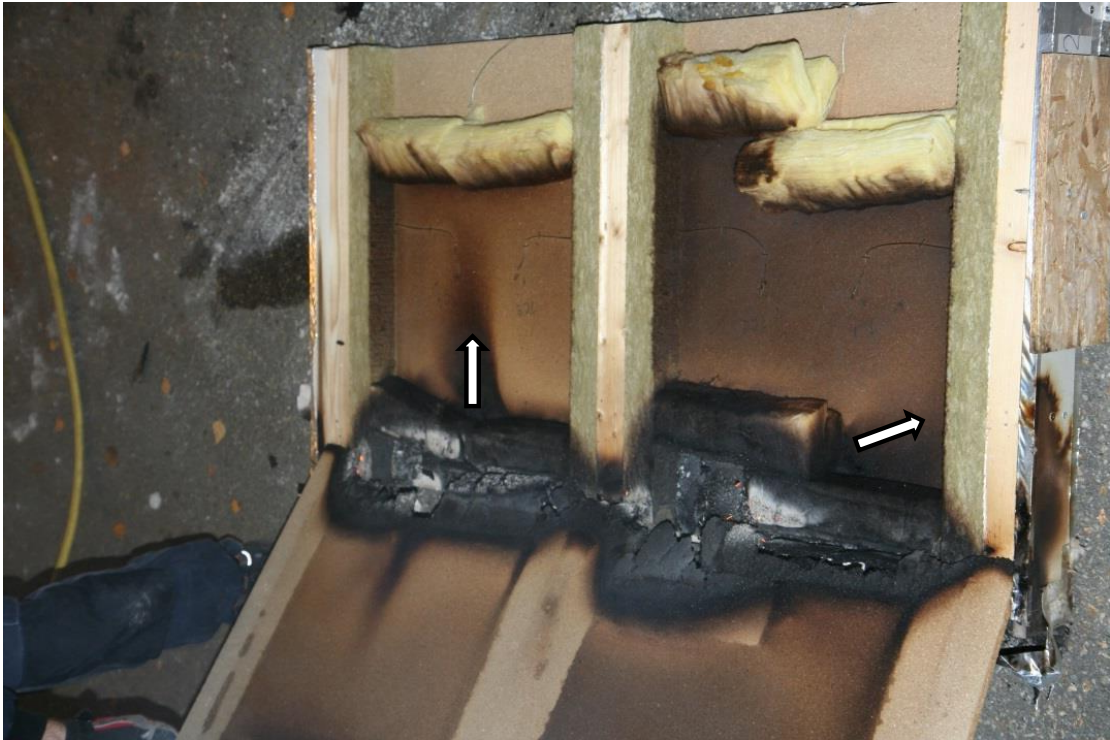
Figure 15 shows the specimen of FSJ2. The arrows indicate the direction of most significant air flow in the joints. Both cavities did not have to be extinguished after the fire test.

*Figure 15 - Inside of the cavities FSJ2.1 (right) and FSJ2.2 (left) after the test*

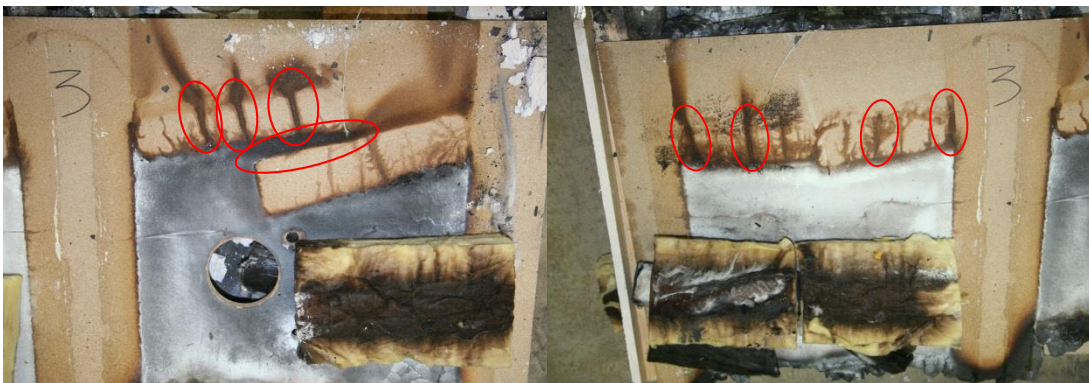
*Figure 16 - Cavity walls of FSJ3.1 (a) and FSJ3.2 (b) after the test*

The second highest temperatures were measured in FSJ3.1. Observation of the specimen after the test (Figure 16 a) showed that the overlap joint was not entirely tight as the cavity barriers were inclined with different angles. This created an undesirable air channel. The test specimen of FSJ3.2 did not show an air channel at the location of the joint. During the installation it was considered easier to make the butt-joint tight.

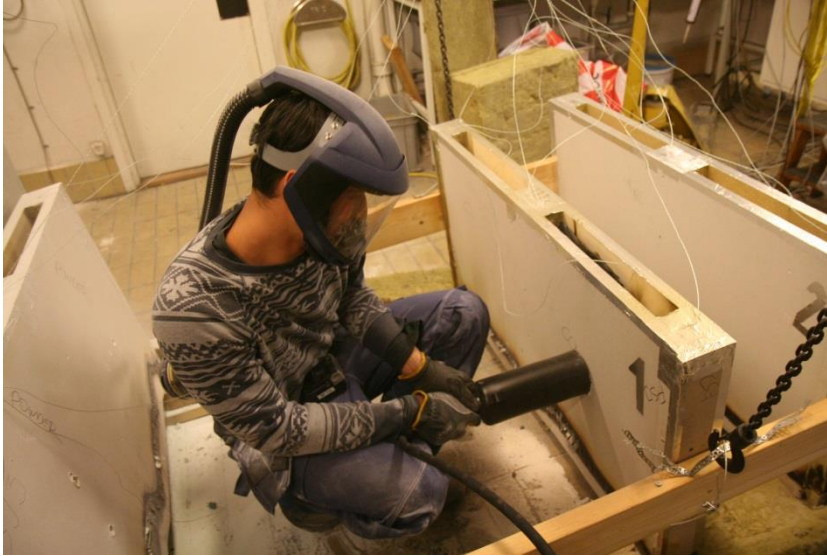
Figure 17 - Extinguishing of specimen FSJ1.

After the test of series 3 there was still combustion in the cavities of specimen FSJ1 and FSJ3. For the extinguishments a hole was drilled through the cavity wall and CO<sub>2</sub> and/or powder extinguishers were used (see Figure 17). The consumed weight of the substance used for extinguishments is reported in Table 6.

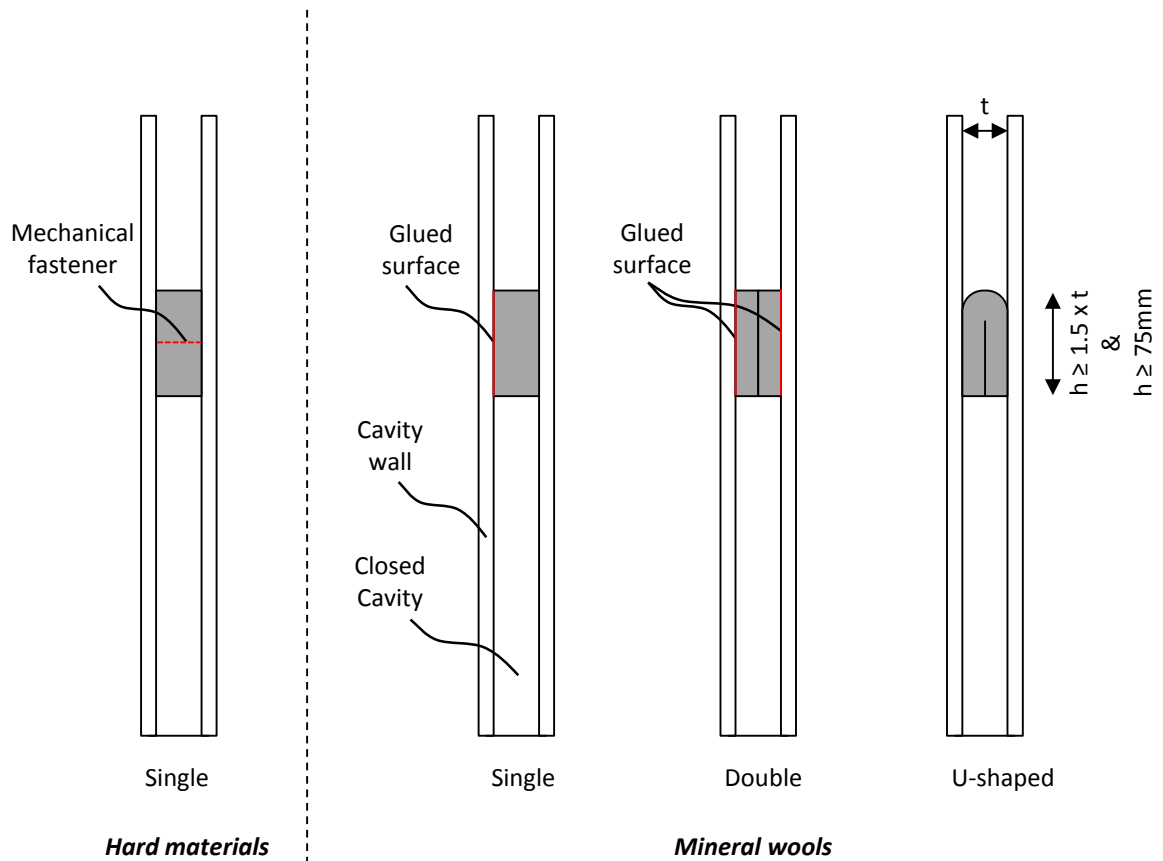
Figure 18 – Cross-sections of single double and U-shaped cavity barriers

There are several methods of installation recommended for cavity barriers. As shown in Figure 18 potential placement of the cavity barriers could be single double or U-shaped. In case mineral wools are used as cavity barriers, the minimum dimension is recommended to be chosen, so that its compressed density after installation is  $50 \text{ kg/m}^3$  or higher. Additionally, its height after installation,  $h$ , should be at least equal or larger than the maximum of 75mm and  $1.5t$ , where  $t$  is the cavity width. For a U-shape placement of the cavity barrier the cross-section should be at least  $t \times 3t$ . Additionally, the minimum density of the uncompressed material should be  $25 \text{ kg/m}^3$ .

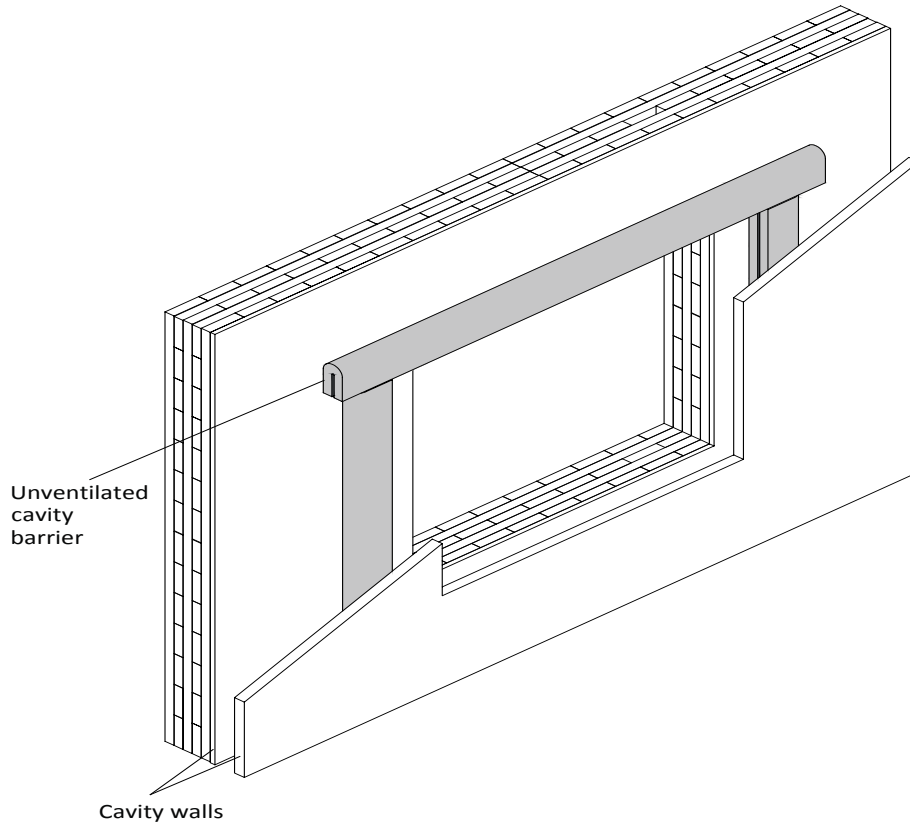
*A fire leaving a compartment through an opening will expose the upper side of the opening significantly more severely, than the lower side of the opening. Therefore, there is an increased risk that the cavity barrier above the opening falls, which would allow the fire to easily access the cavity. By letting highly exposed, horizontally positioned, cavity barriers within walls rest on the vertically positioned elements (Figure 19), the risk of falling becomes small.*

***Figure 19 - Prevention from falling of cavity barrier by robust design***

The design of cavity barriers should aim to (1) avoid falling of the cavity and (2) avoid air channels across and along the cavity barriers. Falling of the specimens can be avoided by appropriate fixation methods and, if possible, by robust design. Using robust design, falling of the barrier can be avoided, even if the primary fixation method (using glue, fasteners or by clamping) fails. An example of a robust solution that prevents falling of highly exposed cavity barriers is shown in *Figure 19*.

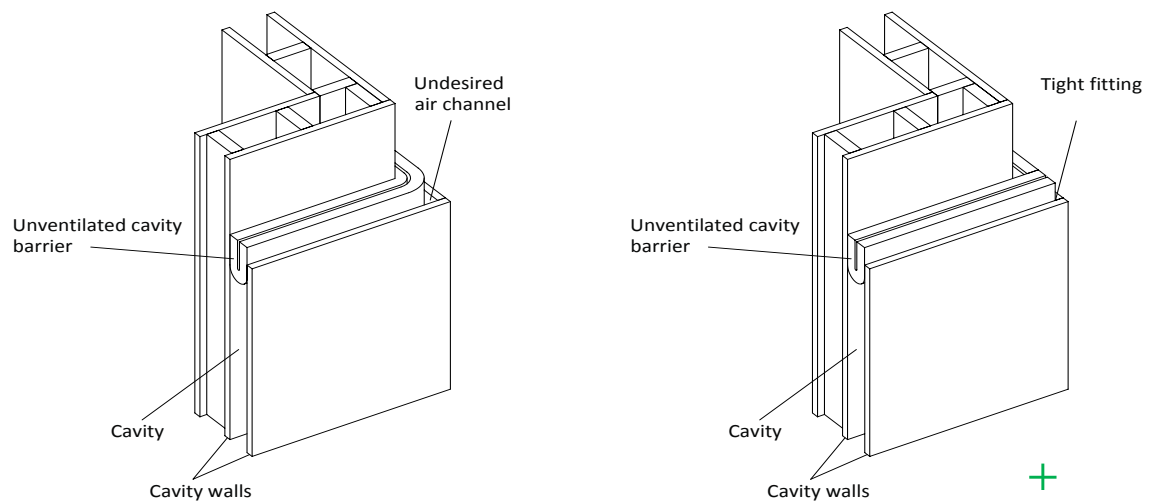
Figure 20 - Possible risk for undesired air channel in the outer corner

Undesired air channels can be avoided by design. Such undesired air channels could occur in corners and bends of the cavity barrier material, as shown in Figure 20. Solutions can be obtained by designing separate cavity barriers which are connected, instead of using bended cavity barrier in corners.

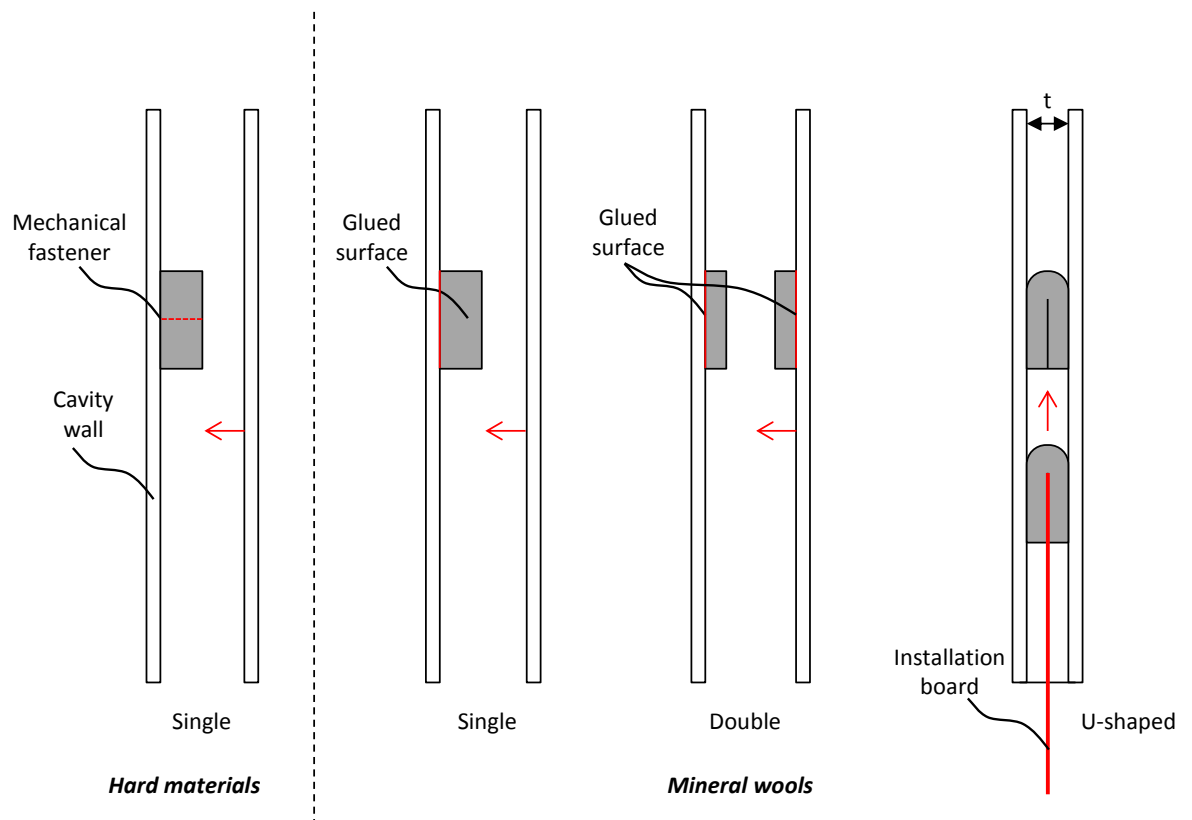
Figure 21 – Schematic drawing of installation

A schematic drawing concerning the installation of single, double or U-shaped placed cavity barriers is shown in Figure 21. The single and double placement of cavity barriers is especially applicable for cavities between modules of modular buildings. In this case the cavity barriers should be fixed to the cavity wall before the cavity is closed. Gluing of the cavity with high temperature resistant adhesives is recommended. For cavity barriers with a double placement, misalignment is allowed as long as the height of the contact area between the cavity barriers is equal or higher than the maximum of 75mm and  $1.5 \times t$  (see Figure 22).

The U-shape placement should be done using an installation board, as shown in Figure 21 and Figure 23. The intended position should be ensured using this installation board, which is especially relevant at the locations of joints. The resistance of the board should be used to indicate whether the cavity barrier is installed firmly.

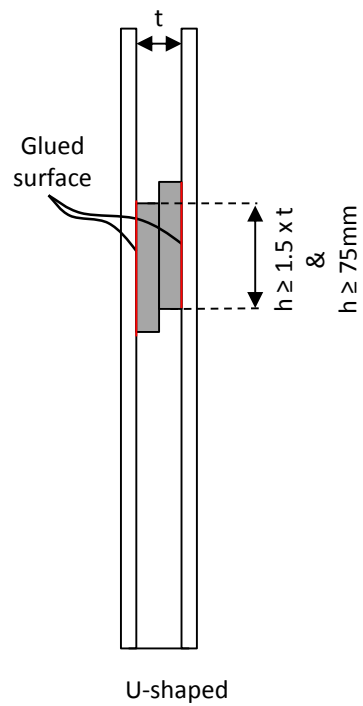
Figure 22 – Allowable geometrical misalignment

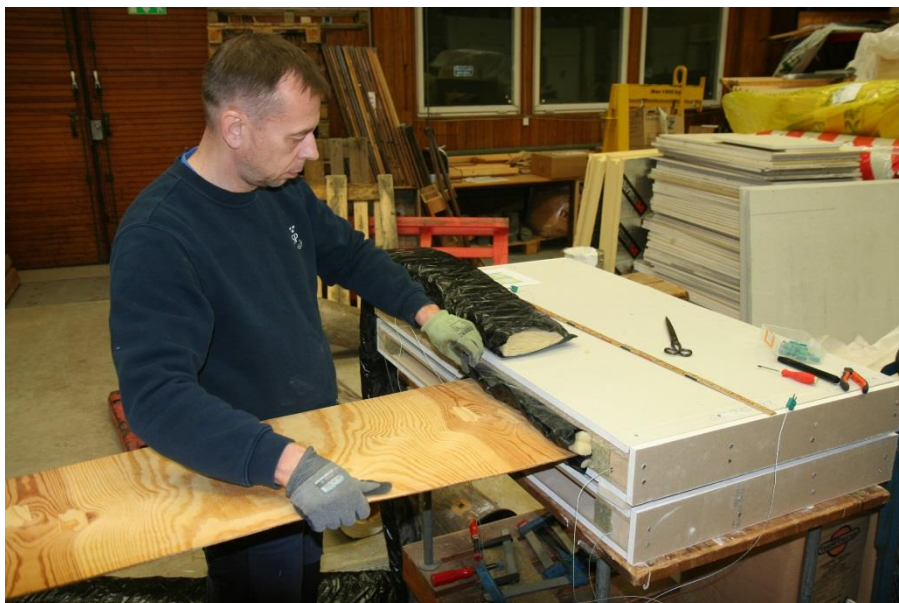
*Figure 23 - Sliding cavity barrier into the cavity for a U-shaped placement*

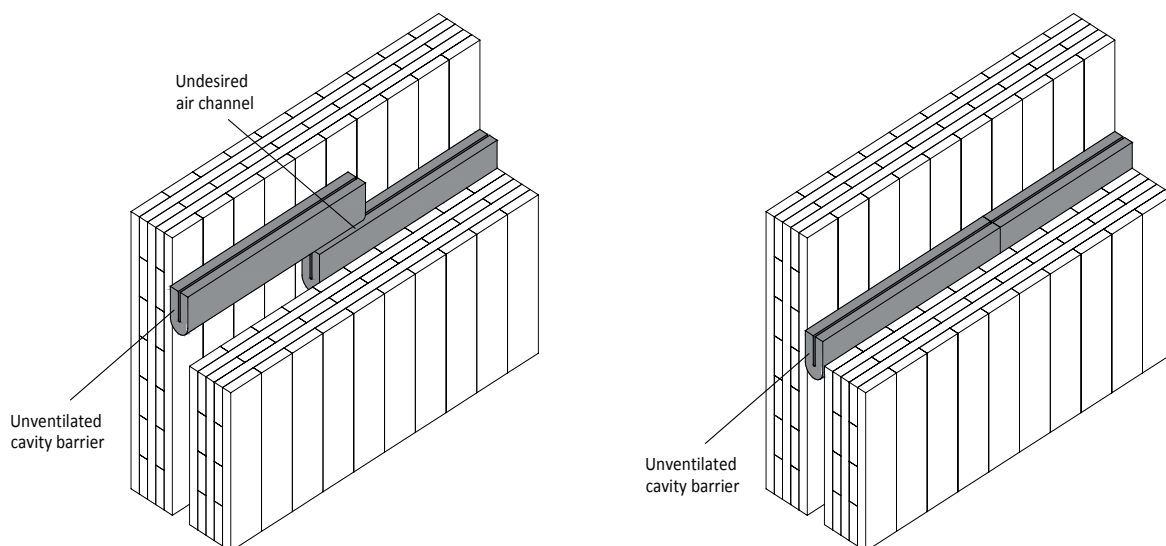
*Figure 24 - Possible risk for undesired air channel with overlapped joint*

Joints between cavity barriers should be made, so that air channels in the joint are avoided. Using cavity barriers with a U-shaped placement could lead to undesired air channels in joints, as shown in Figure 24. Therefore, in-line and butt-joints are recommended for cavity barriers with a U-shaped placement. However, an overlapped joint, as shown on the left hand side of Figure 24, can be applied if (1) the length of the overlap is at least equal the height,  $h$ , of the cavity barrier and (2) the cavity is made of mineral wool without plastic covering. It must be ensured that both cavity barriers in one joint are placed tightly against each other.
