BRANDFORSK
2017:1

Fire Stops in Buildings

Alar Just och Daniel Brandon

Fire stops, cavity barriers, model scale fire tests

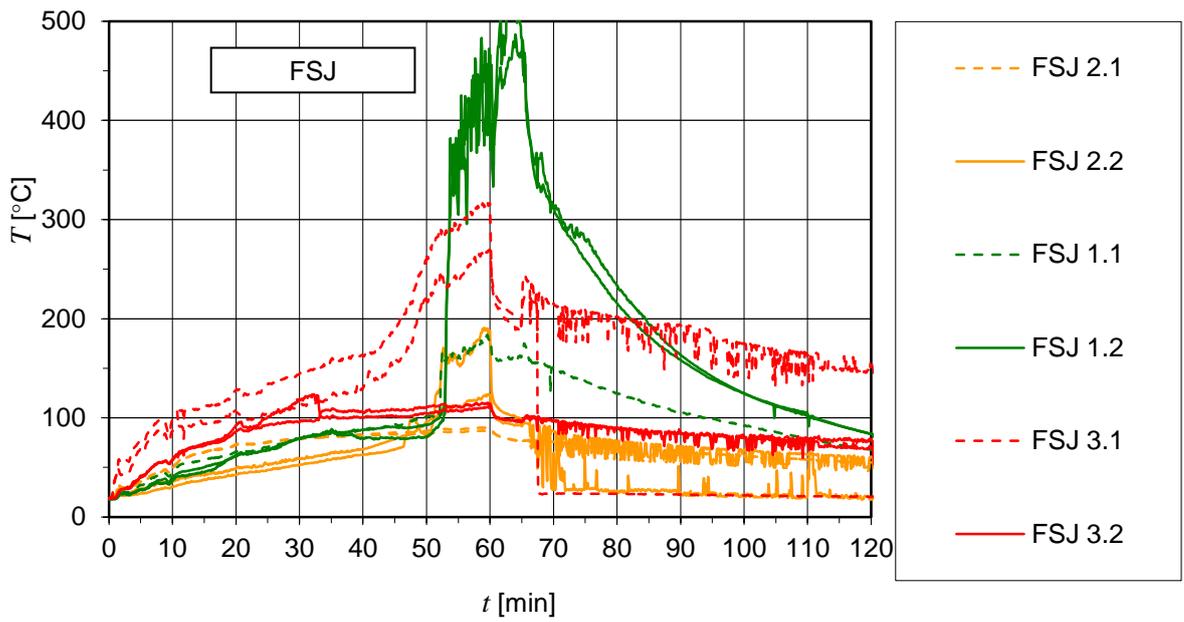
Figure 12 - Temperature measured in the center of the cavities

Temperatures measured in the centre of the cavities are shown in Figure 12. Test FSJ 1.2 showed the highest temperatures in the cavity after one of the cavity barriers fell into the furnace. It can be seen that FSJ2.1 and FSJ2.2 showed the best performance. These correspond to tests of cavity barriers without plastic. Observations of the test specimens after the tests, indicated that there was a significant air flow across the cavity barriers (Figure 13). Air channels are indicated by dark lines in the wooden surface at the position of the barriers. In contrast, the specimens of FSJ 2.1 and FSJ 2.2 (Figure 14), which correspond to cavity barriers without plastic, did not show these lines. The temperatures measured in the cavity were also significantly lower during the test. This indicates that cavity barriers without plastic covering are more suitable to limit the air flow into the cavity.

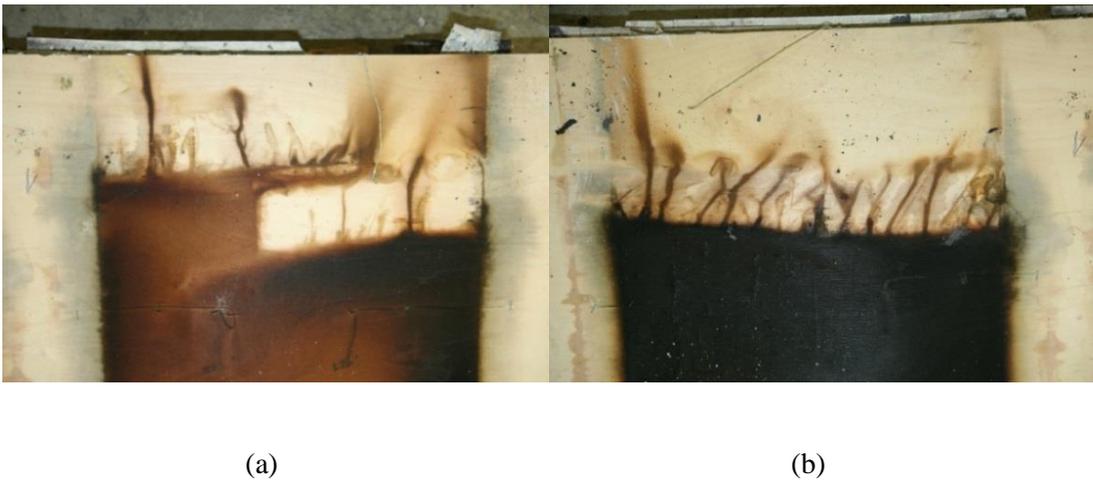
Figure 13 - Cavity walls of FSJ1.1 (a) and FSJ1.2 (b) after the test

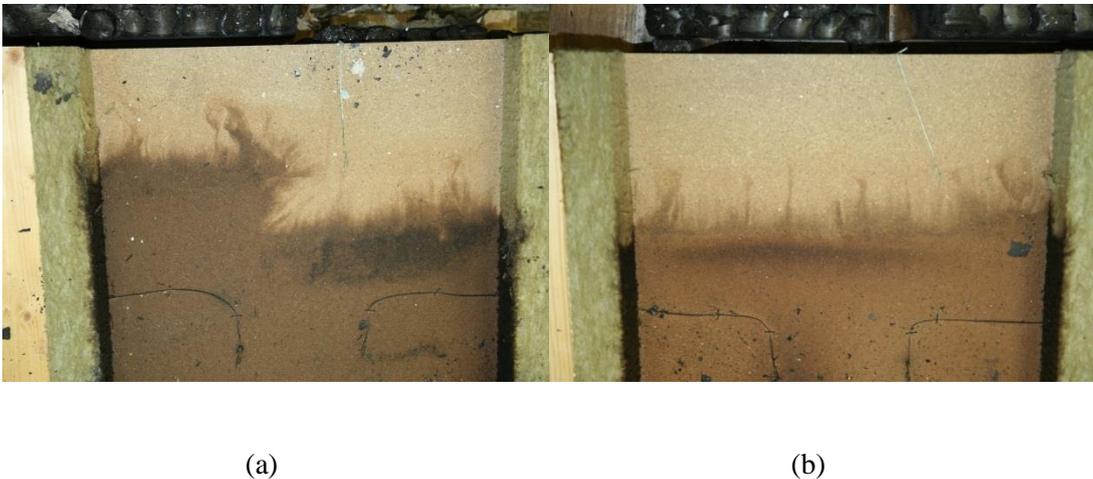
Figure 14 - Cavity walls of FSJ2.1 (a) and FSJ2.2 (b) after the test

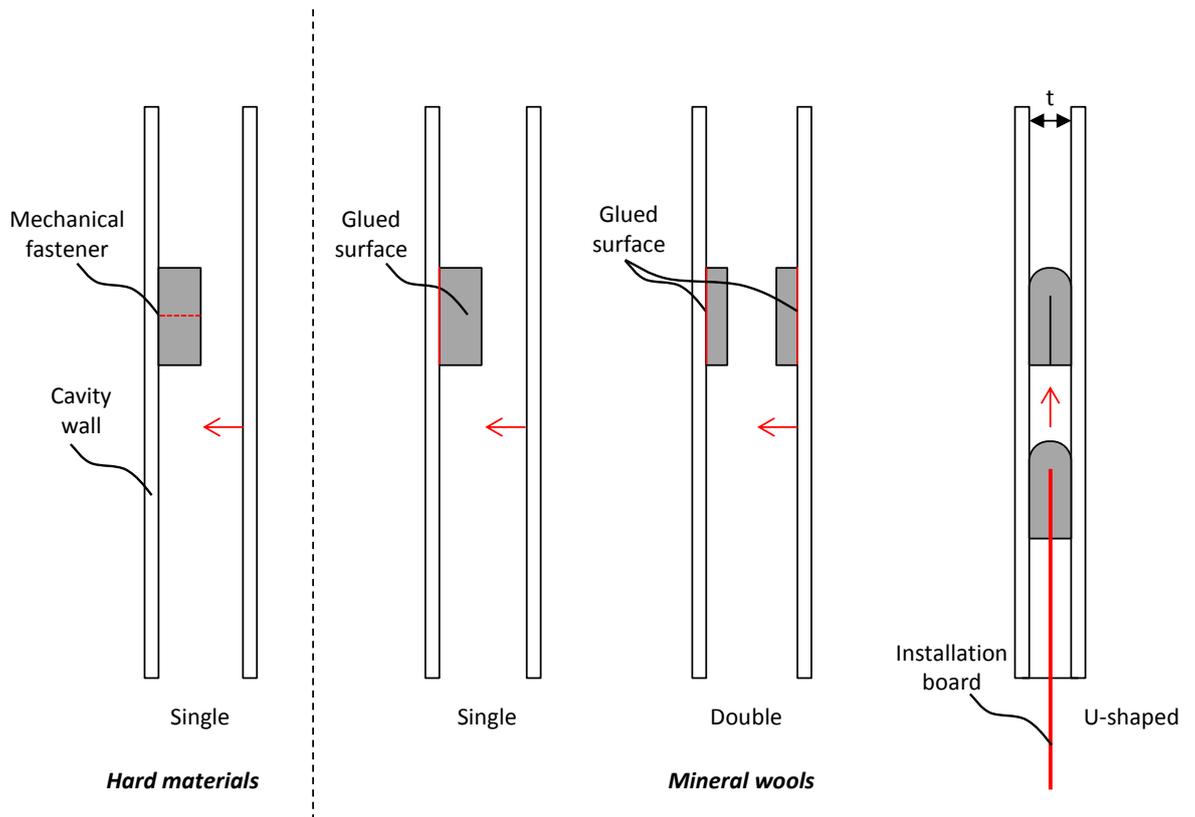
Figure 21 – Schematic drawing of installation

A schematic drawing concerning the installation of single, double or U-shaped placed cavity barriers is shown in Figure 21. The single and double placement of cavity barriers is especially applicable for cavities between modules of modular buildings. In this case the cavity barriers should be fixed to the cavity wall before the cavity is closed. Gluing of the cavity with high temperature resistant adhesives is recommended. For cavity barriers with a double placement, misalignment is allowed as long as the height of the contact area between the cavity barriers is equal or higher than the maximum of 75mm and $1.5 \times t$ (see Figure 22).

The U-shape placement should be done using an installation board, as shown in Figure 21 and Figure 23. The intended position should be ensured using this installation board, which is especially relevant at the locations of joints. The resistance of the board should be used to indicate whether the cavity barrier is installed firmly.
