BRANDFORSK
2018:2:2

Mitigation of fire damages in multi-storey timber buildings – statistical analysis and guidelines for design

RISE Report 2018:43

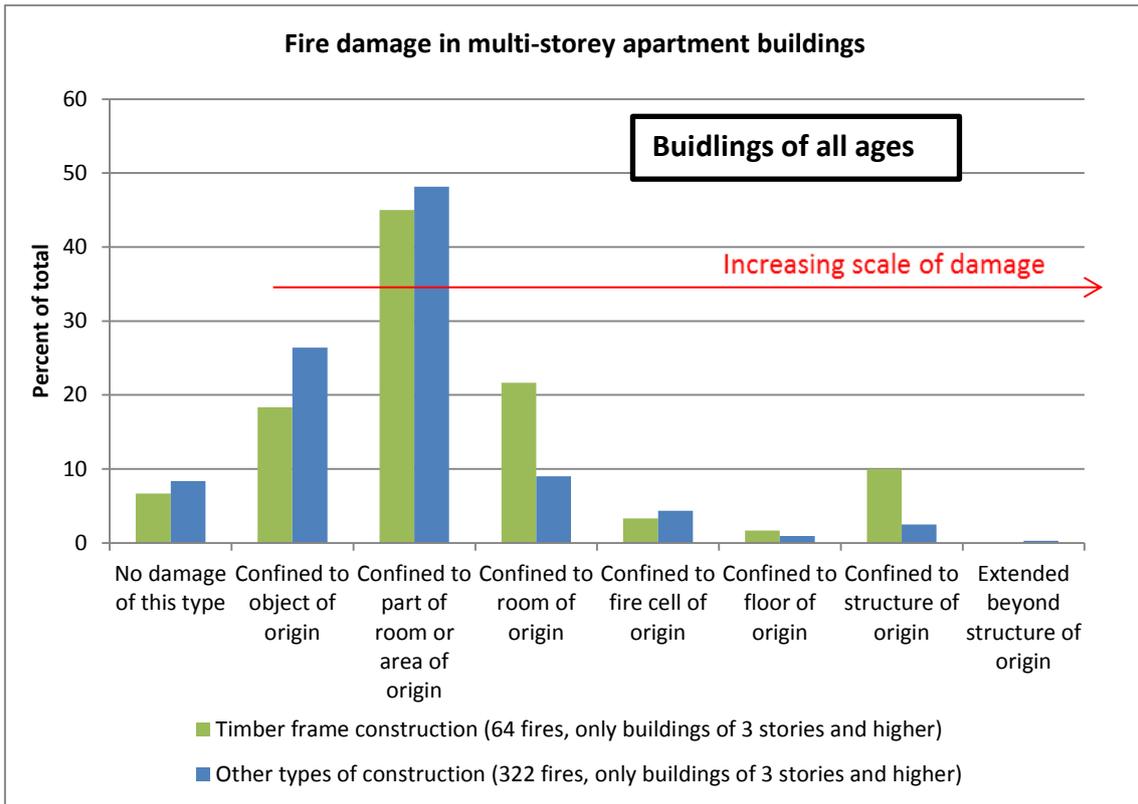
Figure 1 shows a distribution of direct flame damage (by flames and radiation). It should be noted that the data of this figure contains buildings of all ages. About half of the timber frame buildings were built before 1991 and about two-third of the other buildings were built before 1991. It can be seen that there is a higher frequency of large fire damages in buildings of timber frame construction than buildings of other types of construction. However, Figure 2, which includes only fire in modern buildings (constructed after 1991) shows that this difference of large fire damages does not exist for modern buildings. Of apartment buildings built after 1991, there was no fire that extended beyond the fire cell of origin, which indicates that the fire safety design objective was reached successfully for these buildings. The percentage of fires that spread beyond the fire cell of origin was lower for modern timber buildings than for other types of modern buildings. However, this difference is not statistically significant according to a 2-tailed two proportion test with a significance level of 0.05.

Figure 1: Fire damages after fires in New Zealand from 2000 to 2016, distributed in categories indicating the scale of the damage.

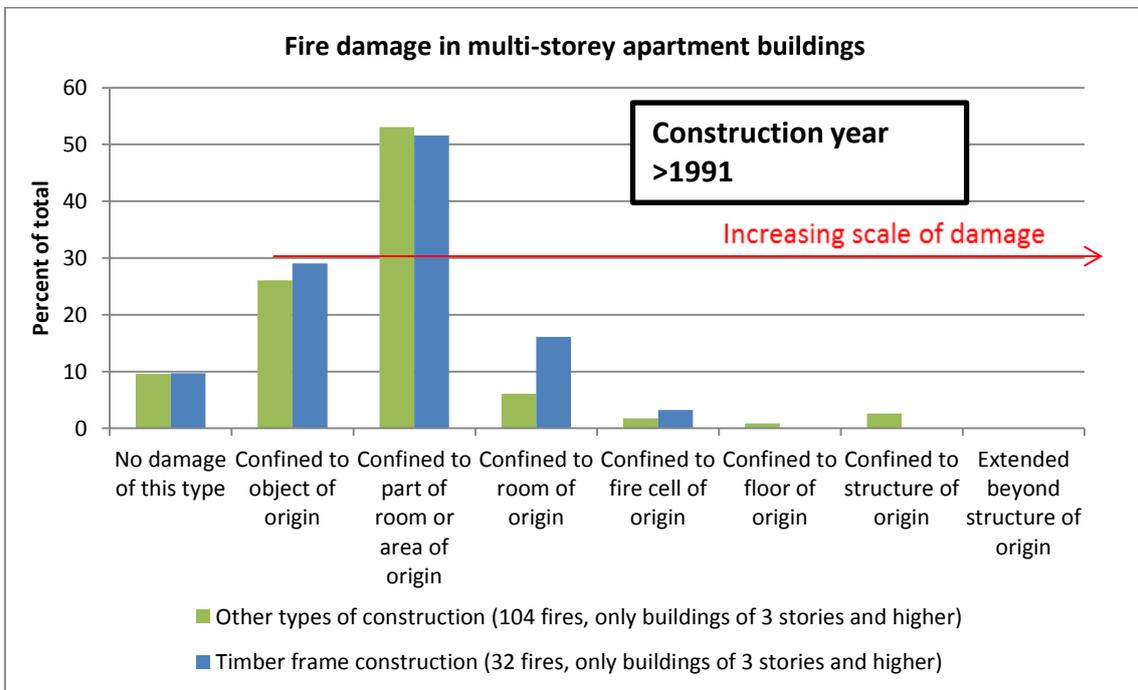
Figure 2: Fire damages after fires in modern buildings in New Zealand from 2000 to 2016, distributed in categories indicating the scale of the damage.

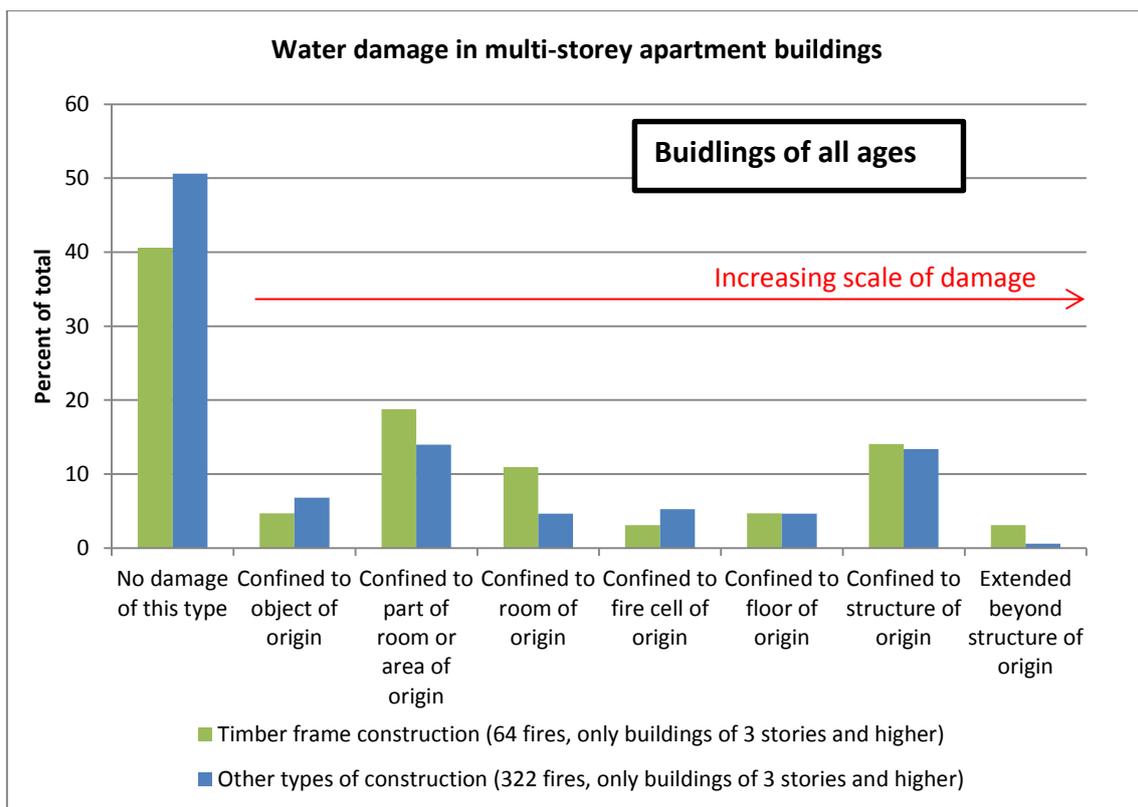
Figure 3 shows the distribution of water damages based on the scale of damage. From the left to the right, the scale of the damage increases, from no water damage at all to damages extended beyond the building of origin. This data includes data of fires in old buildings as well as modern buildings. The distribution of water damages seems to be relatively equal in timber frame construction and other types of buildings.

Figure 3: Water damages after fires in New Zealand from 2000 to 2016, distributed in categories indicating the scale of the damage.

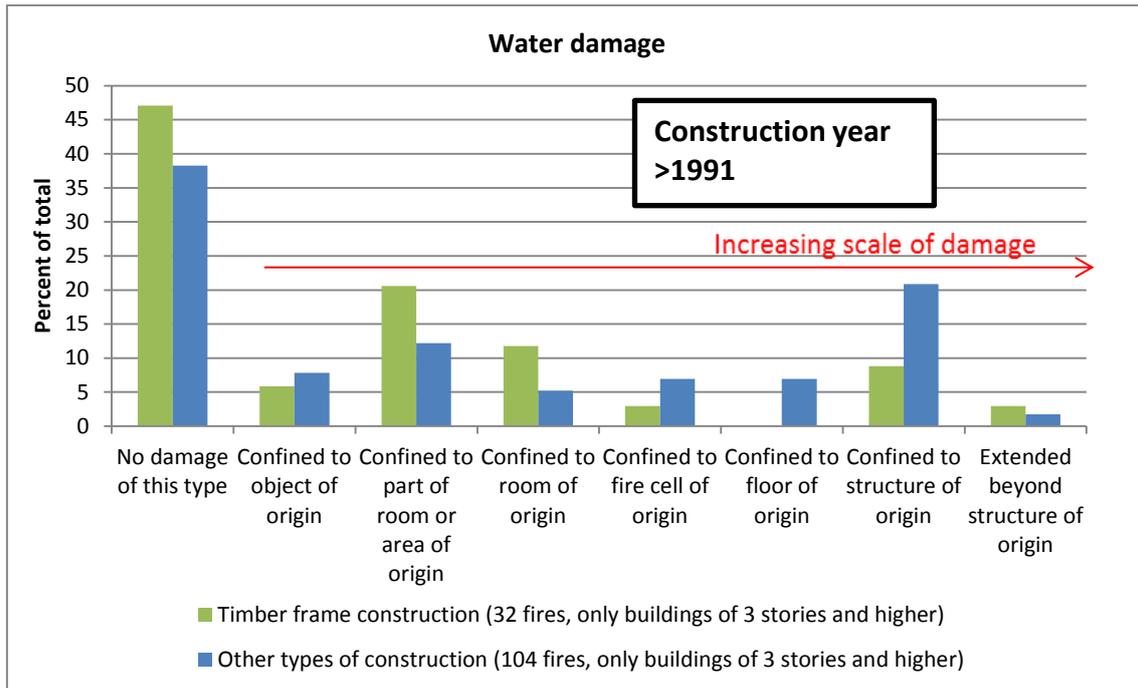
Figure 4 shows a similar graph, for modern buildings only (built after 1991). It can be noted that the spread of water damage in New Zealand was smaller in modern timber frame buildings than in other modern types of buildings. The frequency of water damages that extended beyond the fire cell of origin is lower in modern timber buildings than in other types of buildings. In buildings of timber frame construction, approximately 12% of the water damages extended beyond the fire cell of origin, while in buildings of other types of construction, 30% of the water damages extended beyond the original fire cell. According to a 2-tailed two proportion test with a significance level of 0.05, this difference is statistically significant. It can also be stated that the frequency of high water damages was lower in modern buildings of timber construction than in traditional buildings of timber construction. These statistics are related to the area of the damage, but do not provide any information about the cost of the corresponding restoration. Unfortunately, reliable data needed to compare costs of restoration of water damages in buildings with different materials has not been found.

Figure 4: Water damages after fires in modern buildings in New Zealand from 2000 to 2016, distributed in categories indicating the scale of the damage.

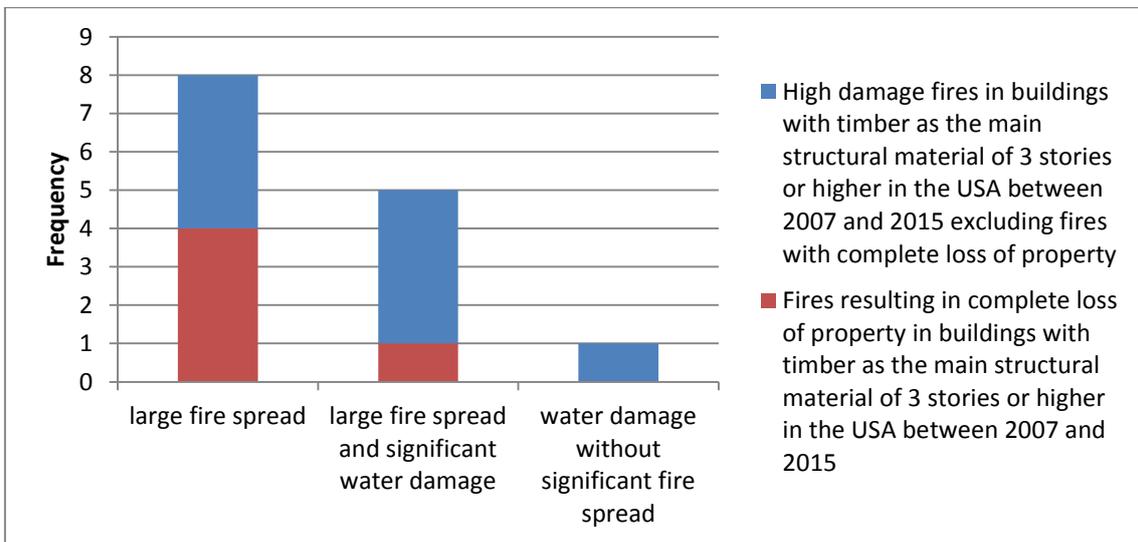
This selection of high damage fires includes 14 fires. Figure 5 indicates the main cause of financial losses according to the description of the fires. It should be noted that this data is dependent on the accuracy and completeness of the original reports owned by the NFPA and the interpretation of the researchers. One of the 14 high damage fires actually remained within one fire compartment. However, in that particular case, sprinkler activation led to extinguishment of the fire, but resulted in high water damages (38% property value loss). The fact that 13 out of the 14 identified high damage fires involve large fire spread, gives a strong indication that limiting the fire spread should be a main strategy to reduce property loss in fires. Of the 6 fires that led to high water damage, 1 was extinguished by sprinklers and 5 were extinguished by the fire brigade (Figure 6). 1 of these 5 fires led to complete loss of property value.

Figure 5: Main causes of high fire damages in the US and their corresponding frequency.

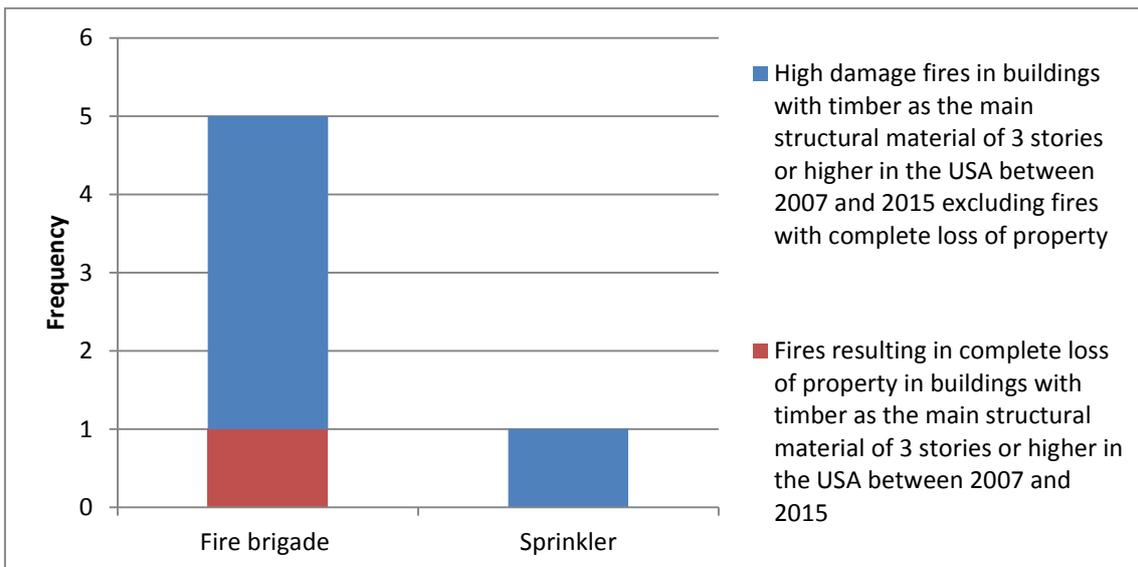
Figure 6: The method of extinguishment of fires that led to high water damages in the US

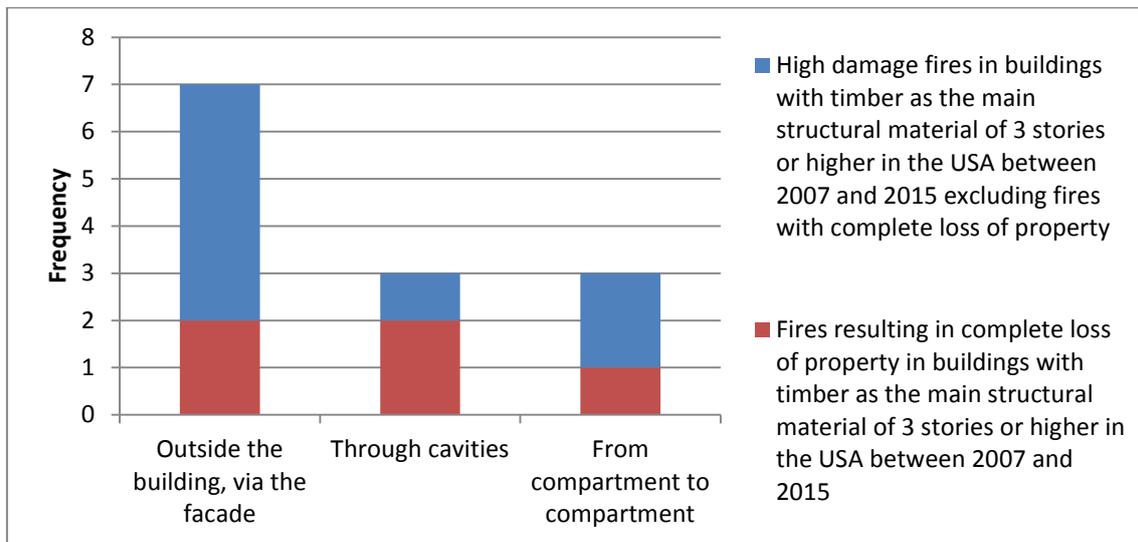
Figure 7 shows that the most frequent mode of significant fire spread is via the façade. In three of eight cases, the fire entered into the attic according to the reports. Additionally, it can be seen that two of the three cavity fires of this high-damage selection led to complete loss of property.

Figure 7: Main modes of fire spread and their corresponding frequency in large damage fires in the US.

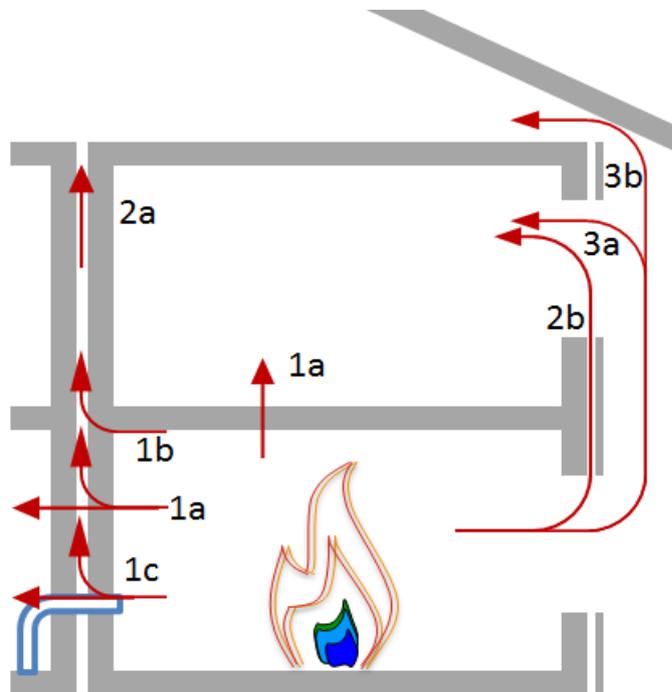
Figure 8: Potential paths of fire and smoke spread out of the compartment considered for the building design

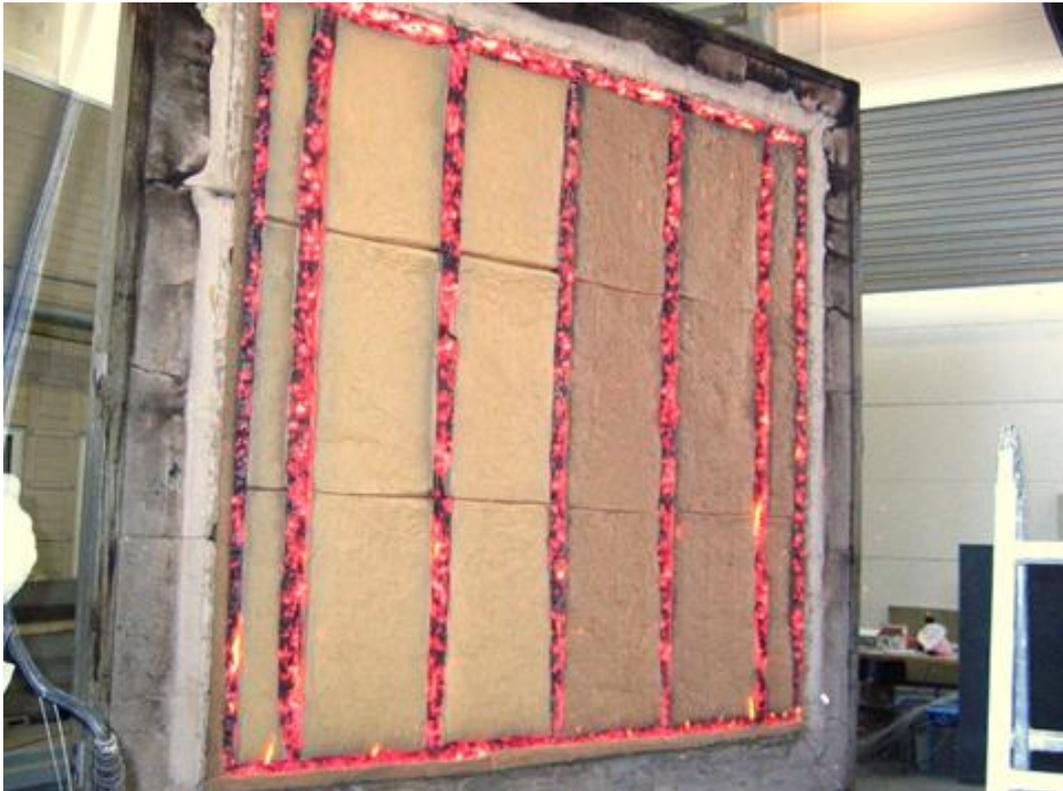
If the fire resistance is demonstrated with a fire resistance test, it is important that the exact same insulation material, product and fastening method are used in the designed building, as were implemented in the fire resistance test. This fastening method could involve fasteners, but also methods to clamp the insulation in place to preventing fall-off (Figure 9).

Figure 9: Stone wool fixed using over-dimensioning after 60 minutes fire test.

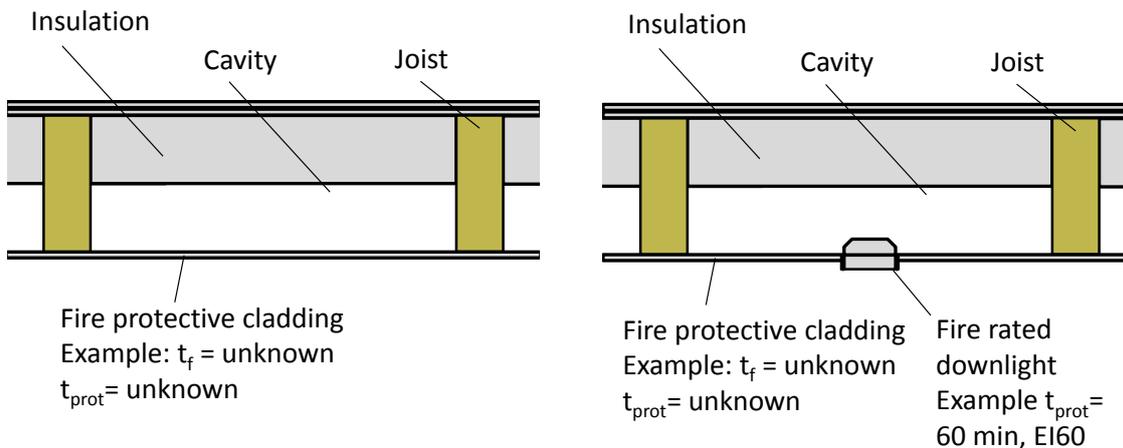
Figure 11: Example B - cross section of a 60minutes fire resistant ceiling (left) and a suitable application of a fire resistant lamp in this ceiling (right)

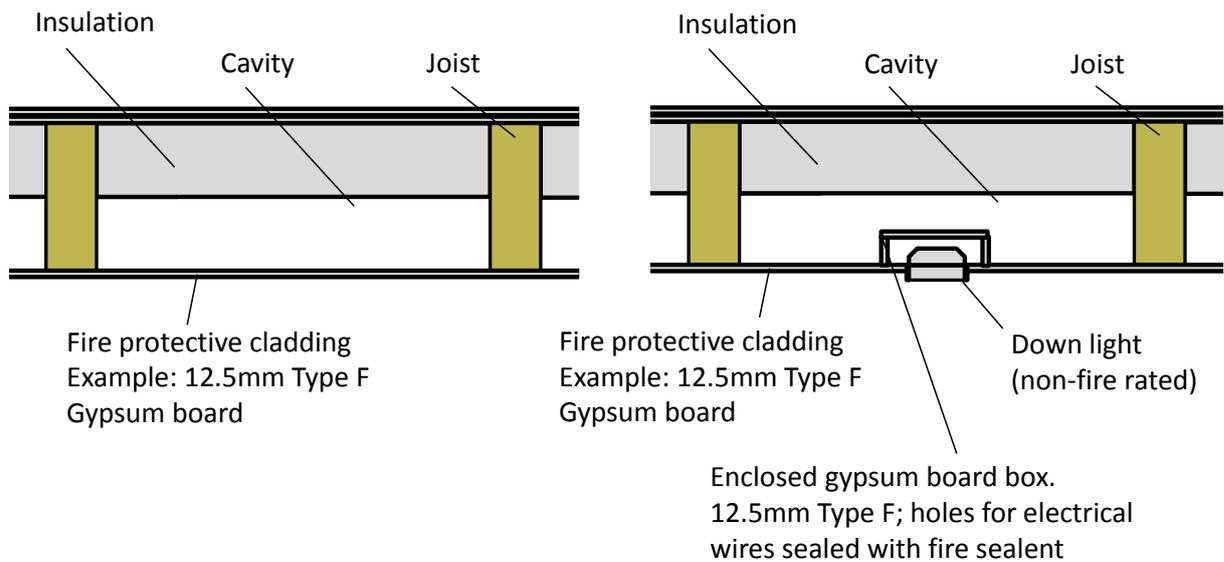
Figure 12: Example C - cross section of a 60minutes fire resistant ceiling (left) and a suitable application of a non-fire-resistant lamp in this ceiling (right)

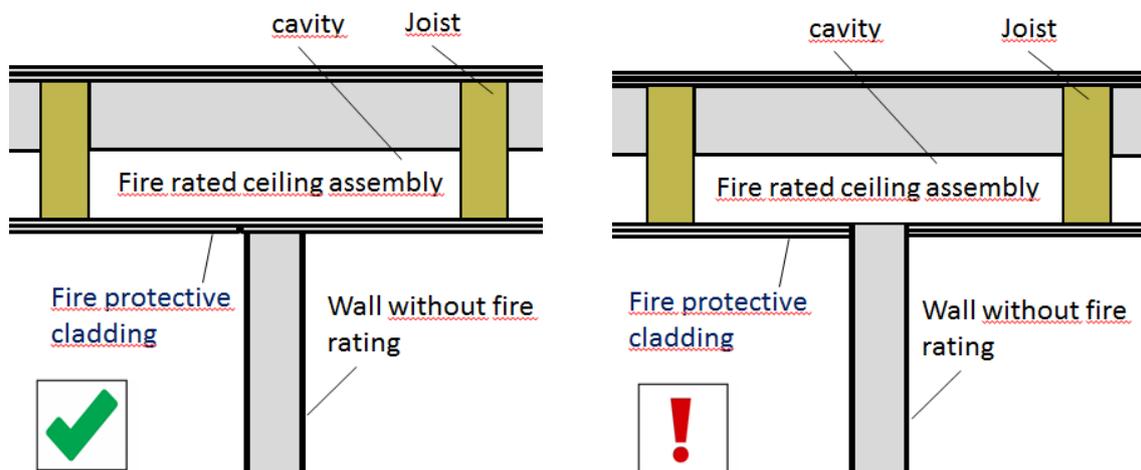
Within fire compartments there may be partitioning walls, which do not have fire resistance requirements. It is, however, important that the fire resistance of adjacent assemblies is not compromised by the failure of the non-fire-rated partitioning wall. Therefore, it is important that the fire protective cladding and insulation of fire resistive assemblies are not penetrated by non-fire rated partitioning walls, such as shown in Figure 13 and Figure 14. The assemblies on the left side of these figures are implemented correctly. The fire resistance of the assemblies on the right side is compromised if the wall fails earlier in a fire, than the base layer of fire protective board.

Figure 13: Example D - cross section of a 60minutes fire resistant ceiling (left) and a suitable application of a fire resistant lamp in this ceiling (right)

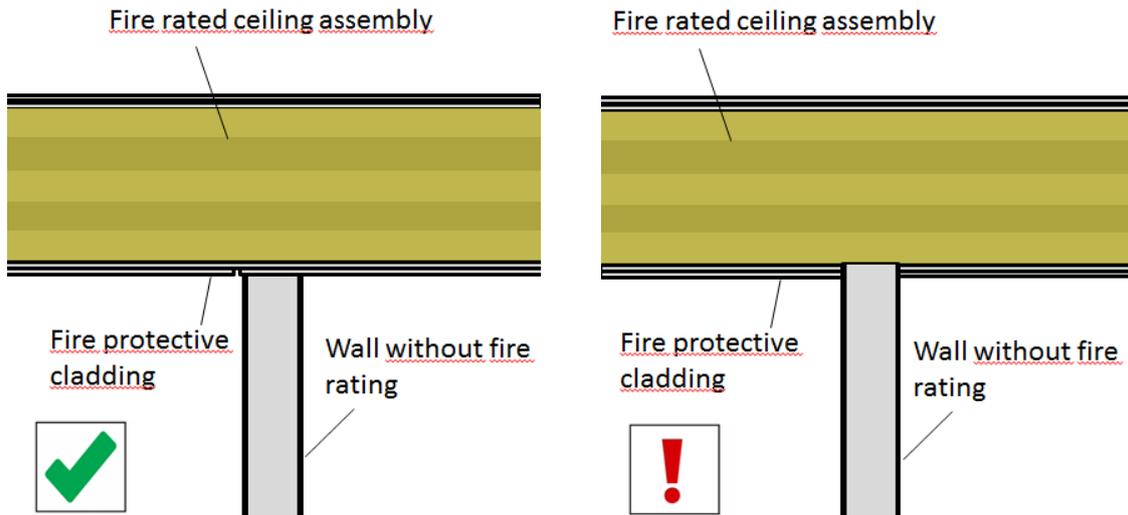
Figure 14: Example E - cross section of a 60minutes fire resistant ceiling (left) and a suitable application of a fire resistant lamp in this ceiling (right)

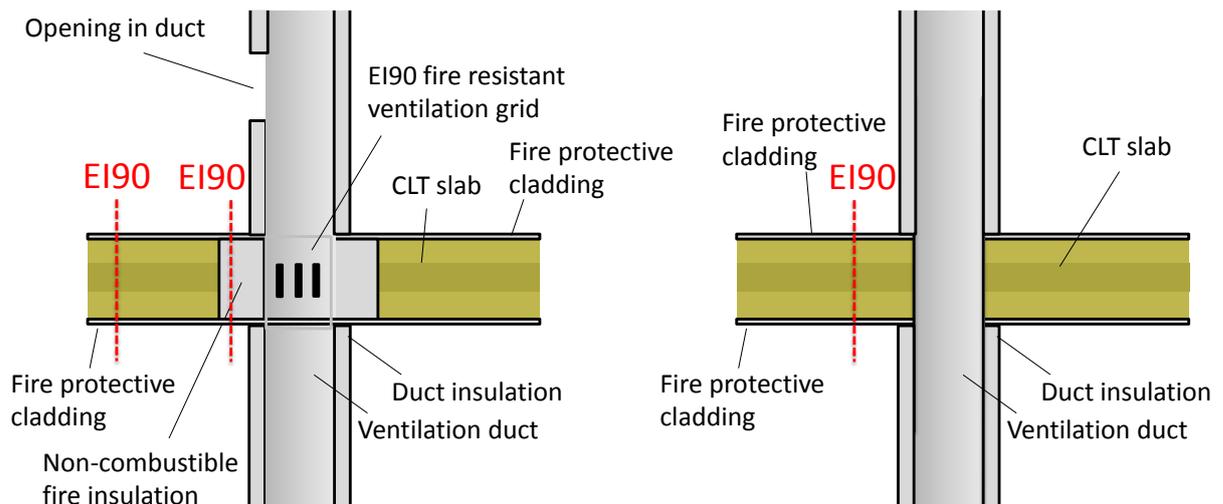
Ventilation ducts generally cross from fire compartment to fire compartment and have been the cause of fire spread out of the compartment in multiple building fires. If the fire can enter the ventilation duct, it is important to block the flames from spreading through the duct. This can be done directly at the ventilation openings, or at the compartment boundaries. Additionally, the duct should be insulated to prevent possible ignition of combustibles near the duct in a neighbouring compartment (Figure 15). A tight fit of the ventilation ducts into the wall opening is required.

Figure 15: Example F - cross section of a 90minutes fire resistant wall with a ventilation duct with possibilities for flames to enter the duct (left) and without possibilities for flames to enter the ducts (right).

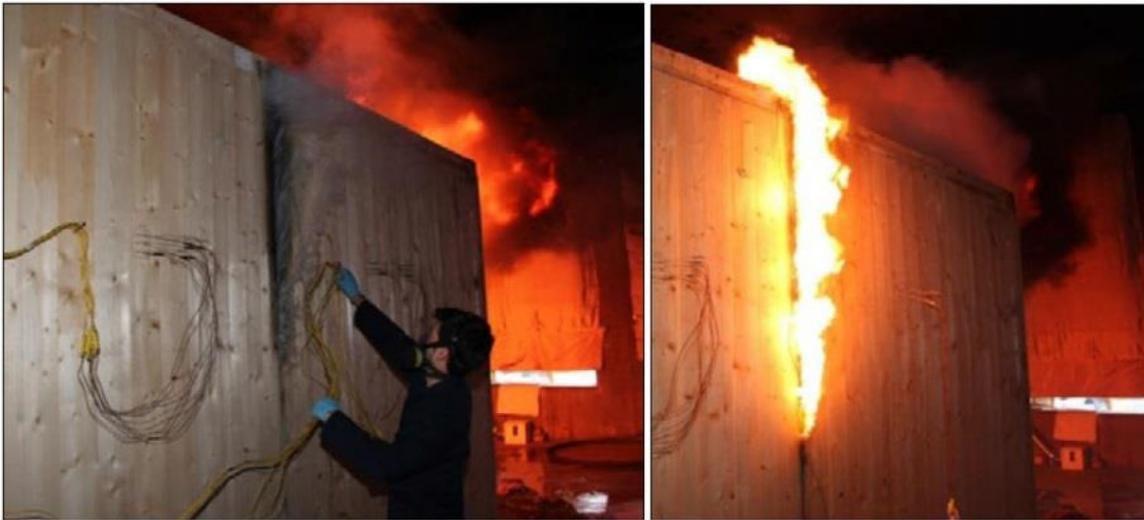
Previous compartment fire tests (Medina Hevia, 2014; McGregor 2014; Kampmeier; 2009) have shown that connections between CLT slabs can be sensitive to fire and smoke spread, as can be seen in Figure 15. Connections are recommended to be sealed using methods, with for example intumescent strips or fire retardant sealant, that have been proven to be effective in fire resistance tests according to EN 1364. There are not enough fire resistance tests available to make conservative general guidelines regarding these connections at this stage.

Figure 16: Fire spread through a CLT splice connection, taken from McGregor (2014).

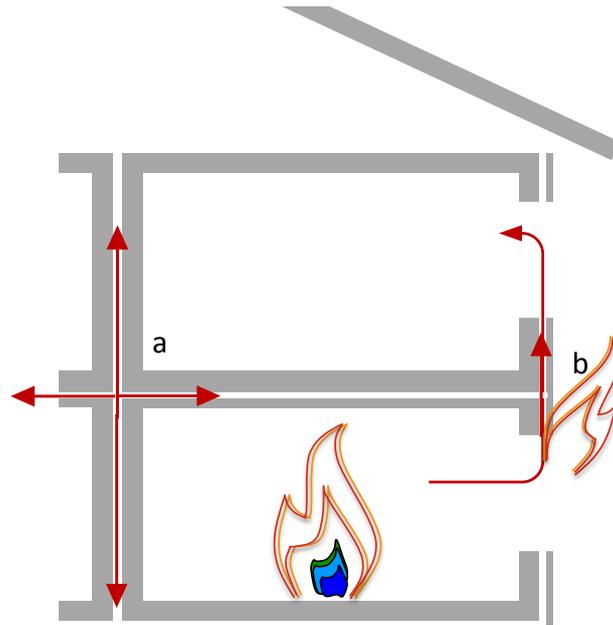
- a) Fire stops in cavities with combustible materials between compartment and between buildings, aiming to stop slowly spreading and long lasting smouldering fires (see Figure 17, type a).
- b) Fire stops in cavities in the façade, aiming to stop fire plumes from traveling through the cavities (see Figure 17, type b).

Figure 17: Potential paths of fire spread through cavities

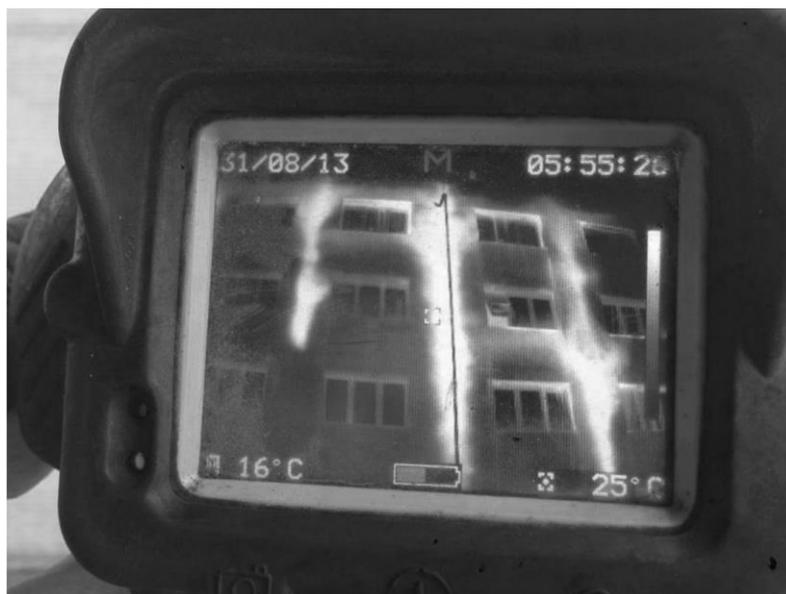
Cavity fires of *type a* can occur in cavities with combustible materials and can involve slow fire spread. The smouldering combustion in these cavities needs significantly less oxygen than flaming combustion and may not extinguish without interference of the fire service. Roughly a fourth of the large damage fires in USA analysed in chapter 3, involved cavity fires of *type a* as the main mode of fire spread. There was also one fire in Sweden in Luleå in 2013, in which a cavity fire of *type a* was the main mode of fire spread (Östman and Stehn, 2014; Figure 18). In a recent project funded by Brandforsk, a new testing method was developed (Just and Brandon, 2016; Brandon *et al.*, 2016) to assess the suitability of fire stops to limit fire spread in cavity fires of *type a*. Guidelines that resulted from that study are discussed further here.

Figure 18: Infrared camera picture indicating a downwards fire spread through cavities²

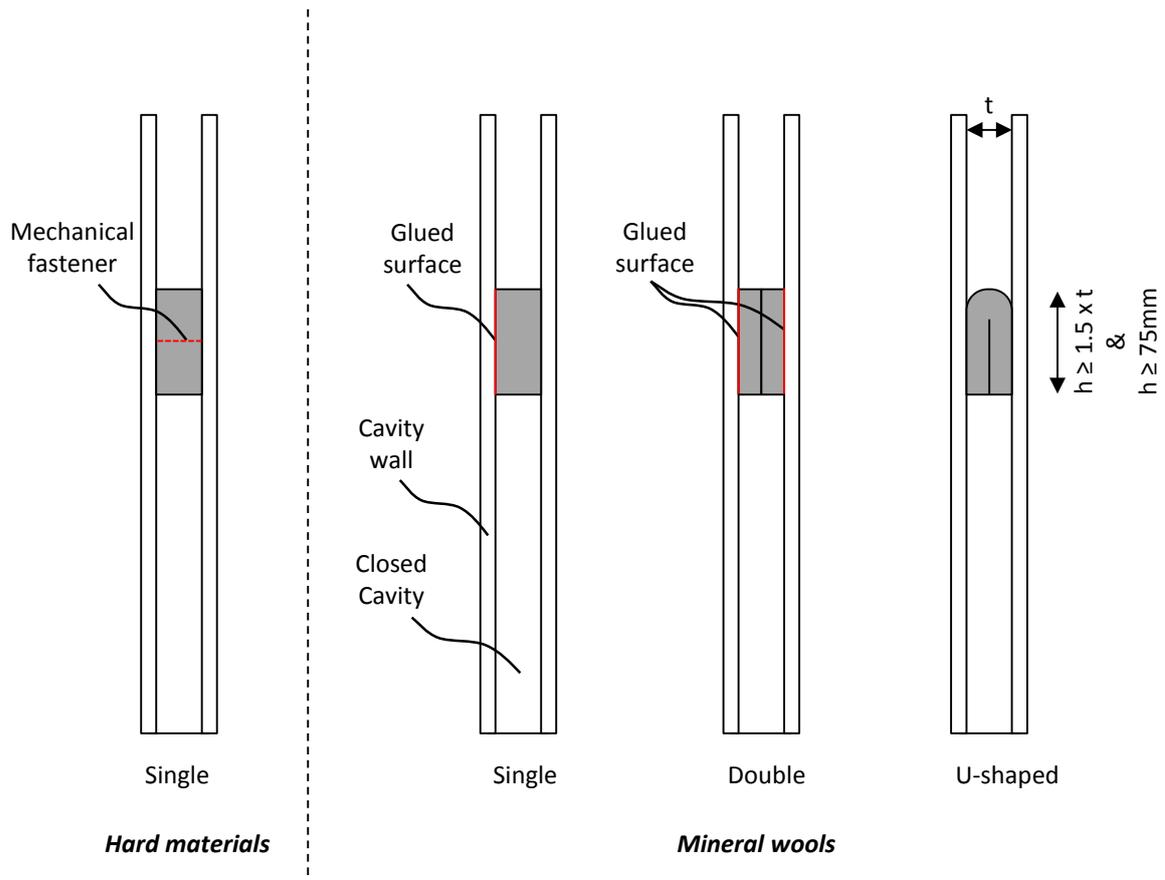
There are several installation methods recommended for fire stops. As shown in Figure 19, potential placement of the fire stops could be single, double, or U-shaped. In case mineral wools are used as fire stops, the minimum dimension is recommended to be chosen, so that its compressed density after installation is 50kg/m³ or higher. Additionally, its height after installation, h , should be at least equal or larger than the maximum of 75mm and $1,5t$, where t is the cavity width. For a U-shape placement of the fire stop, the cross-section should be at least $t \times 3t$. Additionally, the minimum density of the uncompressed material should be 25 kg/m³.

Figure 19: Cross-sections of single double and U-shaped fire stops

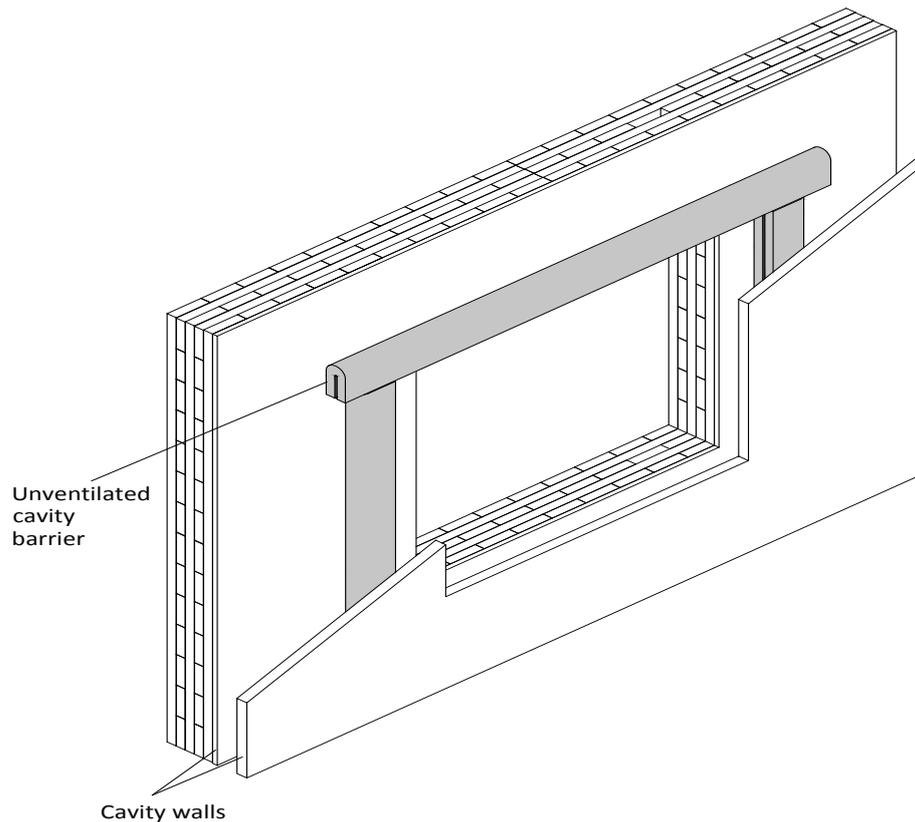
A fire leaving a compartment through an opening will expose the upper side of the opening significantly more severely, than the lower side of the opening. Therefore, there is an increased risk that the fire stop above the opening falls, which would allow the fire to easily access the cavity. By letting highly exposed, horizontally positioned, fire stops within walls rest on the vertically positioned elements (Figure 20), the risk of falling becomes small.

Figure 20: Prevention from falling of fire stop by robust design

The design of fire stops should aim to (1) avoid falling of the cavity and (2) avoid air channels across and along the fire stops. Falling of the specimens can be avoided by appropriate fixation methods and, if possible, by robust design. Using robust design, falling of the barrier can be avoided, even if the primary fixation method (using glue, fasteners or by clamping) fails. An example of a robust solution that prevents falling of highly exposed fire stops is shown in Figure 20.

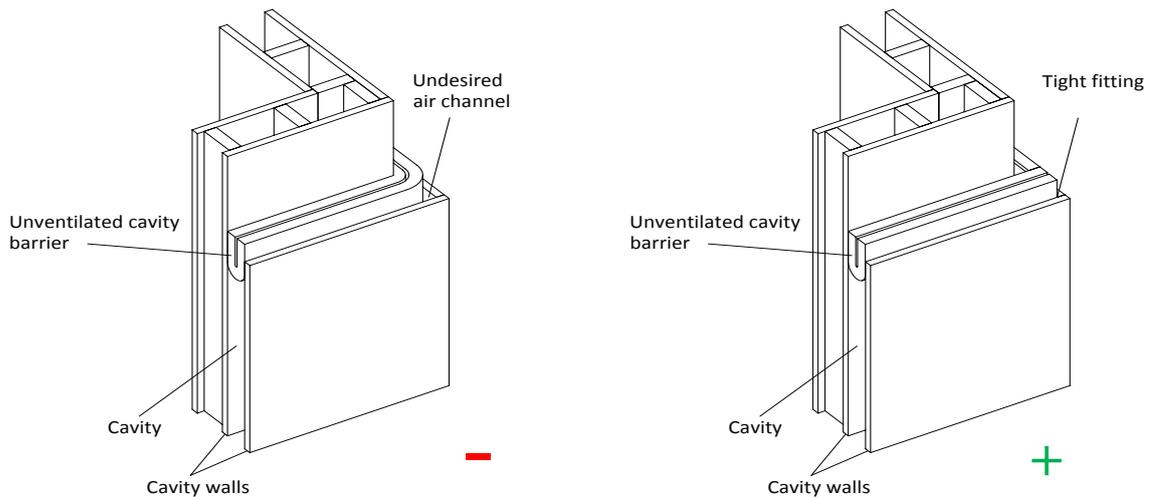
Undesired air channels can be avoided by design. Such undesired air channels could occur in corners and bends of the fire stop material, as shown in Figure 21. Solutions can be obtained by designing separate fire stops which are connected, instead of using bended fire stop in corners.

Figure 21: Possible risk for undesired air channel in the outer corner

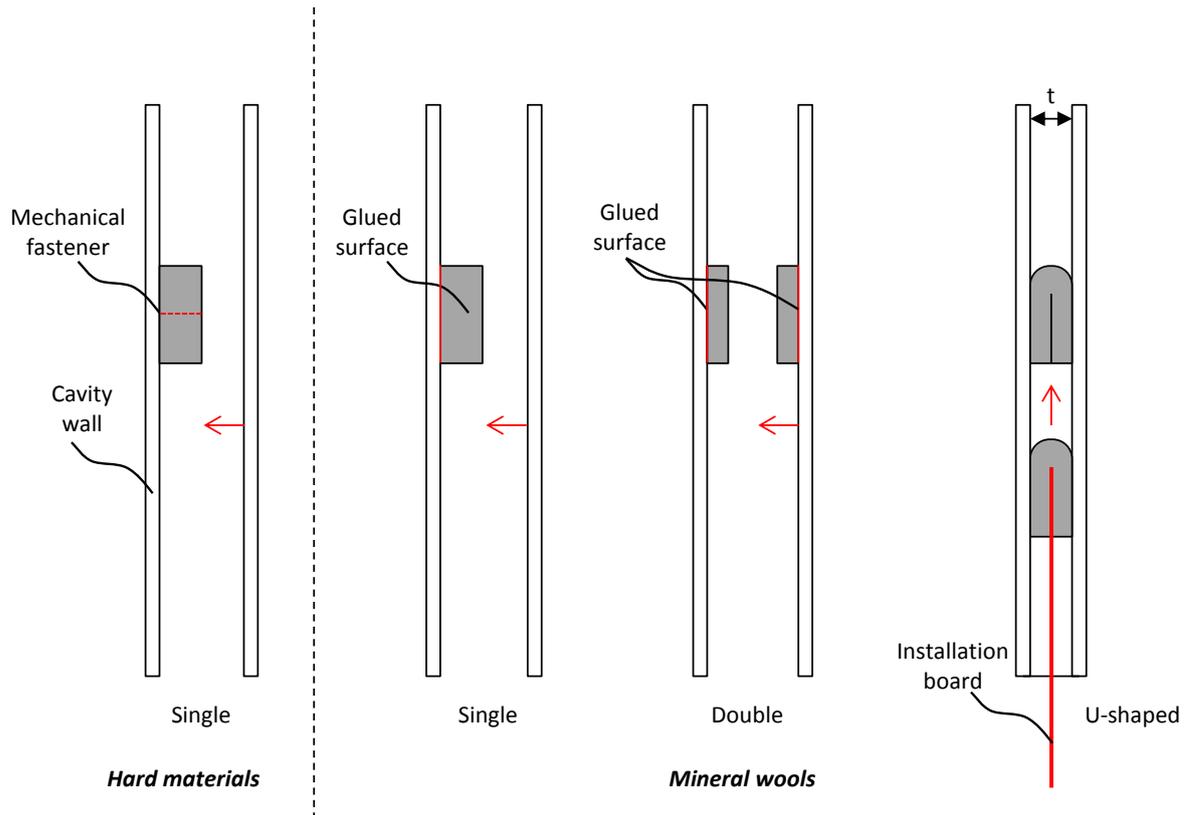
A schematic drawing concerning the installation of single, double or U-shaped placed fire stops is shown in Figure 22. The single and double placement of fire stops is especially applicable for cavities between modules of modular buildings. In this case the fire stops should be fixed to the cavity wall before the cavity is closed. Gluing of the cavity with high temperature resistant adhesives is recommended. For fire stops with a double placement, misalignment is allowed as long as the height of the contact area between the fire stops is equal or higher than the maximum of 75mm and $1.5 \times t$ (see Figure 23).

Figure 22: Schematic drawing of installation (red arrows indicate movement of assembly parts)

The U-shape placement should be done using an installation board, as shown in Figure 22 and Figure 24. The intended position should be ensured using this installation board, which is especially relevant at the locations of joints. The resistance of the board should be used to indicate whether the fire stop is installed firmly.

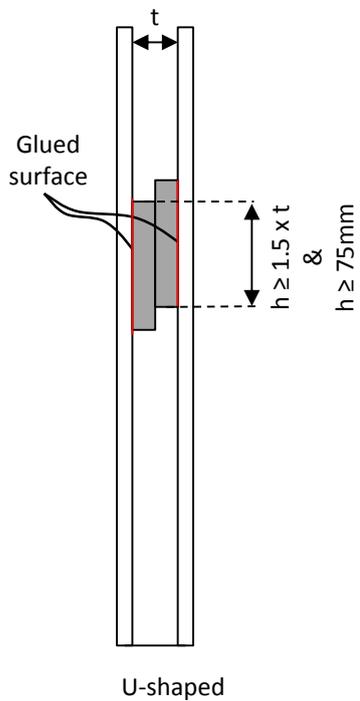
Figure 23: Allowable geometrical misalignment

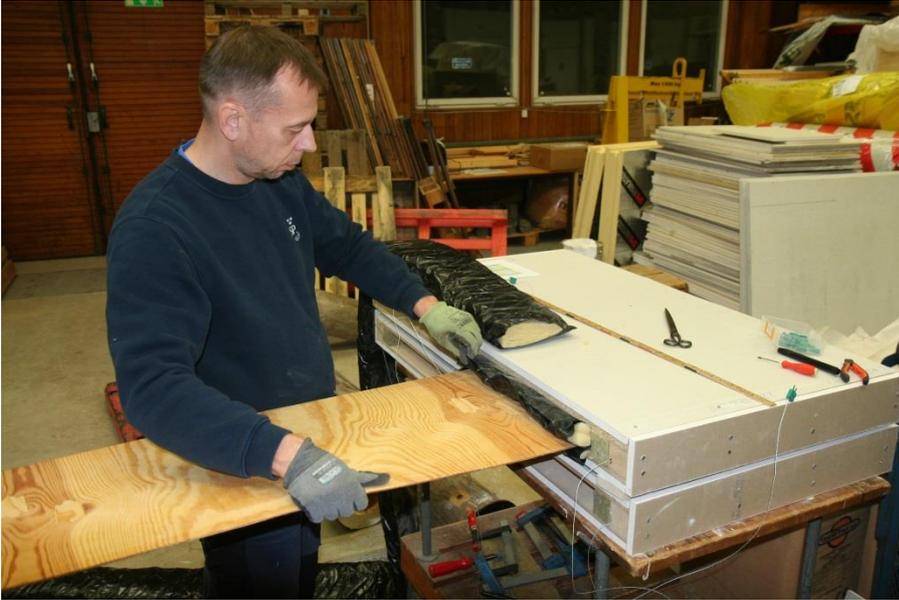
Figure 24: Sliding fire stop into the cavity for a U-shaped placement

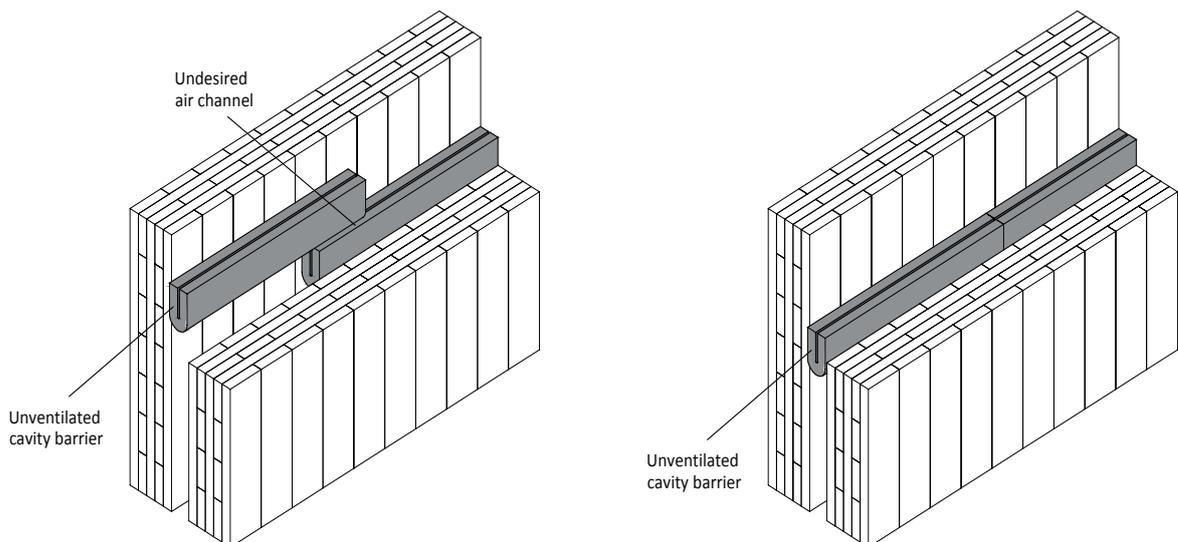
Joints between fire stops should be made, so that air channels in the joint are avoided. Using fire stops with a U-shaped placement could lead to undesired air channels in joints, as shown in Figure 25. Therefore, in-line and butt-joints are recommended for fire stops with a U-shaped placement. However, an overlapped joint, as shown on the left hand side of Figure 25, can be applied if (1) the length of the overlap is at least equal the height, h , of the fire stop and (2) the cavity is made of mineral wool without plastic covering. It must be ensured that both fire stops in one joint are placed tightly against each other.

Figure 25: Possible risk for undesired air channel with overlapped joint

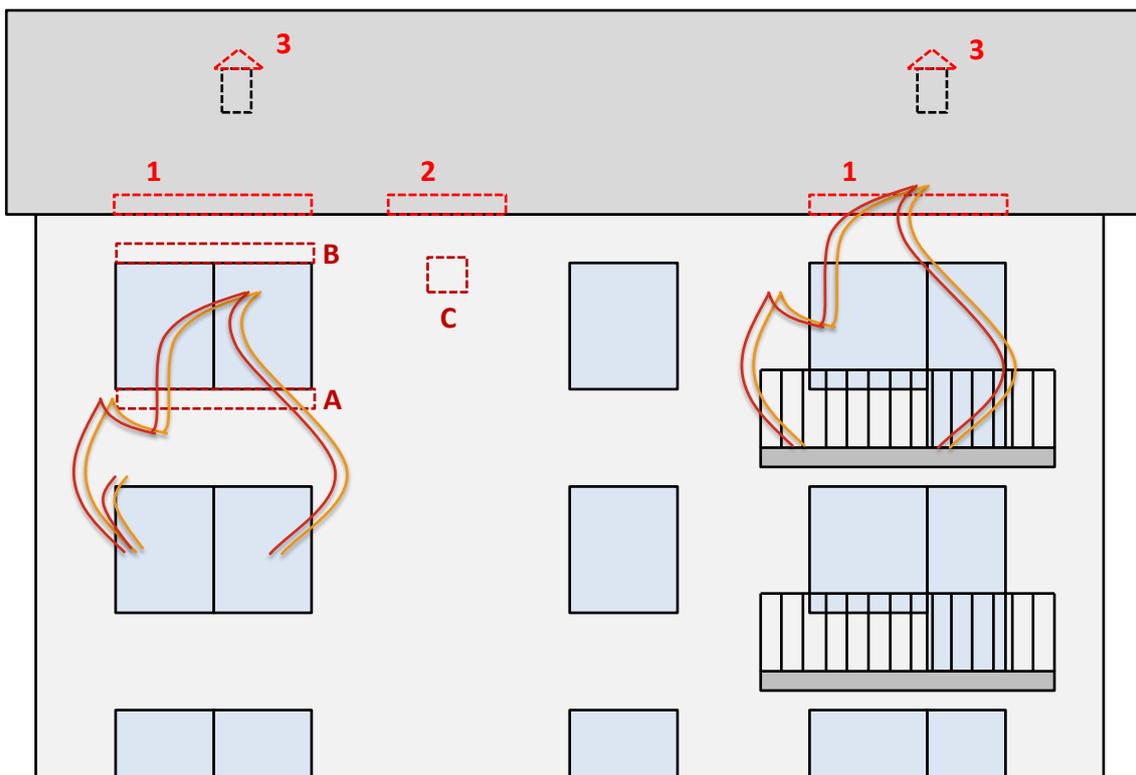
Ventilation openings for attics are commonly positioned at the façade at the eave (locations 1 and 2 in Figure 26). Ventilation openings placed above the window (location 1 in Figure 26) have been the access for fire spread to the attic in multiple building fires. A ventilation opening at location 2 instead of location 1 in Figure 26 reduces the risk of fire spread to the attic. However, dependent of the design of the roof, the fire plume may travel horizontally under the eave and potentially reach the ventilation opening at location 2. Therefore, it is recommended to apply fire stopping solutions in attic vents under the eave or to ventilate through other means such as mechanical ventilation using an air supply from other locations.

Ventilation openings for compartments are often positioned under windows (location A in Figure 26). However, in case of a flashover fire in the apartment below this ventilation opening, the fire plume may reach into this ventilation opening, increasing the risk of fire spread to multiple fire compartments. This risk is significantly smaller if the ventilation opening is above the window (location B in Figure 26). The risk is significantly more reduced if the ventilation openings are not positioned above windows or balconies or other potential sources of large fire plumes (location C in Figure 26).

Figure 26: Common locations of ventilation openings for attics and other compartments

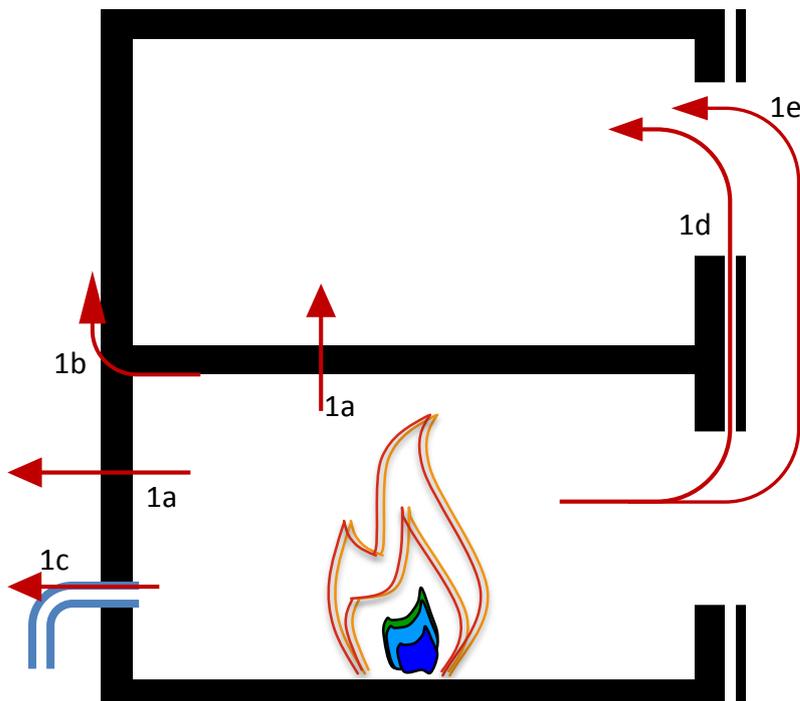
- a. Limitation of spread through the wall or ceiling
- b. Limitation of fire and smoke spread through connections between CLT slabs
- c. Limitation of fire and smoke spread through wall and ceiling penetrations
- d. Limitation of fire spread via the cavity of the façade
- e. Limitation of fire spread via the façade surface.

Figure 27: Potential paths of fire and smoke spread out of the compartment considered for the building design

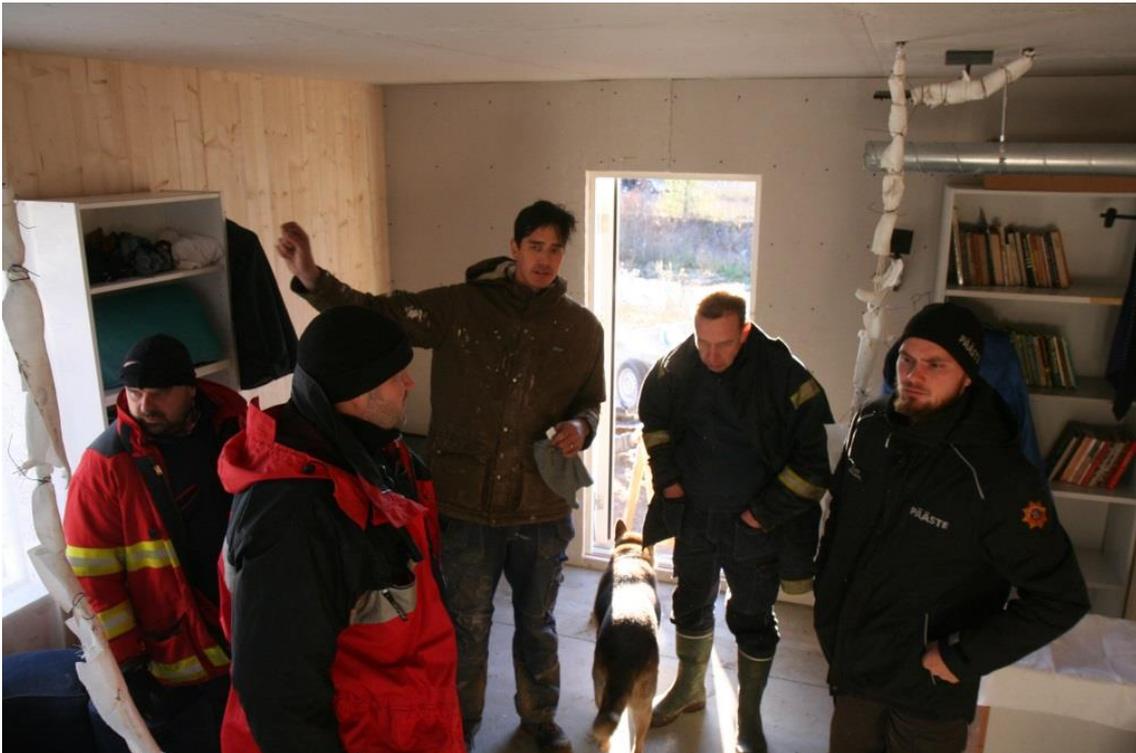
The interior dimensions of the compartments on both floors were 4.5m x 3.5m x 2.5m (depth x width x height). Both compartments had two windows of 1.5 x 1.5m. The windows on the lower floor were intentionally broken 20 minutes after ignition, to allow flashover to occur.

Figure 28: Interior of compartment before the fire test

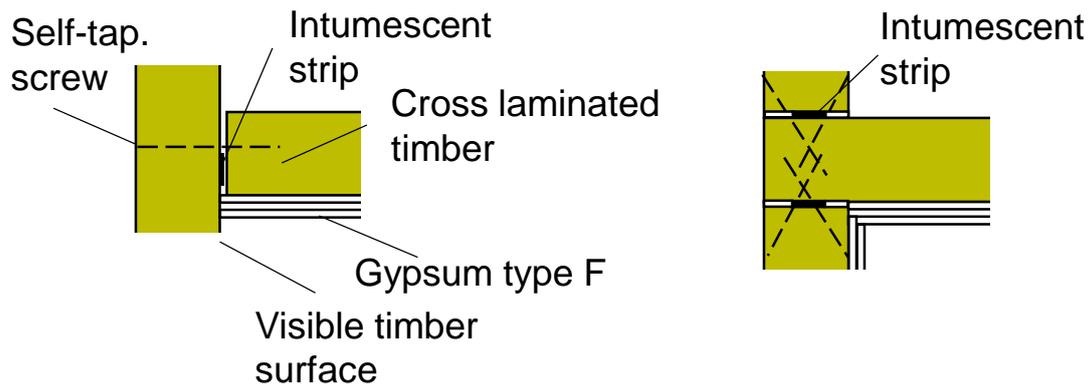
Connection configurations in which the ceiling is positioned on top of a wall (see, Figure 30, left) and of connections in which the ceiling is hanging besides a continuous wall (see, Figure 30, right) were, both, tested. The largest gap measured between a CLT wall and the CLT ceiling panel was 14 mm (Figure 31).

Figure 30: Implemented connections between floors and walls
