BRANDFORSK
2018:2:2

Mitigation of fire damages in multi-storey timber buildings – statistical analysis and guidelines for design

RISE Report 2018:43

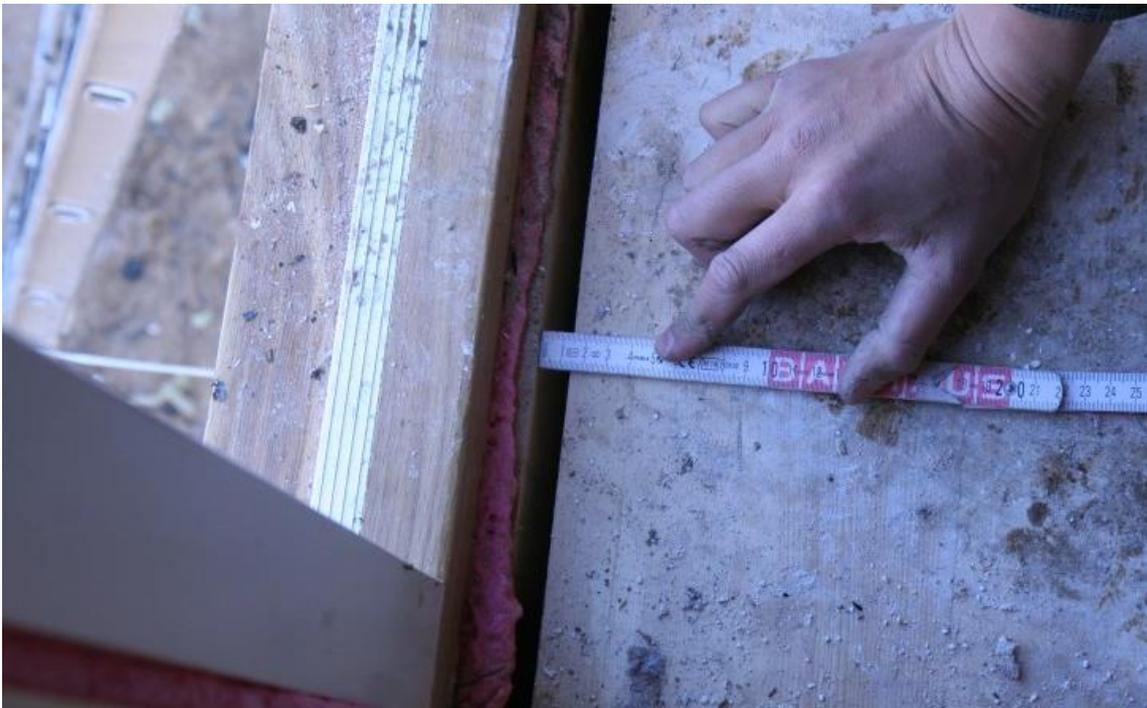
Figure 31: maximum gap measured (14mm) in between wall and floor slab

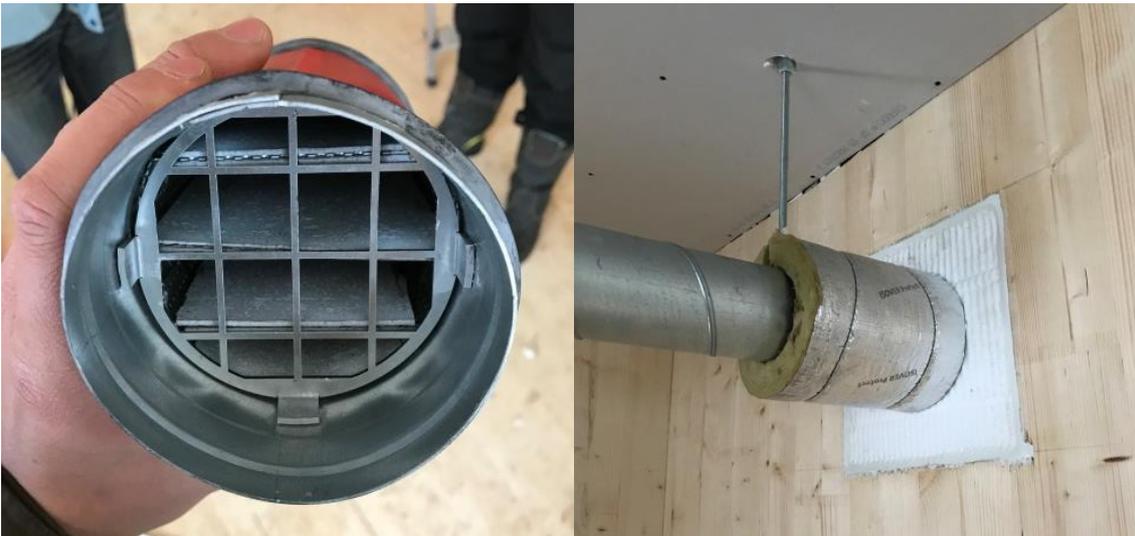
Several small wall and ceiling penetrations and one larger penetration for a ventilation shaft were implemented. The ventilation shaft had a grid with intumescent strips that expand at elevated temperatures to stop the fire from spreading. The shaft was partially protected by stone wool insulation. The ventilation grid was positioned in a hole through stone wool insulation with the same thickness as the wall (see Figure 33). The other small penetrations were for cables and tubes. These were sealed using fire caulk, rated for 60 minutes fire resistance.

Figure 33: Fire resistive ventilation grid (left) installed in an exposed CLT wall (right).

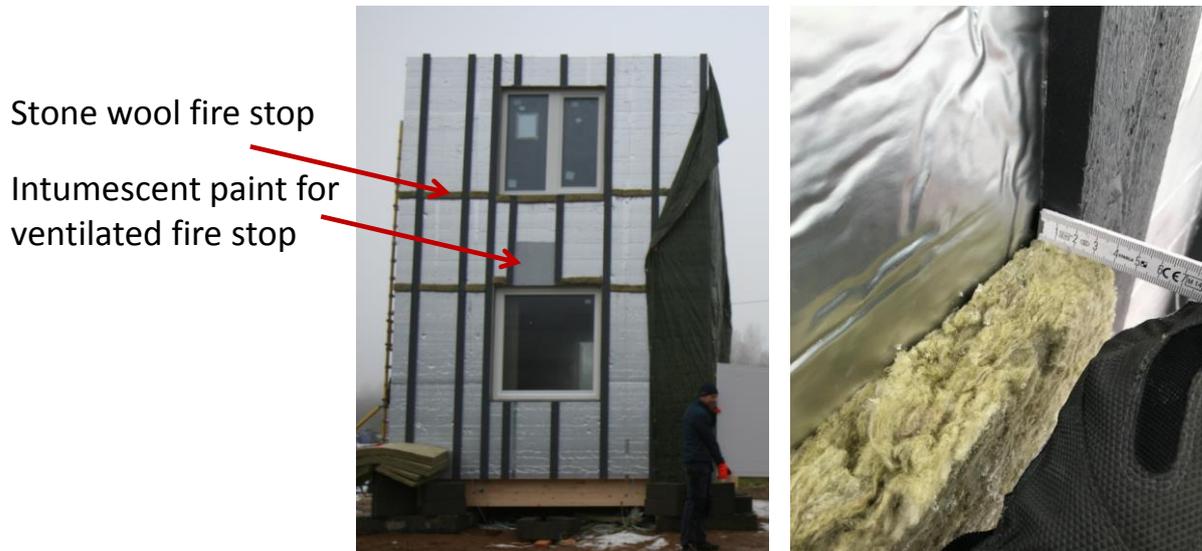
boards were attached, in horizontal lines just above and just below the windows (Figure 34). Additionally, to assess a method to limit fire spread in ventilated cavities a 500mm high layer of intumescent paint in a façade cavity above the fire plume of the window (a severely exposed location) was implemented. A stone wool fire stop, as described before, was positioned at the upper part of this cavity.

Figure 34: Fire stops installed during the construction phase

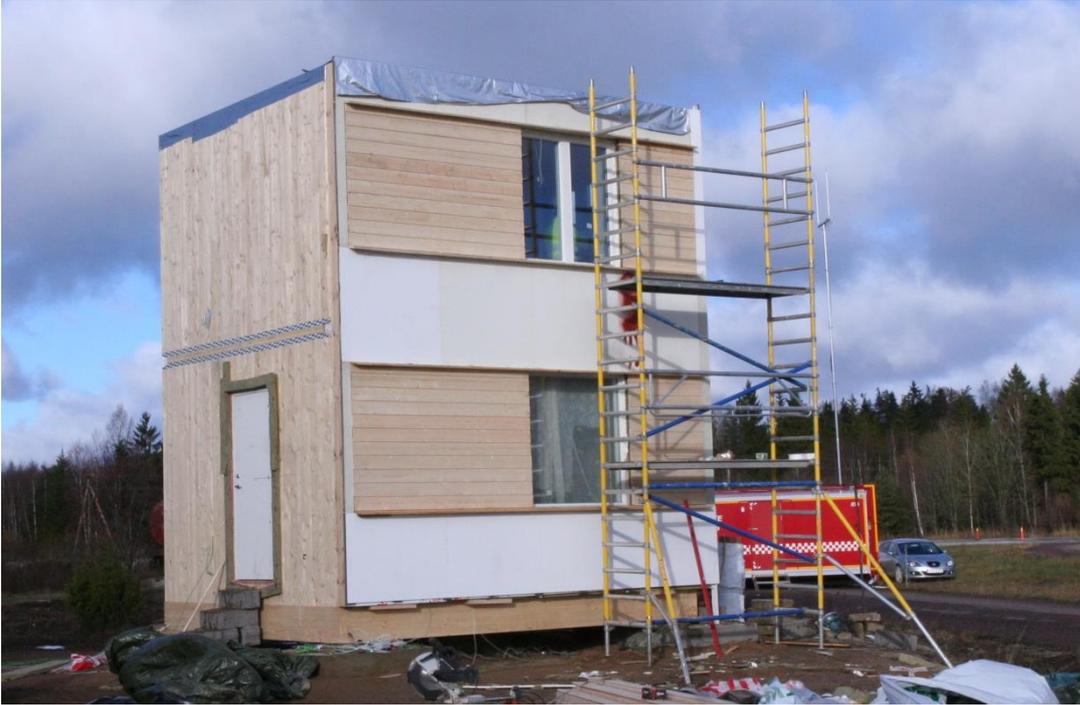
As timber is a combustible material, fire can generally spread on a façade with untreated timber. Treatment or impregnation of timber in a façade is, however, not recommended, as studied impregnations wear off within a few years. Therefore, this study seeks for a solution for implementing untreated timber in facades. Limiting the fire spread within the cavity is the first step of the strategy, as this can avoid heating the façade panels from two opposite sides. The fire spread on the façade is further limited by implementing a 1.2 meter strip of non-combustible cement board (see Figure 35). In order for the fire to spread from the first floor façade to the second floor façade, the fire needs jump over 1.2 meter of non-combustible material. 30 minutes fire resistant windows (EI30) were used in the second floor, in order to prevent fire spread to the upper floor.

Figure 35: Façade of the building with timber panels and non-combustible cement board strips.

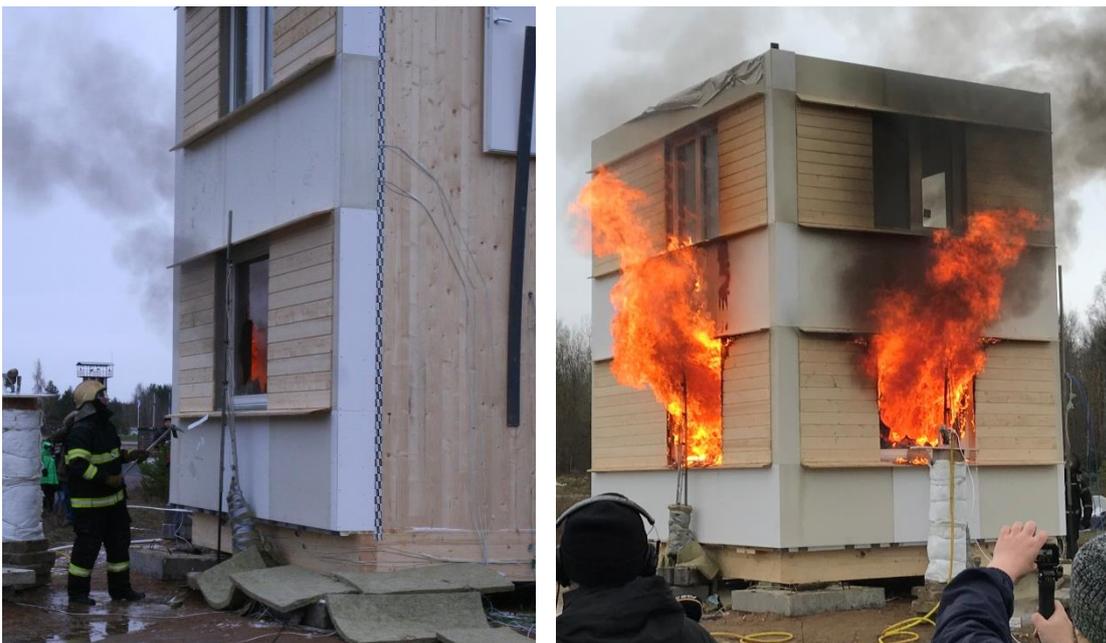
Figure 36: Breaking of the window at 0:20h (left) flashover at 0:47h (right)

Event	Testing time (h:mm)	Short description
Ignition	0:00	A couch against the long wall under the window was ignited using a highly flammable oil and a propane burner.
Breaking of window	0:20	In accordance with the test protocol, the windows of the ignited compartment were broken, because the gas temperatures decreased for at least 10 minutes. The lack of oxygen inside did not allow the fire to develop (see Figure 36, left)
Flashover	0:47	Flashover occurred and fire plumes were exiting both windows (see Figure 36, right)
Start of decay	1:05	The fire plumes on the outside disappeared and the temperatures inside the compartment started to drop.

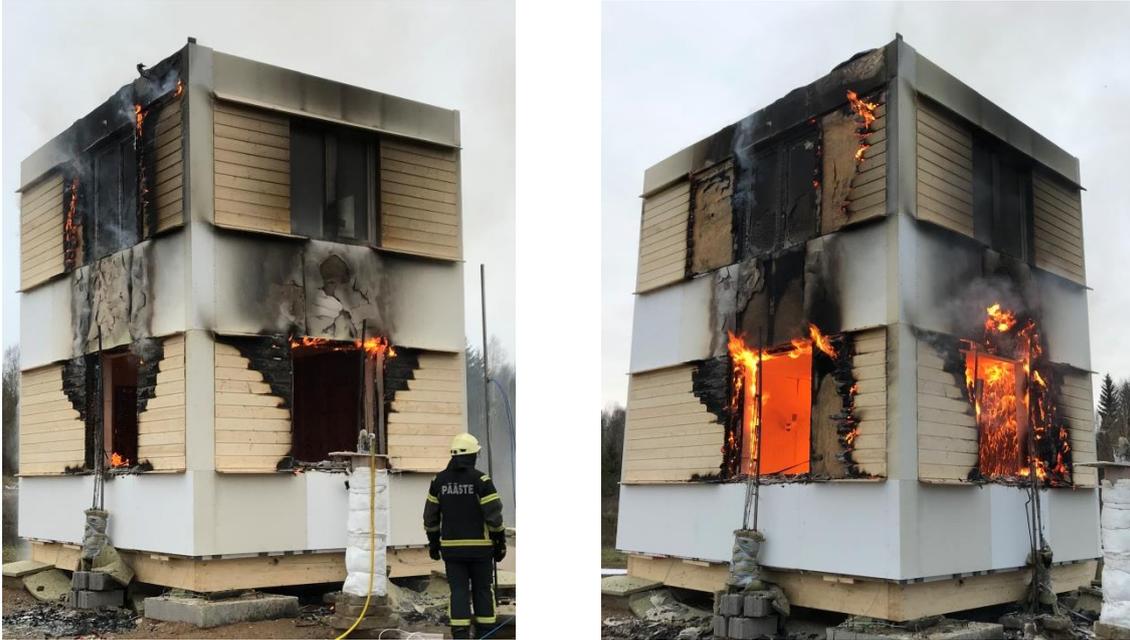
Figure 37: 35 minutes into the first decay phase at 1:17h (left) start of the second decay phase at 1:40h (right)

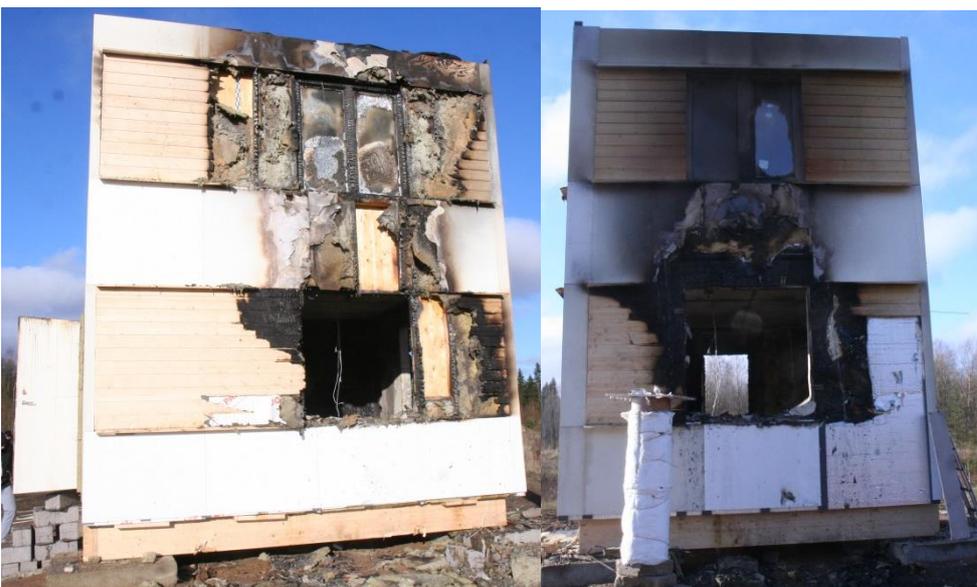
Fire spread via the façade was larger for the façade with stone wool insulation than for the façade with combustible PIR insulation. In the PIR façade, the timber façade panels on the second floor did not ignite. The façade with stone wool insulation had fire spread to the timber panels on the second floor. Both facades had similar cavities and similar fire stops in these cavities. Both of the 30 minute fire resistant windows withstood the fire without failure of the inner glass. It should be stated that there are numerous PIR insulation materials. The performance of this PIR insulation does, therefore, not guarantee similar performance for other PIR insulation materials.

Figure 38: Façade with stone wool insulation (left) and PIR insulation (right, some panels removed)

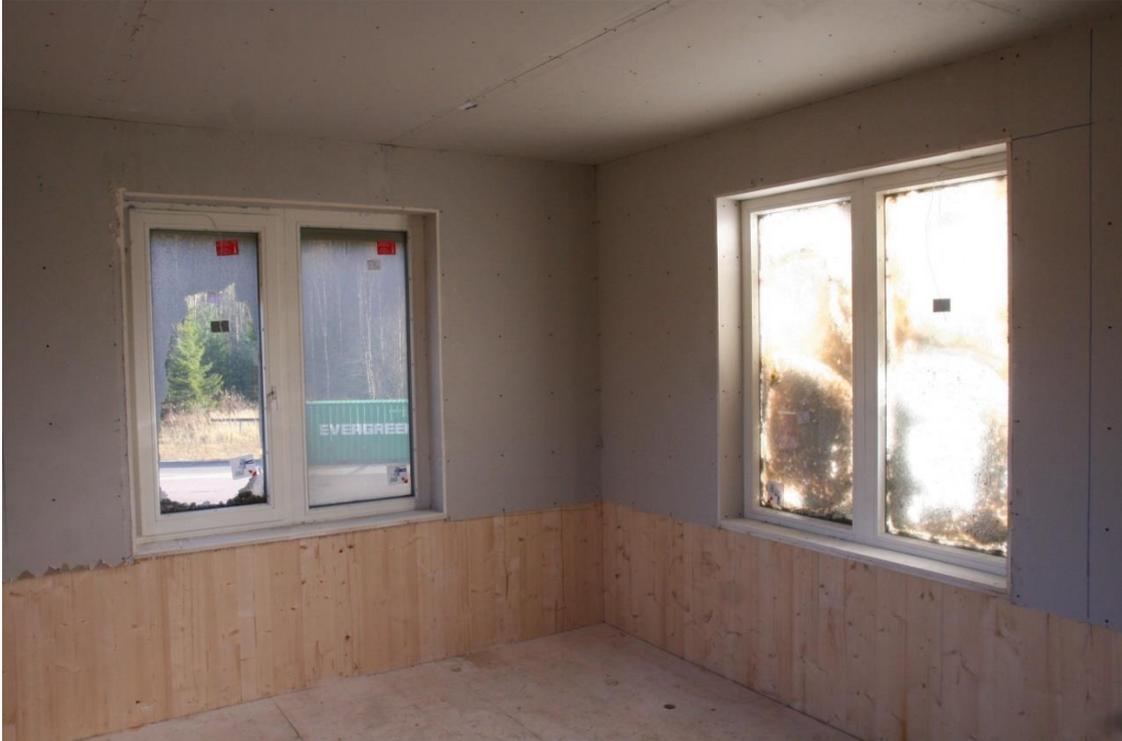
The interior of the upper floor was practically undamaged (Figure 39 and Figure 40). Besides some minor colouring of an area of approximately 30 cm², no fire damage could be seen. The intumescent strips in corner connections of the CLT elements expanded and the temperatures measured on the unexposed side did not indicate any fire spread.

Figure 39: 2nd floor after the test

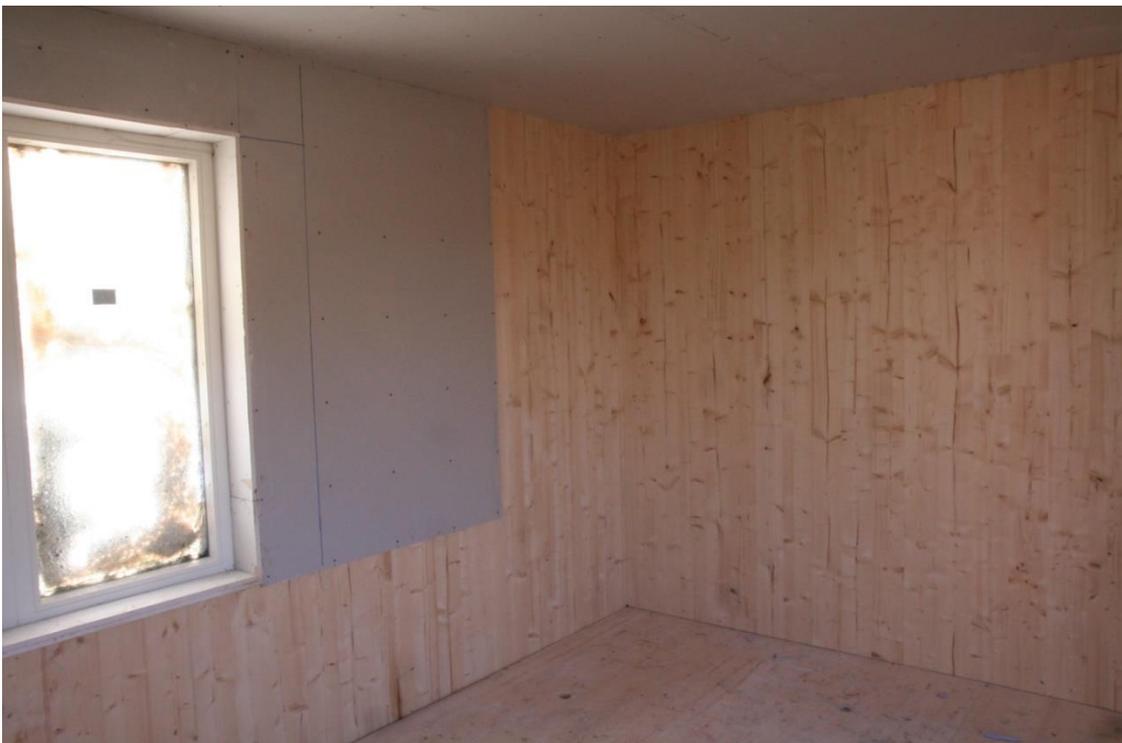
Figure 40: 2nd floor after the test (some minor colouring seen in the bottom of a wall)

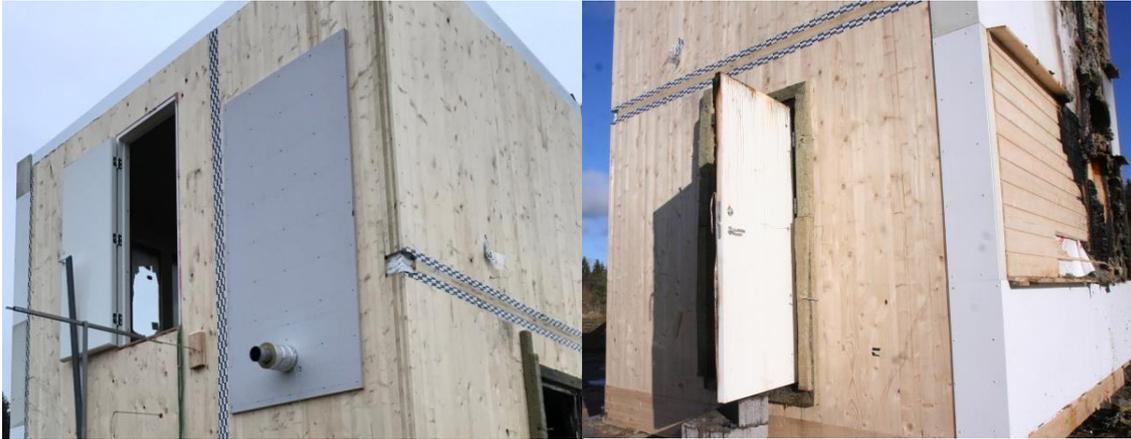
Temperatures measured on the none-exposed sides of penetrations did not indicate fire spread and remained close to ambient temperature. Thermal cameras indicated that, the temperatures on the unexposed side of connections and penetrations did not increase significantly. Also visually, none of the penetrations showed any sign of fire spread (Figure 41). The 30 minutes fire resistant door withstood the fire without complete integrity failure. However, during the decay phase a significant amount of material fell from the door, which made a loud noise and was observed visually through the window.

Figure 41: Unexposed side of the ventilation duct (left) and the 30 minutes fire resistant door (right).
