Cost-effective method to estimate fire protection treatment status on existing facades

Björn Källander
Konrad Wilkens
Nils Johansson

Keywords: fire-retardant-treated wood, facades, equilibrium moisture content, fire testing

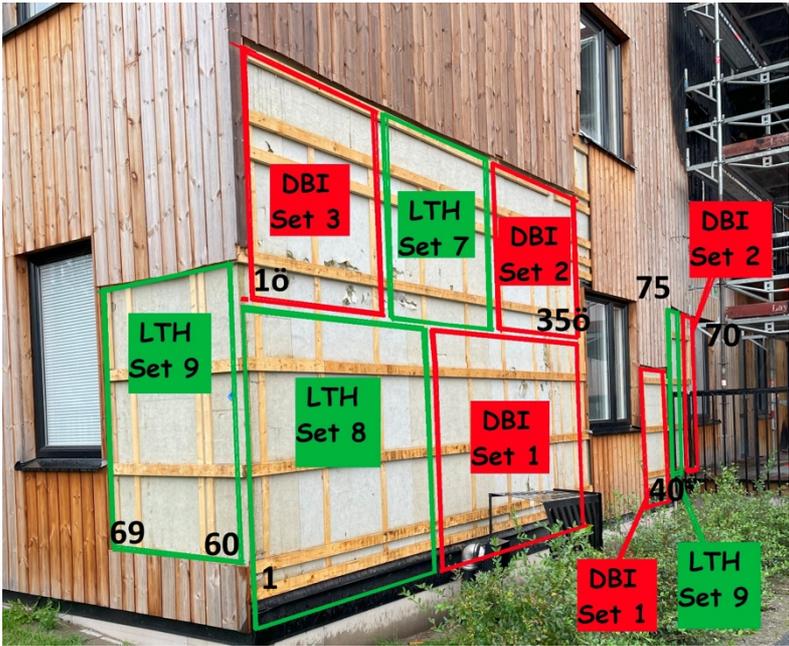
Figure 3: Exposed boards on the south-west side of the building. The shows what samples that were taken for tests at DBI for and for tests at LTH.

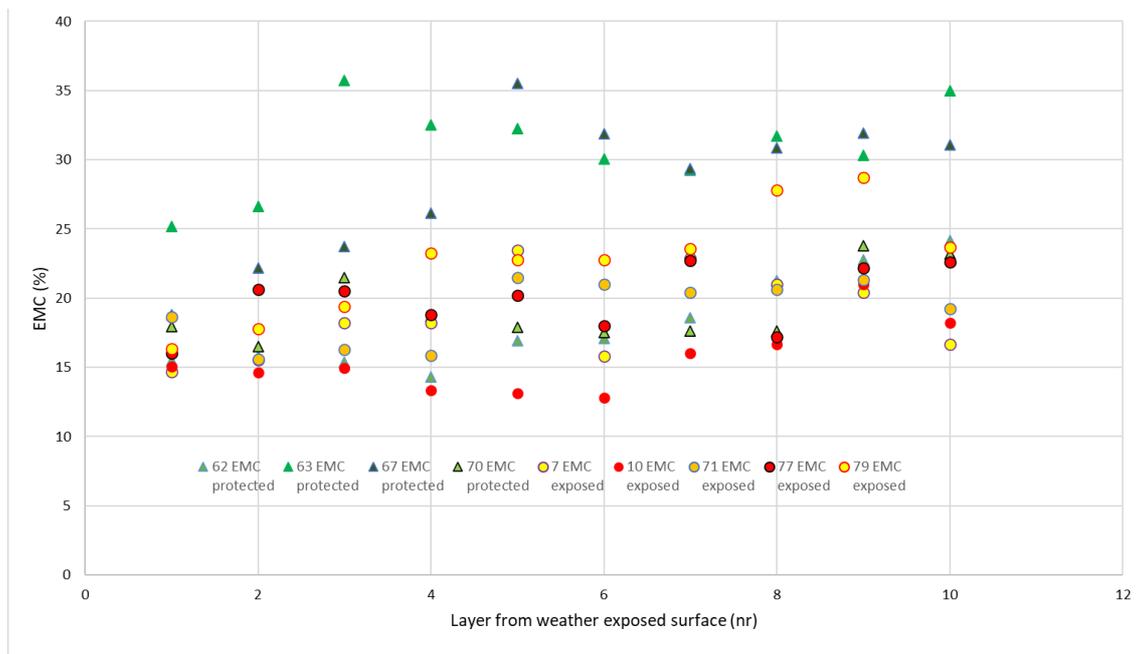
Figure 13: Individual EMC-gradient values Material C samples.

Figure 13 shows the individual EMC gradient values determined on samples treated with Burnblock taken from the house in Southern Sweden (Material C) and Figure 14 the average values from the same measurements. The EMC distributions of both the protected samples and the weather exposed samples show significantly lower EMC on the outer surface layers as compared to the layers towards the inside.

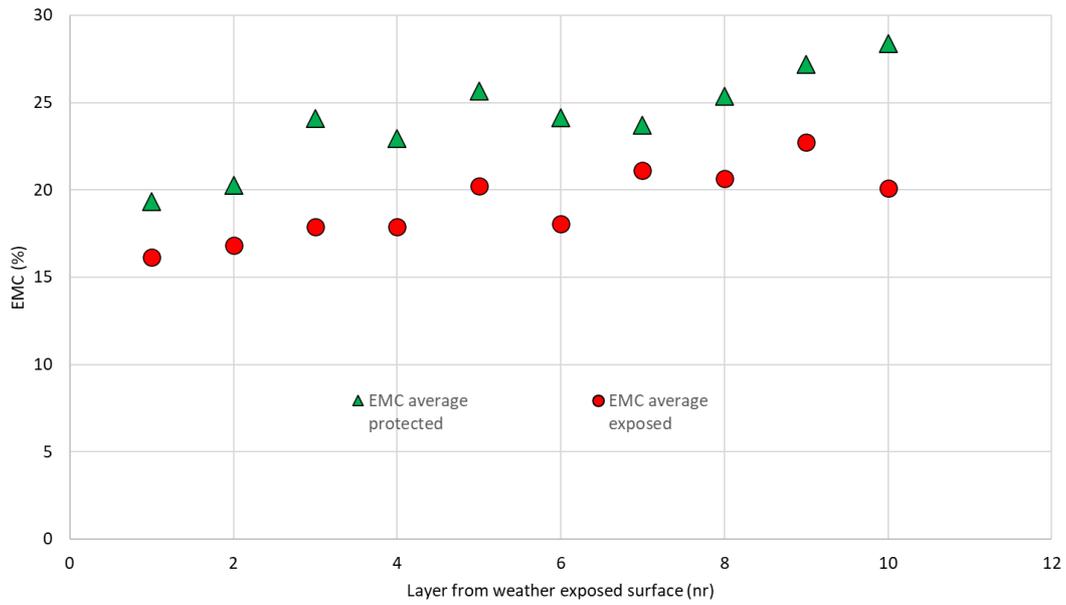
Figure 14: Average EMC-gradient for each layer in Material C samples.

The results presented in Figure 14 indicate that the Burnblock system (Material C), without polymer binder, show a gradient through the cross section from the inside of the boards to the outside, where the EMC of the wood close to the external surface is significantly lower than the EMC at the interior surface. This gradient is seen for both the protected and fully weather exposed samples. The EMC values also seem to be lower for the weather exposed material compared to the protected, as was seen in the cross sections. The gradient is a strong indication of migration of retardants from the interior of the façade towards the outside. Migration and consequently leakage have occurred both in the weather exposed boards and the boards protected against precipitation.

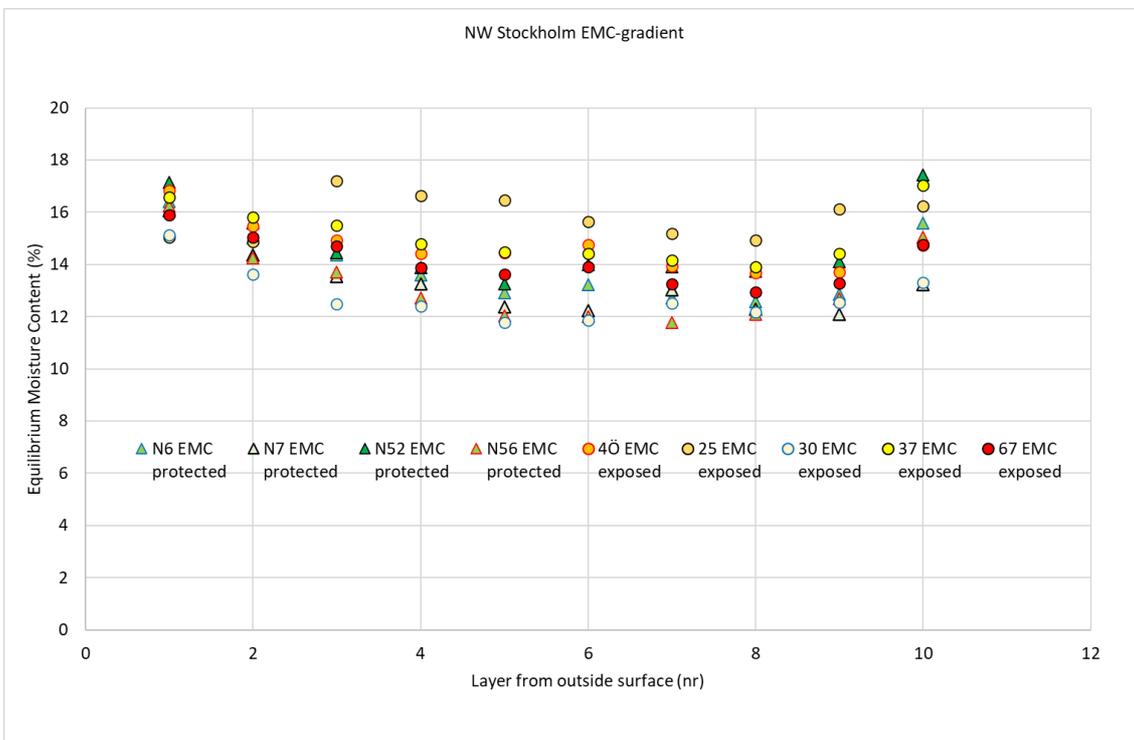
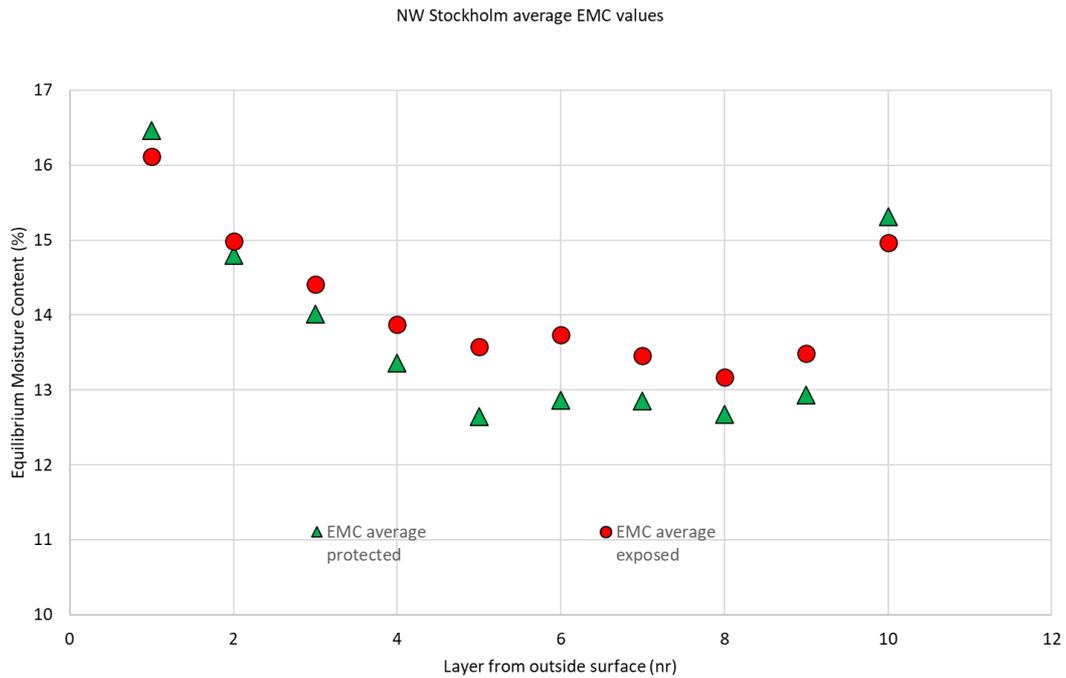
Figure 15: Individual EMC values for Material B samples.

The EMC pattern is principally different in the Material B (Woodsafe WFX) samples treated with polymer binder taken from the house NW Stockholm. Instead of a gradient through the cross section from the inside to the outside, the boards show a pattern with lower EMC in the core compared to both the inner and outer surfaces.

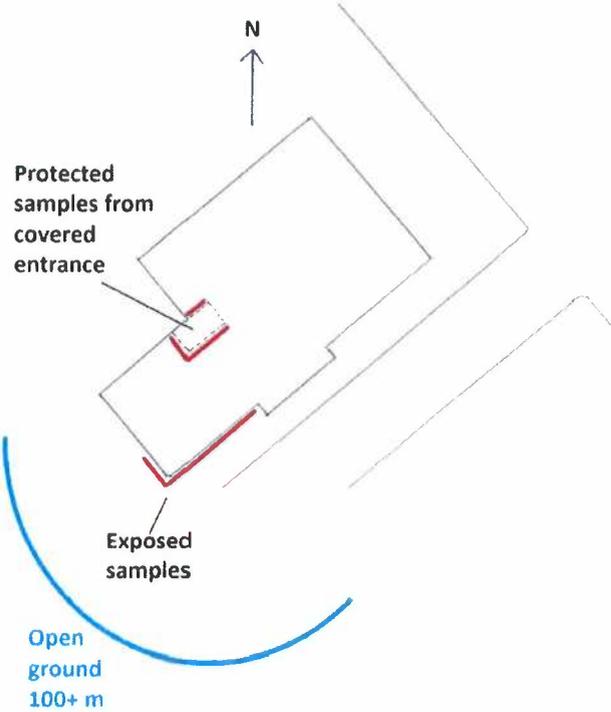
Location and numbering of protected samples

- SBI samples cut from lower end of boards
  - discolouration mainly above SBI-samples
  - exception samples N37, N38, N39 and N40

- Discolouration needs to be taken into account when building test samples
