# Large-scale ro-ro deck fire suppression tests

### **Large-scale ro-ro deck fire suppression tests**

SP Report 2009:29  
ISBN 978-91-86319-17-5  
ISSN 0284-5172  
Borås 2009

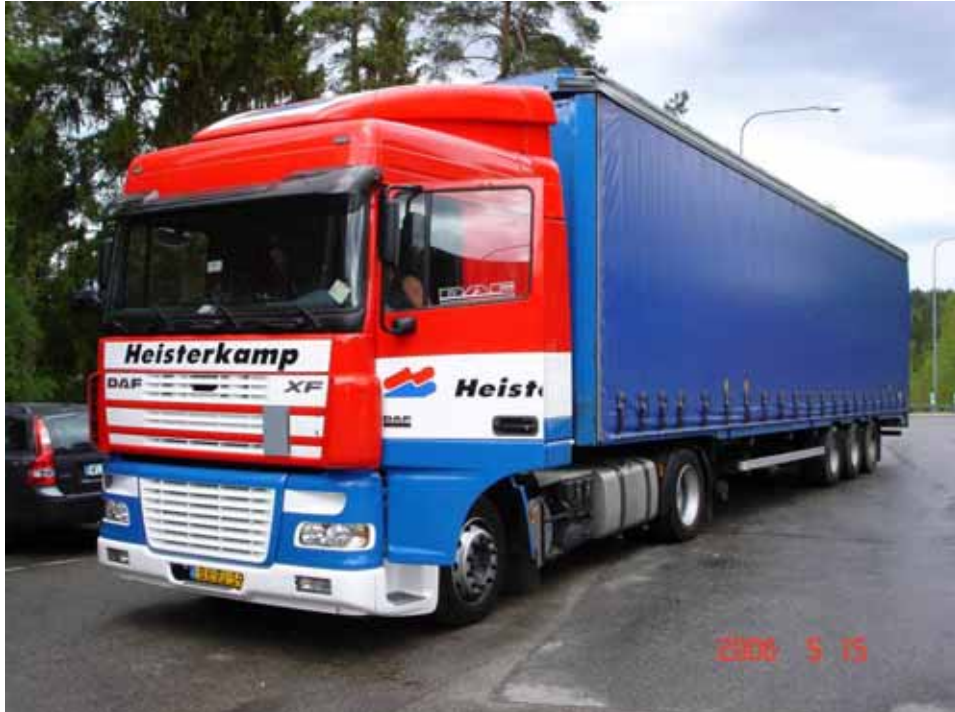
**Figure 2** A common type freight truck used throughout Europe, where the trailer is covered by a tarpaulin, both on the sides (“curtain sides”) and over the top.

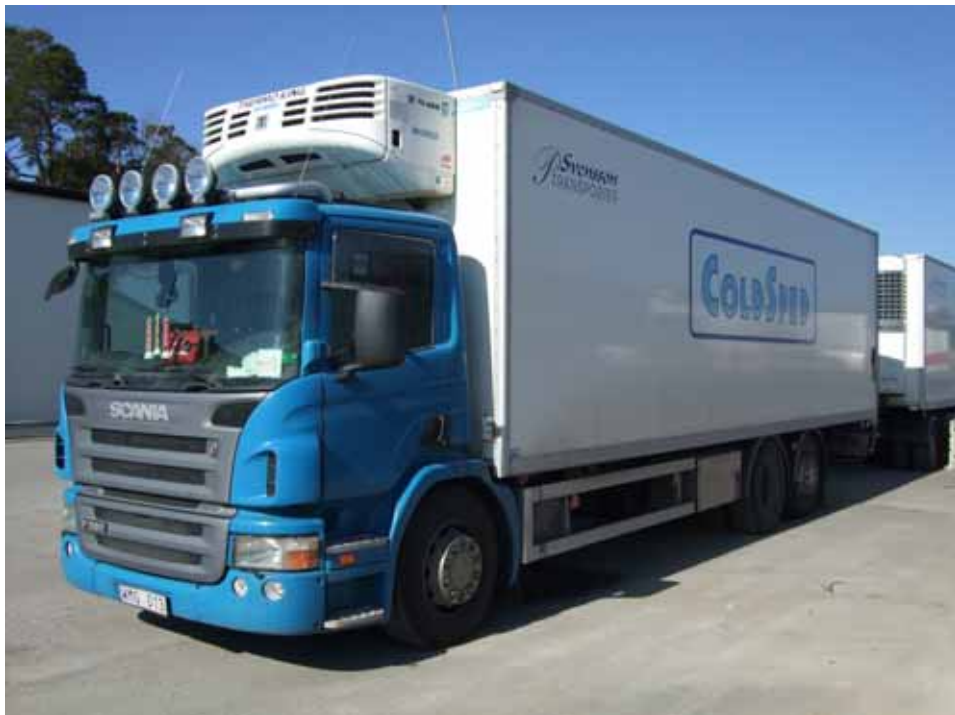
**Figure 3** A common type freight truck used for temperature controlled (freezer or refrigeration) transportation of for example food products.

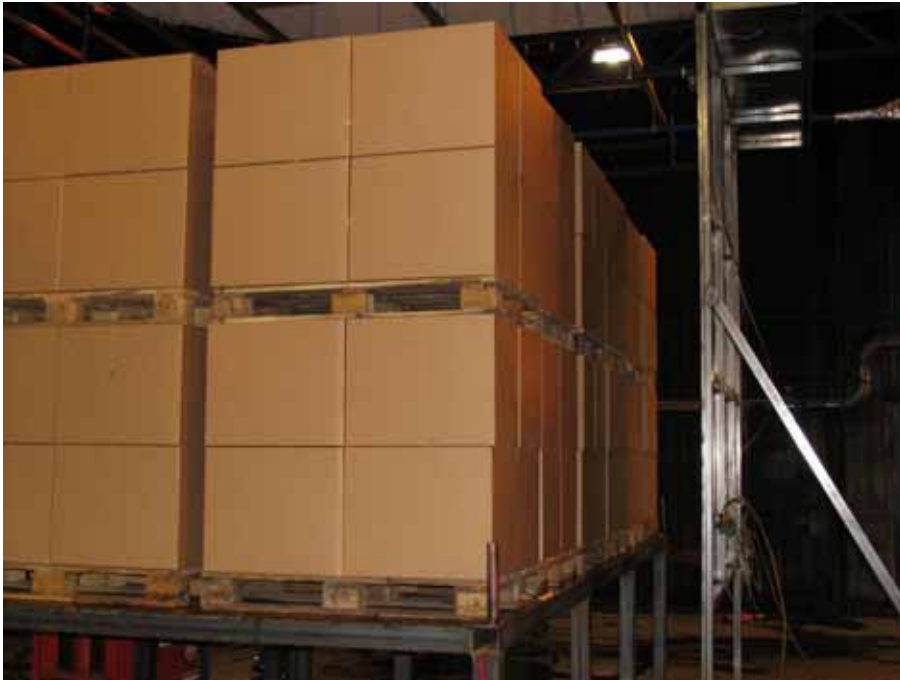
**Figure 4** An illustration of the arrangement of the commodity on the trailer mock-up, showing the steel screen on the right hand long side. A similar screen was positioned on the left hand side.

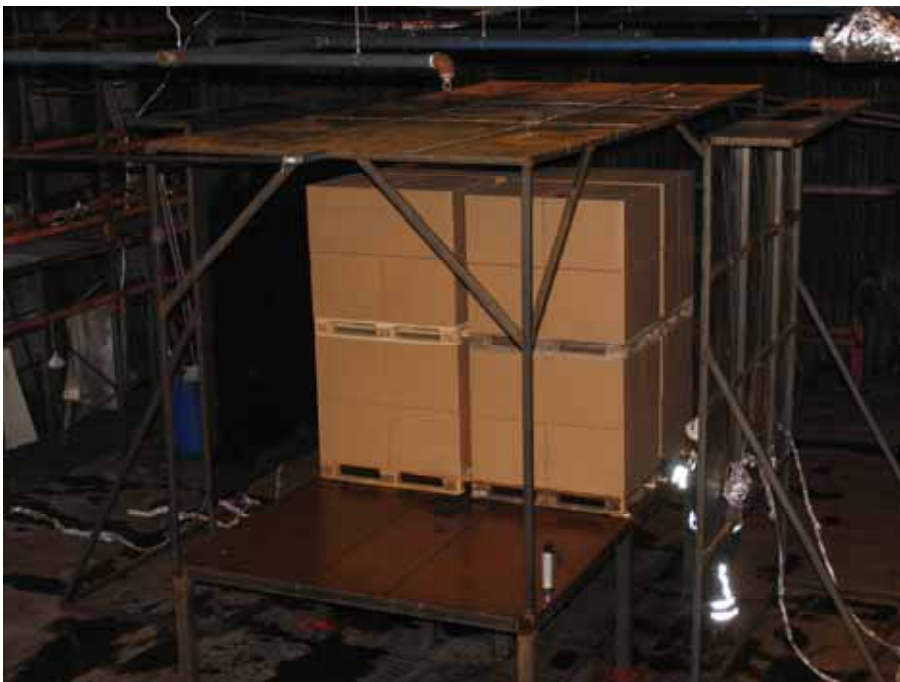
**Figure 5** The trailer mock-up with the roof installed. Note that less amount of commodity, two instead of six rows was used for these tests.

For the tests with the roof of the trailer mock-up the amount of commodities was reduced to two rows, i.e., one third of the amount of commodity used for the tests without the roof, see figure 5.

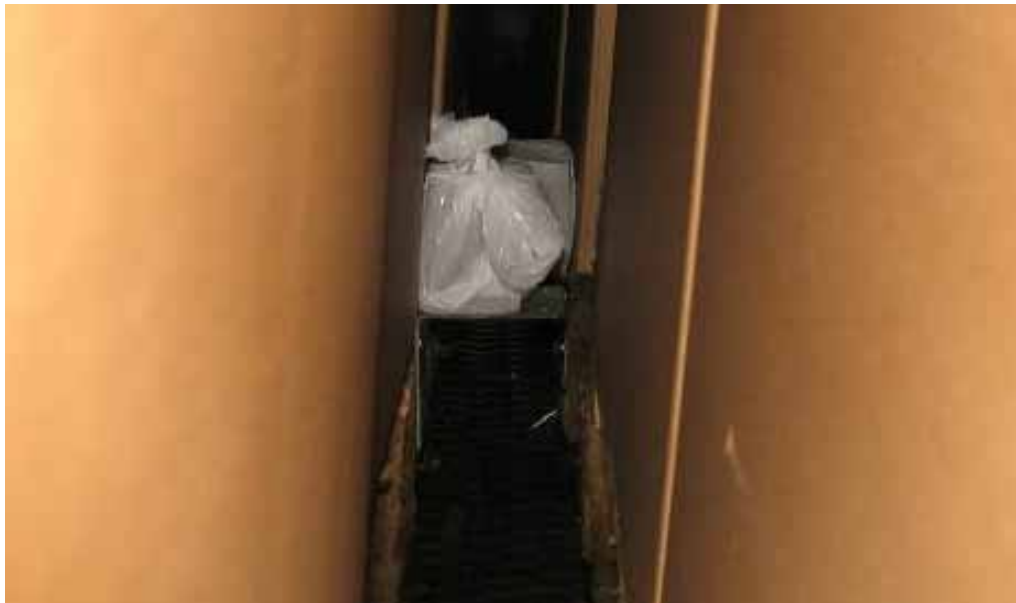
**Figure 13** The standardised igniters that consisted of a cube from pieces of insulating fibre board soaked with heptane and wrapped in a polyethylene plastic foil bag.

The commodity was ignited at the flue, near the bottom of the central stacks using four standardised ignition sources positioned directly against the corrugated cartons. The ignition source consists of a cube, 60 mm × 60 mm × 75 mm, made from pieces of insulating fibre board. Each cube was soaked with 120 mL of heptane and wrapped in a polyethylene plastic foil bag prior to the test.

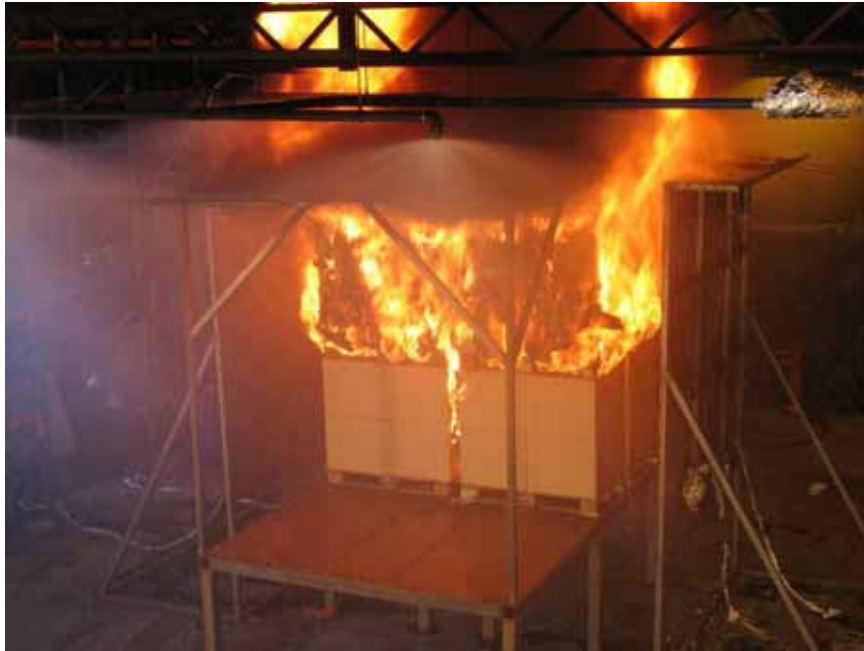
**Figure 16** The fire size at the manual activation of the system for the tests without the roof of the trailer mock-up, here exemplified with Test 5S(15). Time 02:13 [min:sec] after fire ignition.

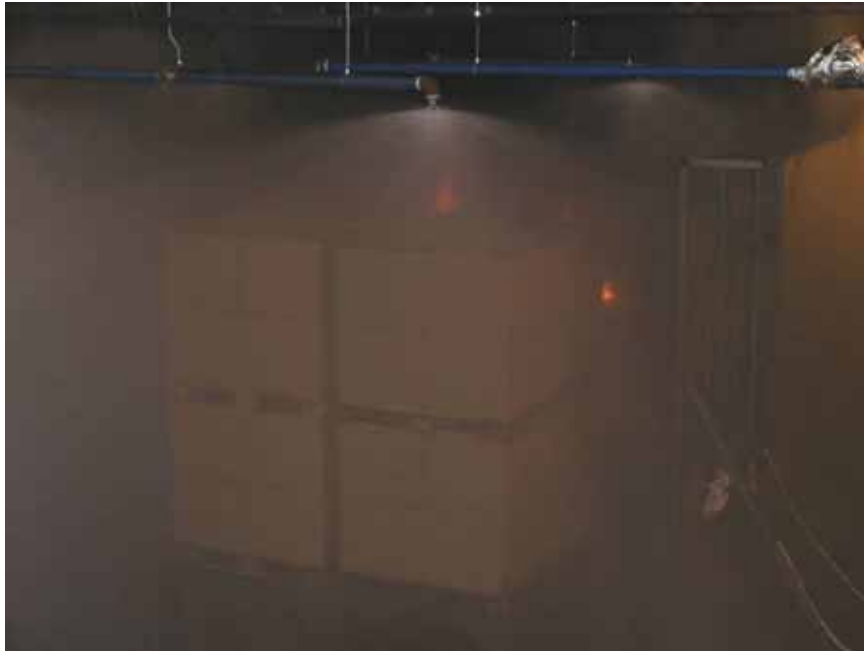
**Figure A-7**      **Test 1E(15):** Photo taken 03:00 [min:sec] after fire ignition. The fire is suppressed and only small flames are visible at the longitudinal and vertical flue spaces.

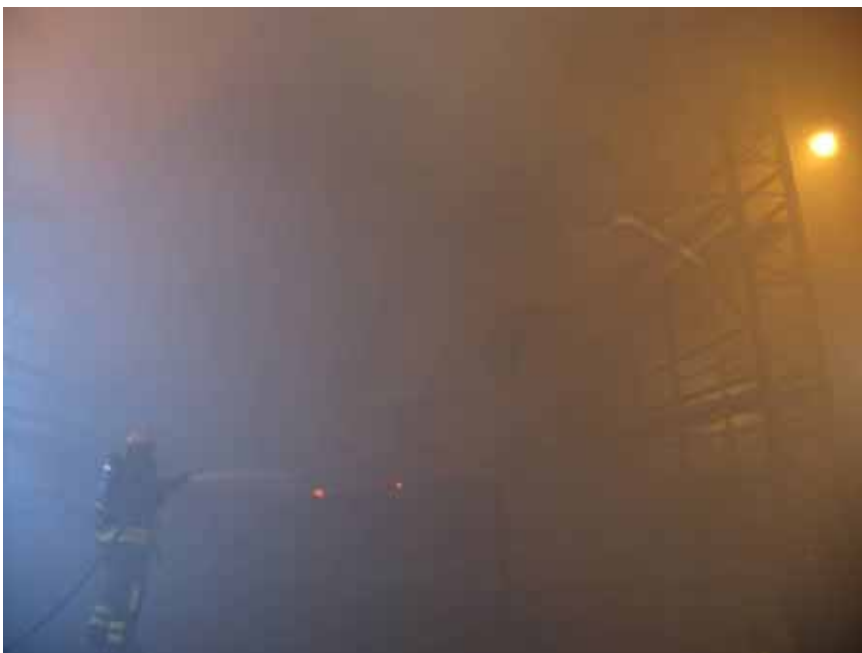
**Figure A-77** Test 7E(HP-5.8): Photo taken 30:15 [min:sec] after fire ignition. The high-pressure water mist system has been shut off and manual fire fighting of the remaining (small) fire has started.

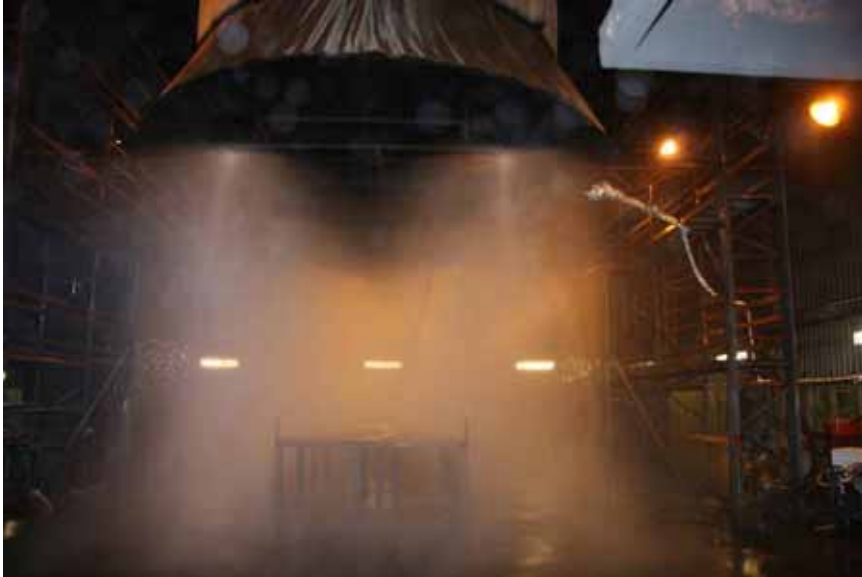
**Figure A- 81    Test 8E(10): The water spray from the nozzles prior to the test.**

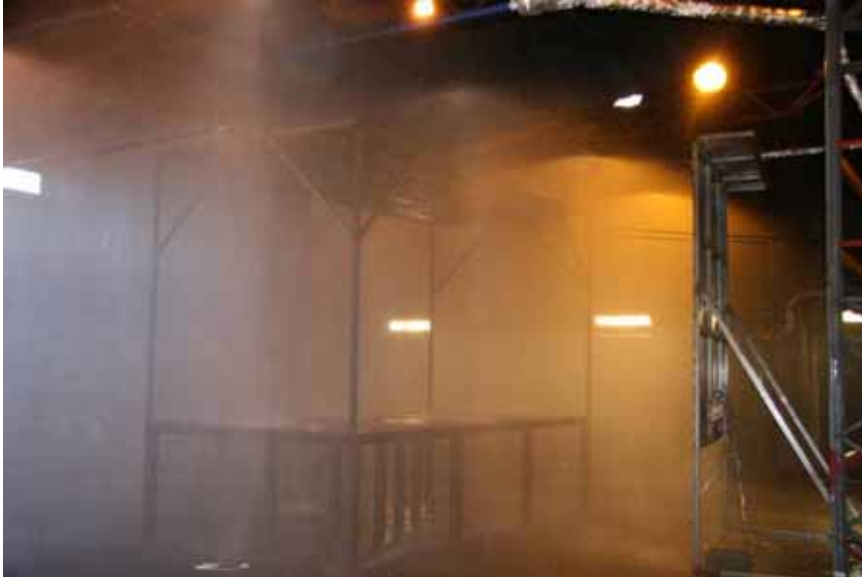
**Figure A-97** Test 1S(15): The water sprays from the nozzles prior the test.

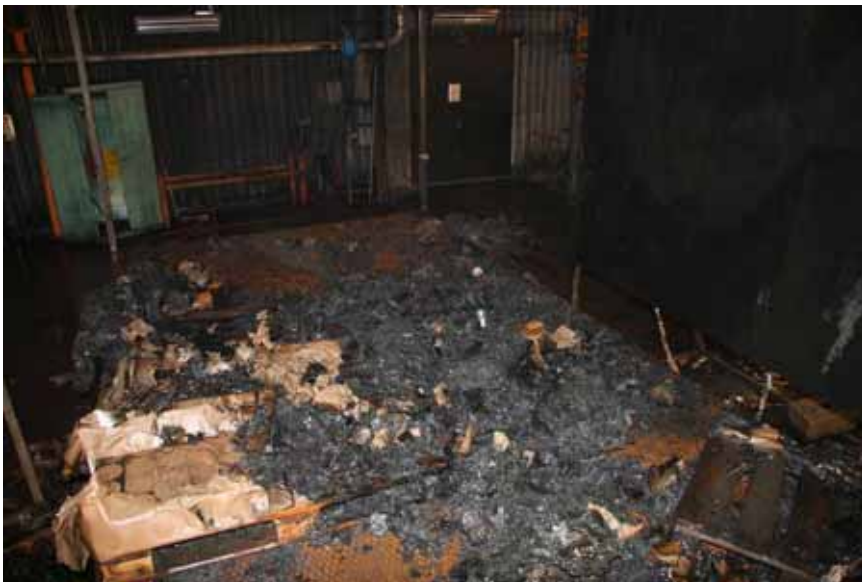
**Figure A-140** Test 4S(5): The fire damages after the test. Almost all combustible material is consumed.
