Validation data for room fire models;
Experimental background

Validation data for room fire models: Experimental background

SP Report 2016:54
ISBN 978-91-88349-56-9
ISSN 0284-5172
Borås 2016

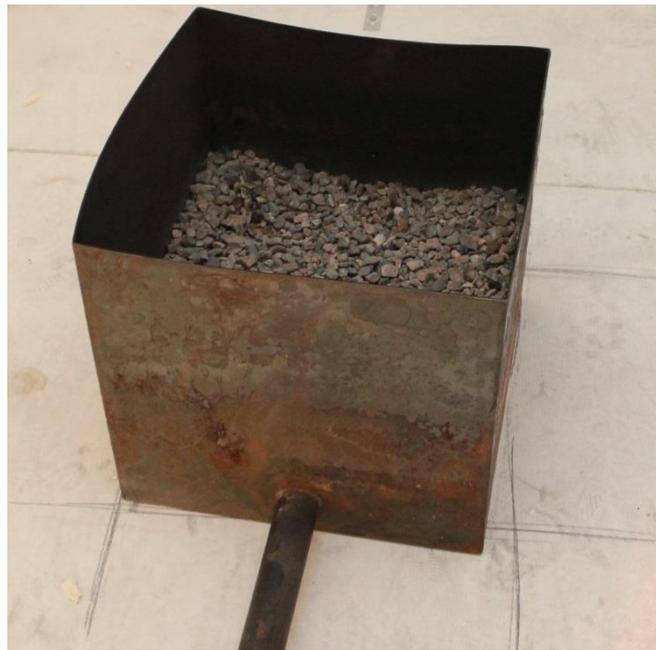
Figure 2. The propane sand diffusion gas burner used in all tests.

The fire source consists of a non-premixed propane burner with a controlled mass flux. The mass flux is calibrated such that it represents a specific heat release rate for free burning conditions, i.e. it has been tested under a calibrated oxygen consumption calorimeter where the mass flow is correlated to total heat release rate (HRR). This system has previously been used in tunnel fire experiments (Ingason, Appel, Li, Lundström, & Becker, 2014). The burner is a 300 mm by 300 mm square burner of stainless steel, see Figure 2. The gas inlet is through the wall close to the bottom of the burner and half the volume is filled with gravel (~10-20 mm stones). Five different fire scenarios were defined, see Table 1.

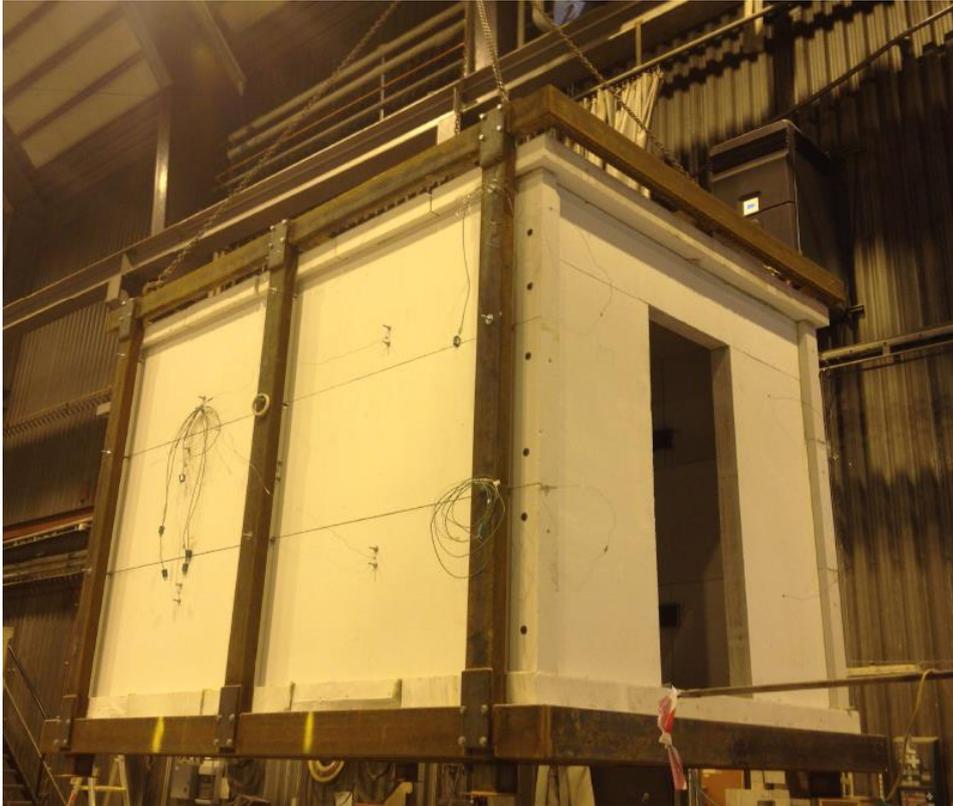
Figure 3. Test object A, enclosure made of 100 mm lightweight concrete, walls, ceiling as well floor.

Test series A was conducted on a structure from light weight concrete (LWC) of type Siporex with a thickness of 100 mm. Figure 3 shows a photo of the enclosure supported by a steel frame. The density of the material was measured before testing. Also, two samples from the same batch were used to measure moisture content by drying in a furnace at 105 °C during 24 h. The density of these samples were 754 and 767 kg/m³ containing 35 and 42 % moisture (as water content/dry material), respectively. More details are found in Table 2

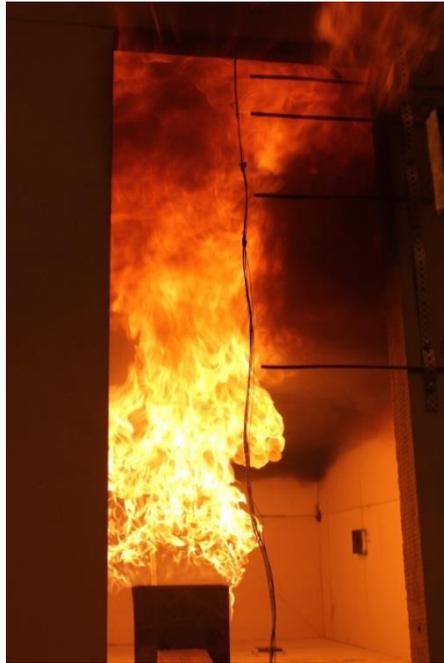
Figure 8. Photo from test A1 – virgin LWC, 1000 kW.

The burner was placed in the centre of the enclosure floor and burned at a constant rate of 1000 kW. Despite the symmetric setup the flames in the ceiling actually had a tendency towards the right side of the enclosure. This had a great impact on the temperatures which increased from left to right. A temperature gradient was also noticed in the back to front direction with higher temperatures closer to the opening compared to the back, most significant in the smoke layer. This was noticed both by both TC and PT temperature measurements.

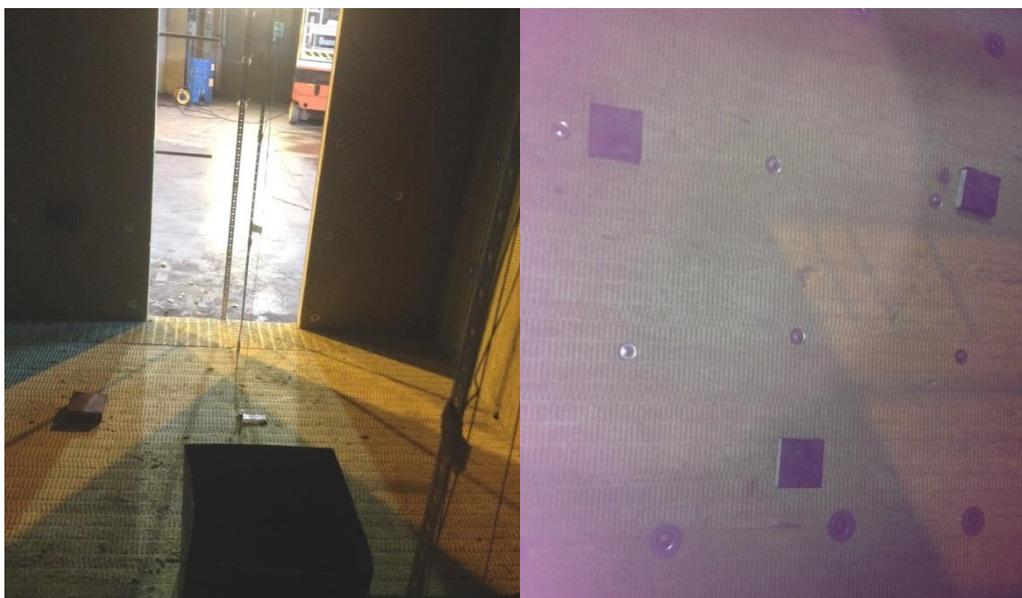
Figure 30. Photos of the interior surfaces of the test object before test B1.

The steel structure used in the remaining series was for series B insulated on the inside using stone wool with a nominal density of 200 kg/m^3 and a nominal thermal conductivity of 0.04 W/mK . The insulation thickness was 5 cm and therefore the enclosure inner dimensions were smaller in this series compared to all the other series. Figure 30 shows photos of the interior. The burner was placed in the centre and set at 1000 kW throughout the test. PT temperatures are shown from Figure 31 and Figure 32.
